## **Report 01-208**

**coastal passenger and freight ferry *Arahura***

**machinery space flooding**

**7 June 2001**

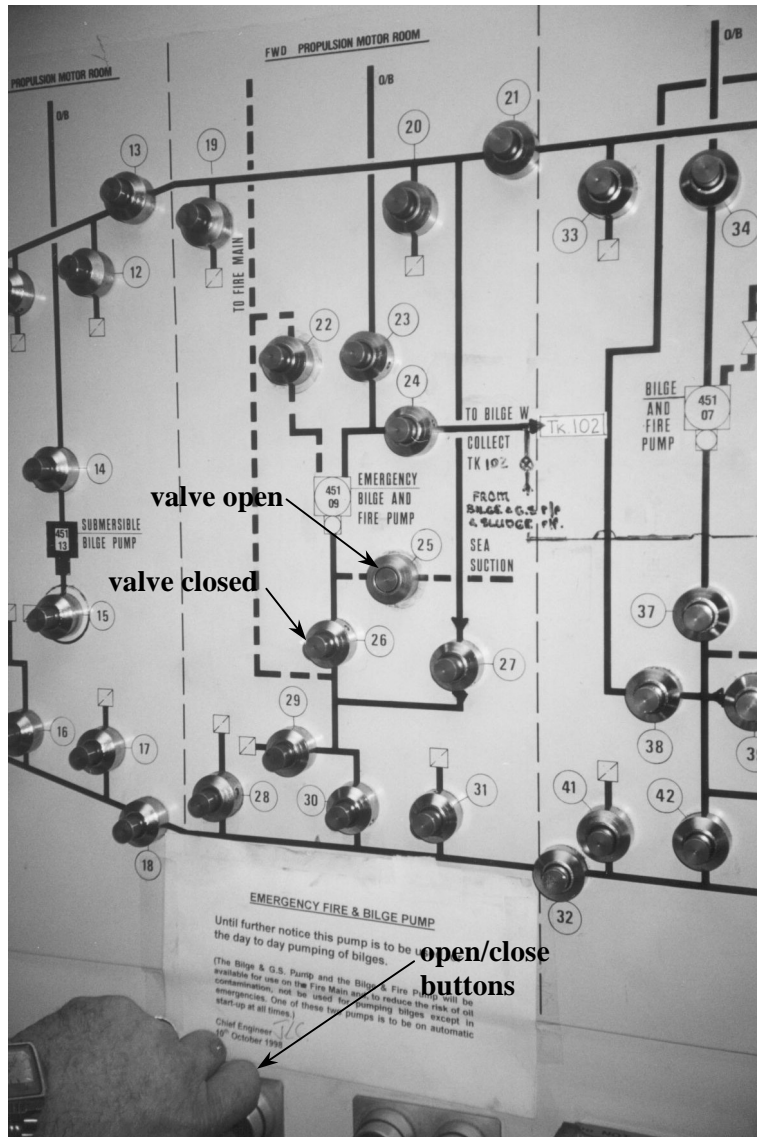
**Figure 6**  
Mimick panel

- 1.4.4 The valves in the bilge pumping system were all operated pneumatically from the engine control room or manually at the valve. They could also be operated from the emergency control centre situated on the bridge. The remote systems consisted of a mimic panel showing the valves, pipe work and pumps. Each valve had an open and close button below the mimic panel and an open and closed indicator in the valves position on the mimic panel. When the indicator button was protruding the valve was closed and, when flush, open (see Figure 6).
