# RAILWAY OCCURRENCE REPORT

02-101 derailments due to washouts and slips, various trains and locations

between 3 January 2002 and 19 January 2002

## express freight Train 841, Buller Gorge, 3 January 2002 express freight Train 929, Rangitata, 4 January 2002 express freight Train 720, Mina, 19 January 2002

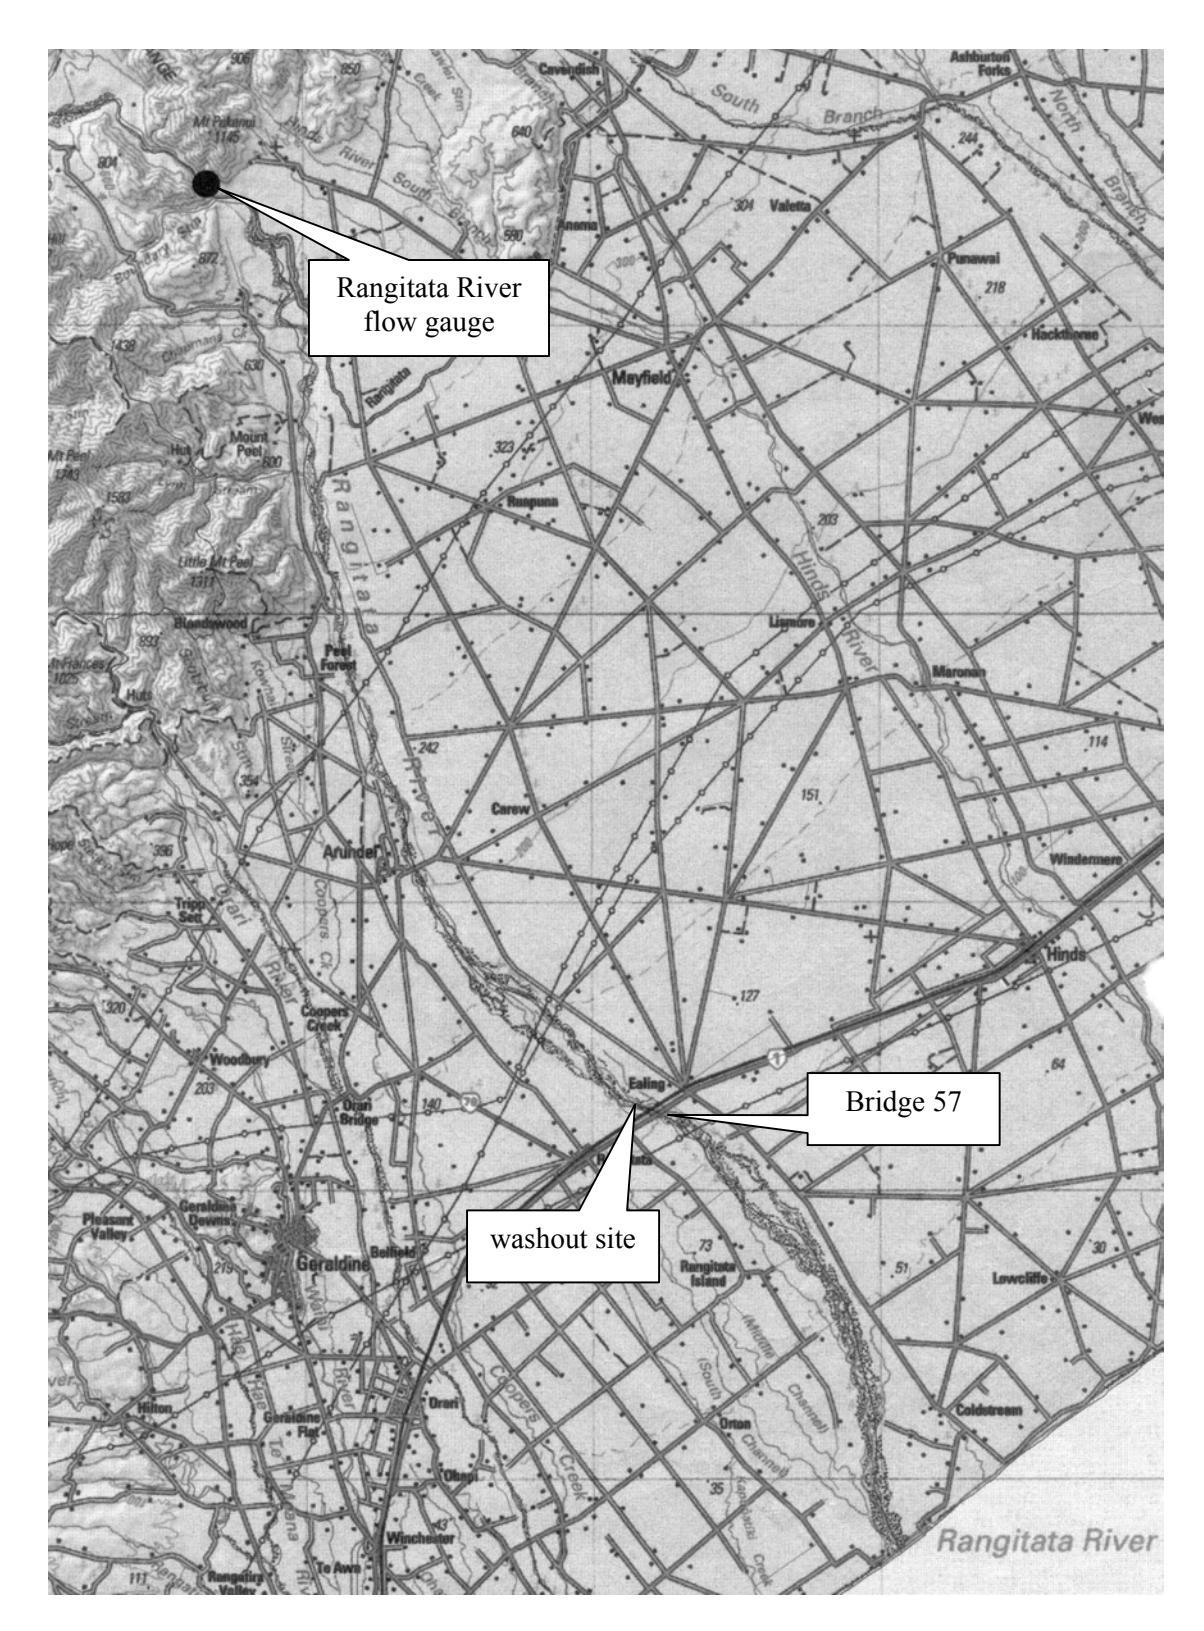
- 2.4.2 The Regional Council operated a flow recorder for the Rangitata River at the Rangitata Gorge, about 33 km upstream from Bridge 57 (see Figure 4). The peak flow on the day of the accident was recorded at 0815 as 1496 cumecs. Following the accident, the Regional Council advised that the estimated time for a recorded flow to reach Bridge 57 would have been between 4 and 5 hours, so the peak flow at the bridge would have been between 1215 and 1315.

Figure 4 Map showing location of the Rangitata River Rail Bridge and the flow recorder at Rangitata Gorge (map courtesy of Canterbury Regional Council)
