## RAILWAY OCCURRENCE REPORT

02-116      express freight Train 533, derailment, near  
Te Wera

26 July 2002

**Report 02-116**  
**express freight Train 533**  
**derailment**  
**near Te Wera**  
**26 July 2002**

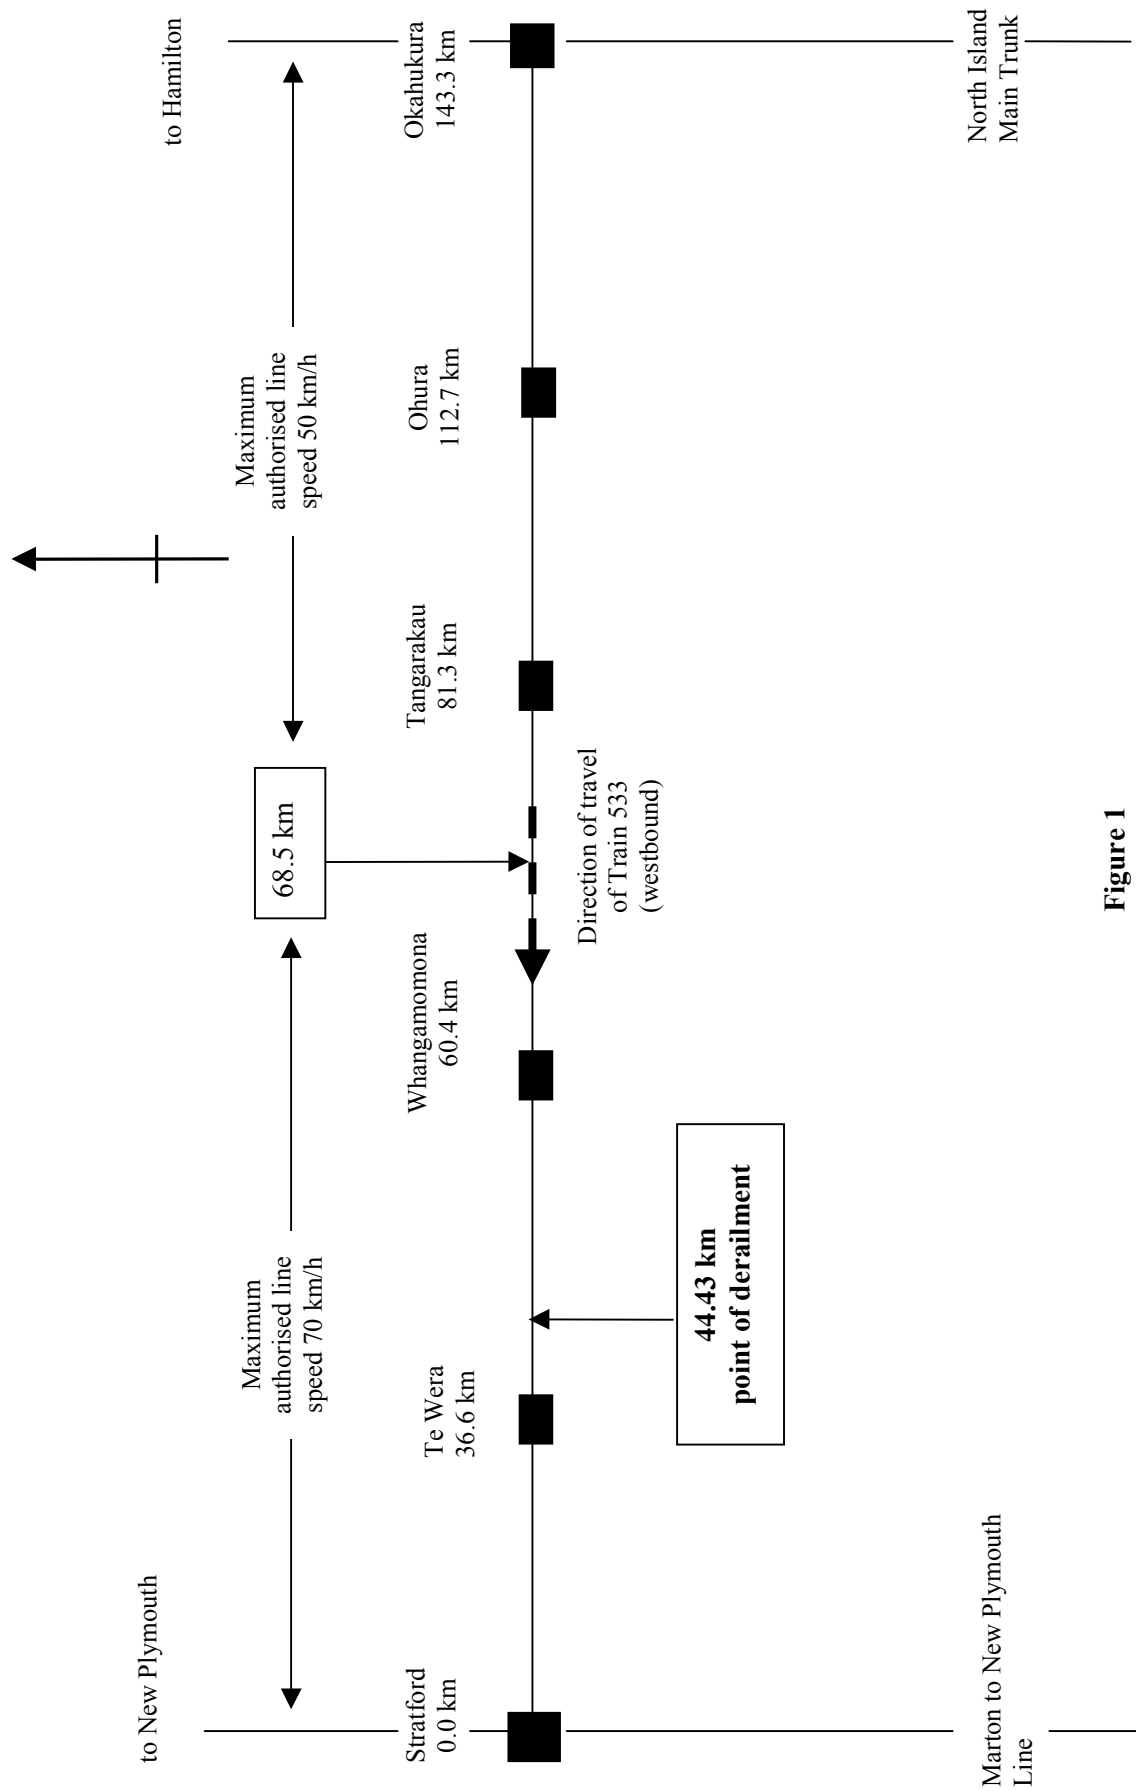
**Figure 1**  
**Diagram of Stratford – Okahukura Line (not to scale)**

- 1.2.1 The Stratford - Okahukura Line (SOL) branched off the Marton to New Plymouth Line at Stratford and ran for 143.3 kms through remote and isolated country to Okahukura, where it joined the North Island Main Trunk (see Figure 1).

- 1.2.3 Kilometrage on the SOL was designated from Stratford (0.00 km) to Okahukura (143.3 km). The maximum line speed between Stratford and 68.5 km was 70 km/h and on the remaining 74.8 km to Okahukura was 50 km/h (see Figure 1).

- 1.2.5 The derailment occurred as the train was rounding a 150 m radius, 45 km/h left-hand curve in the direction of travel (westbound) at the 44.43 km between Whangamomona and Te Wera. The curve was approached down a 300 m long, 1 in 51 gradient, after exiting Tunnel 2.
