RAILWAY OCCURRENCE REPORT

02-122	express freight Train 215, derailments, Hamilton and Te Kuiti	18 October 2002
	express freight Train 934, derailment, Sawyers Bay	25 March 2003

Report 02-122

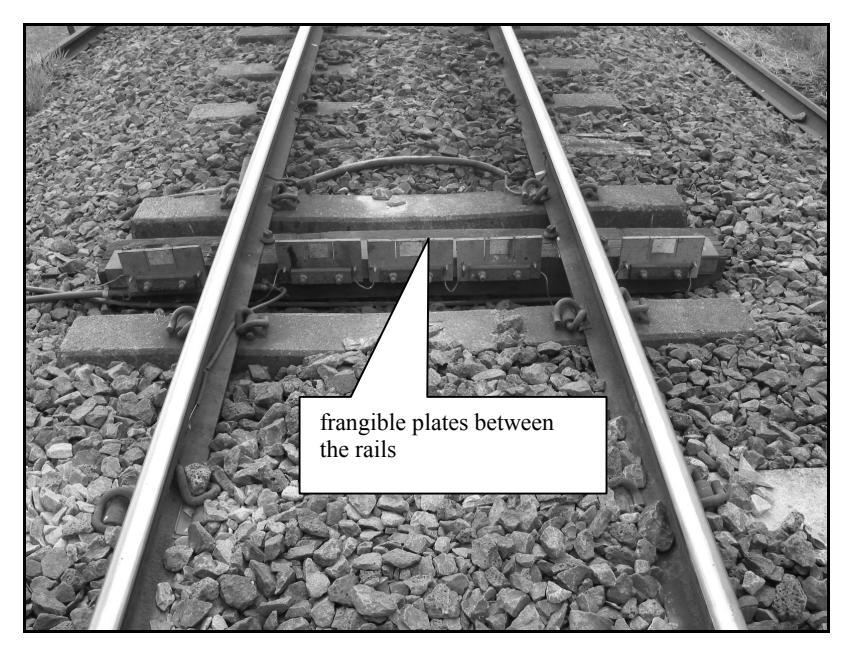
Figure 13 The dragging equipment detector at Te Kawa

1.7.1 Since 1993 Tranz Rail had installed a number of dragging equipment detectors (DED) on its network. Dragging equipment was detected by frangible plates mounted in 5 sections, 3 between the rails and one on either side (see Figure 13). This bar formed part of an electrical circuit, which provided an alarm output if any section of the bar no longer provided electrical continuity, for example if it was broken by dragging equipment.

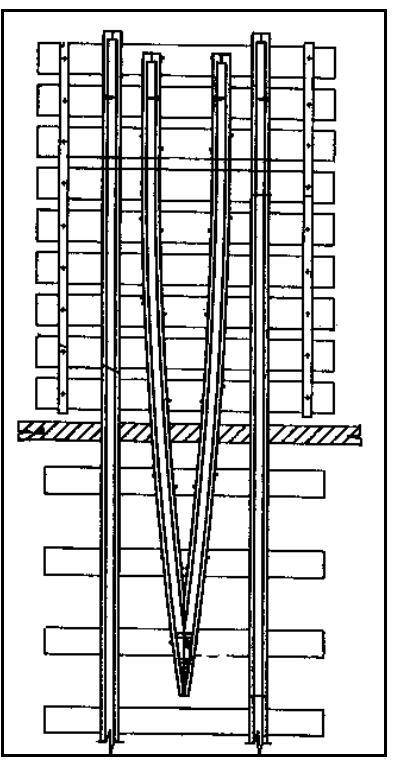
Figure 16 Diagram showing positioning of guard rails

- 1.8.8 Guard rails, which ran inside and parallel to the running rails (see Figure 16), were in place across Bridge 214 to prevent any derailed wagons from going over the side of the bridge by ensuring that the wheels of such wagons were steered into the space between the running rail and the check rail as they crossed the bridge. The guard rails came together in a V shape at each end of the bridge.
