MARINE OCCURRENCE REPORT

02-204 coastal cargo ship Kent, collision and flooding, Wellington Harbour

14 July 2002

collision with pontoon and subsequent flooding of engine room

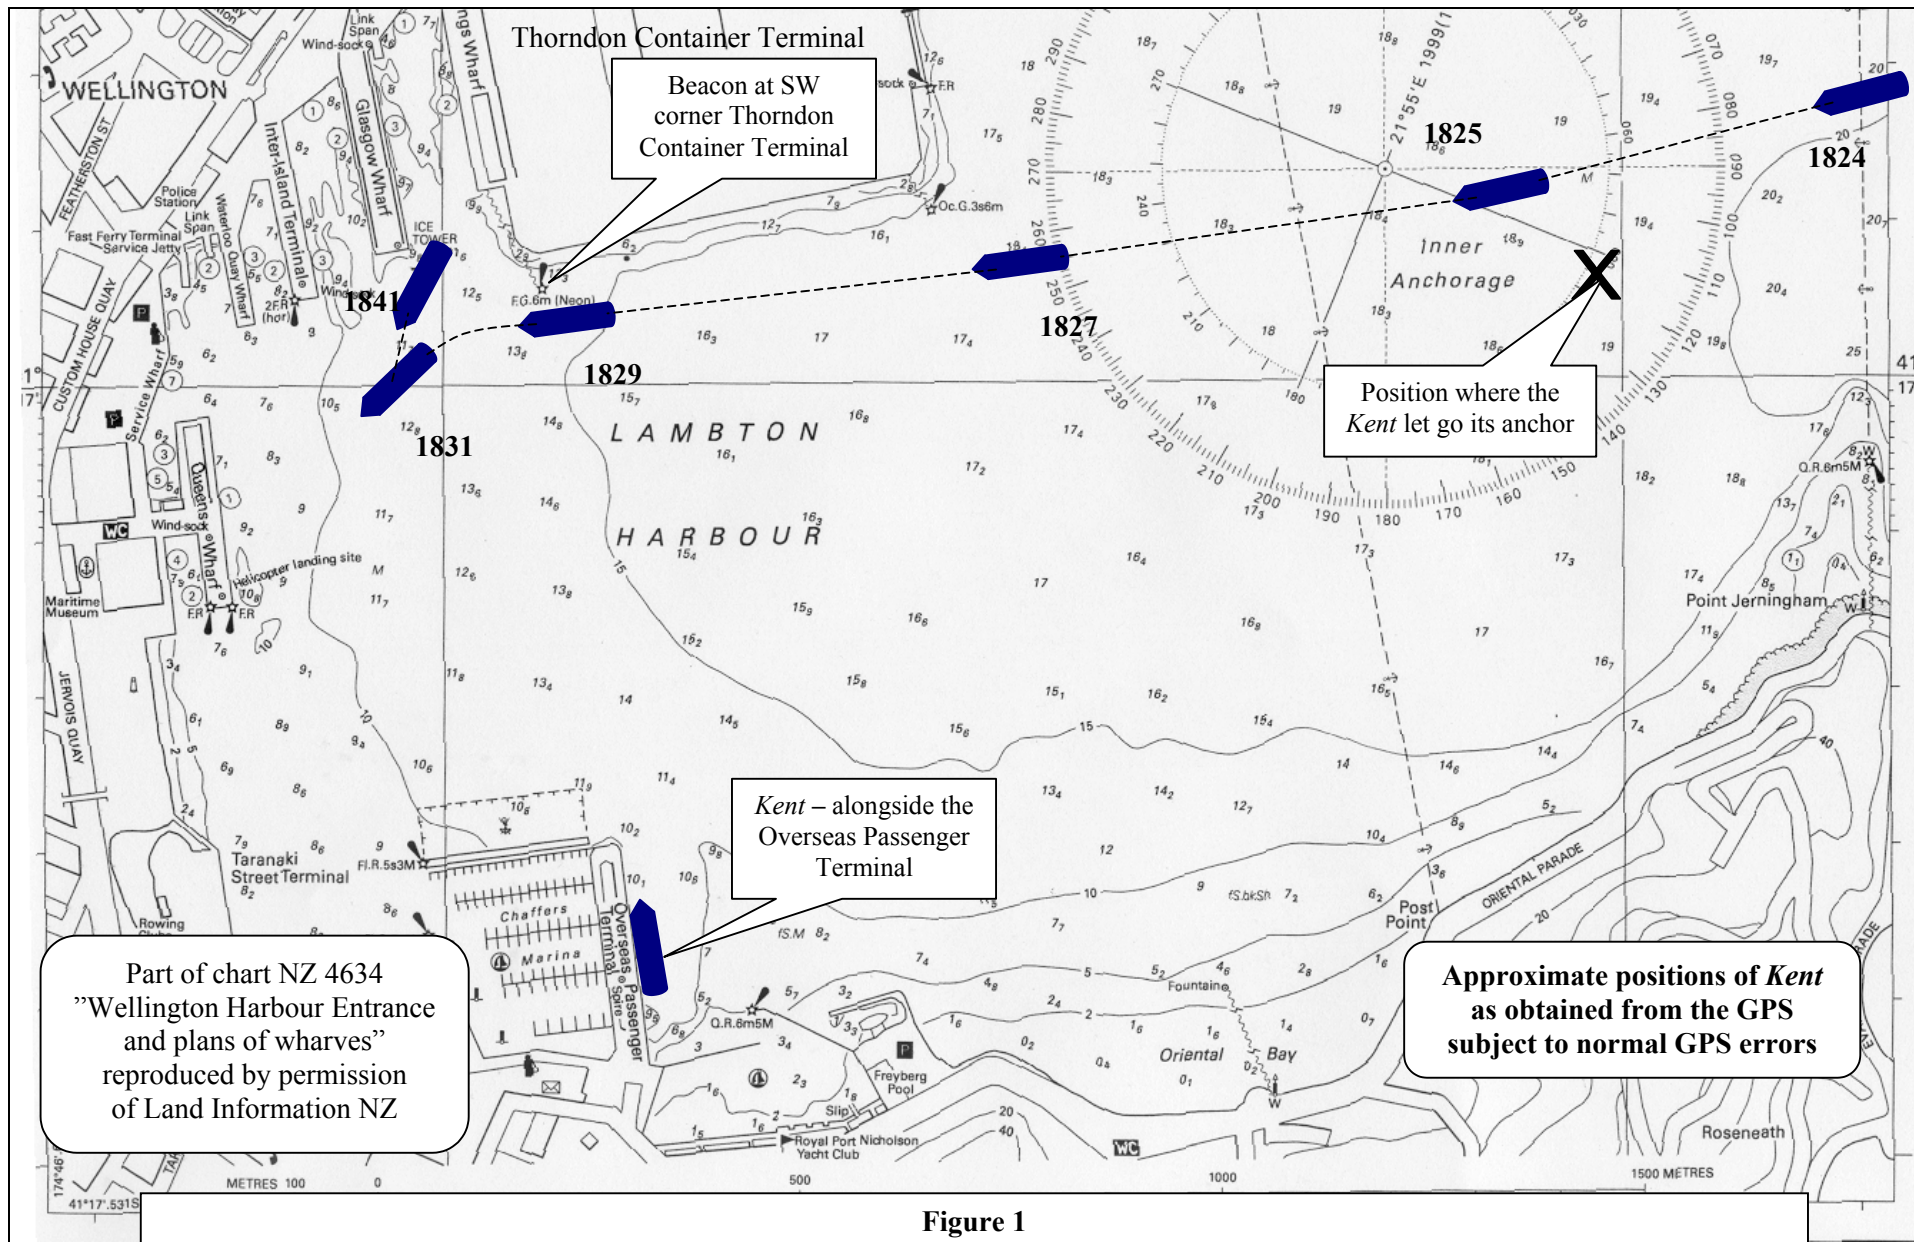
Figure 1
Section of chart NZ 4643 showing inward-bound track of the Kent and the position where it let go its anchor after the collision

- 1.1.2 As the ship approached Point Jerningham (refer Figure 1) at about 1823, the engines were placed on standby and the ship's speed reduced.
- 1.1.3 As the ship passed the light beacon off the south-west corner of the Thorndon Container Terminal, the mate/master adjusted the course to bring the ship's head round into the wind. The way was completely taken off the ship and it was then allowed to drop back under the control of the engines and the bow thruster. The stern entered the basin between Glasgow and Kings Wharves, and as the bow neared the outer end of Glasgow Wharf (refer Figure 2 – position 2) the seamen on the forecastle sent a heaving line ashore, followed by a headline. When the headline was secure on a bollard near the end of the wharf the crew heaved it tight.

- 1.1.7 At approximately 1901, the *Kent* anchored to the north of Point Jerningham using the starboard anchor (refer Figure 1). The anchor did not hold and the ship was driven by the wind towards the north. The Beacon Hill signal station operator was informed that the ship had collided with a pontoon that was now possibly adrift in the harbour. At 1907, the mate/master updated Beacon Hill and informed the operator that the ship had been holed on its port side (refer Figure 3), and that the engine room was flooding but the pumps were coping with the flow. The mate/master requested that a tug be called to stand by the ship. Shortly after this time, the chief engineer advised the bridge team that the pumps were no longer keeping pace with the ingress of water and that the ship would soon lose power. At 1909, the ship lost all power. The Beacon Hill signal station operator was advised of this.

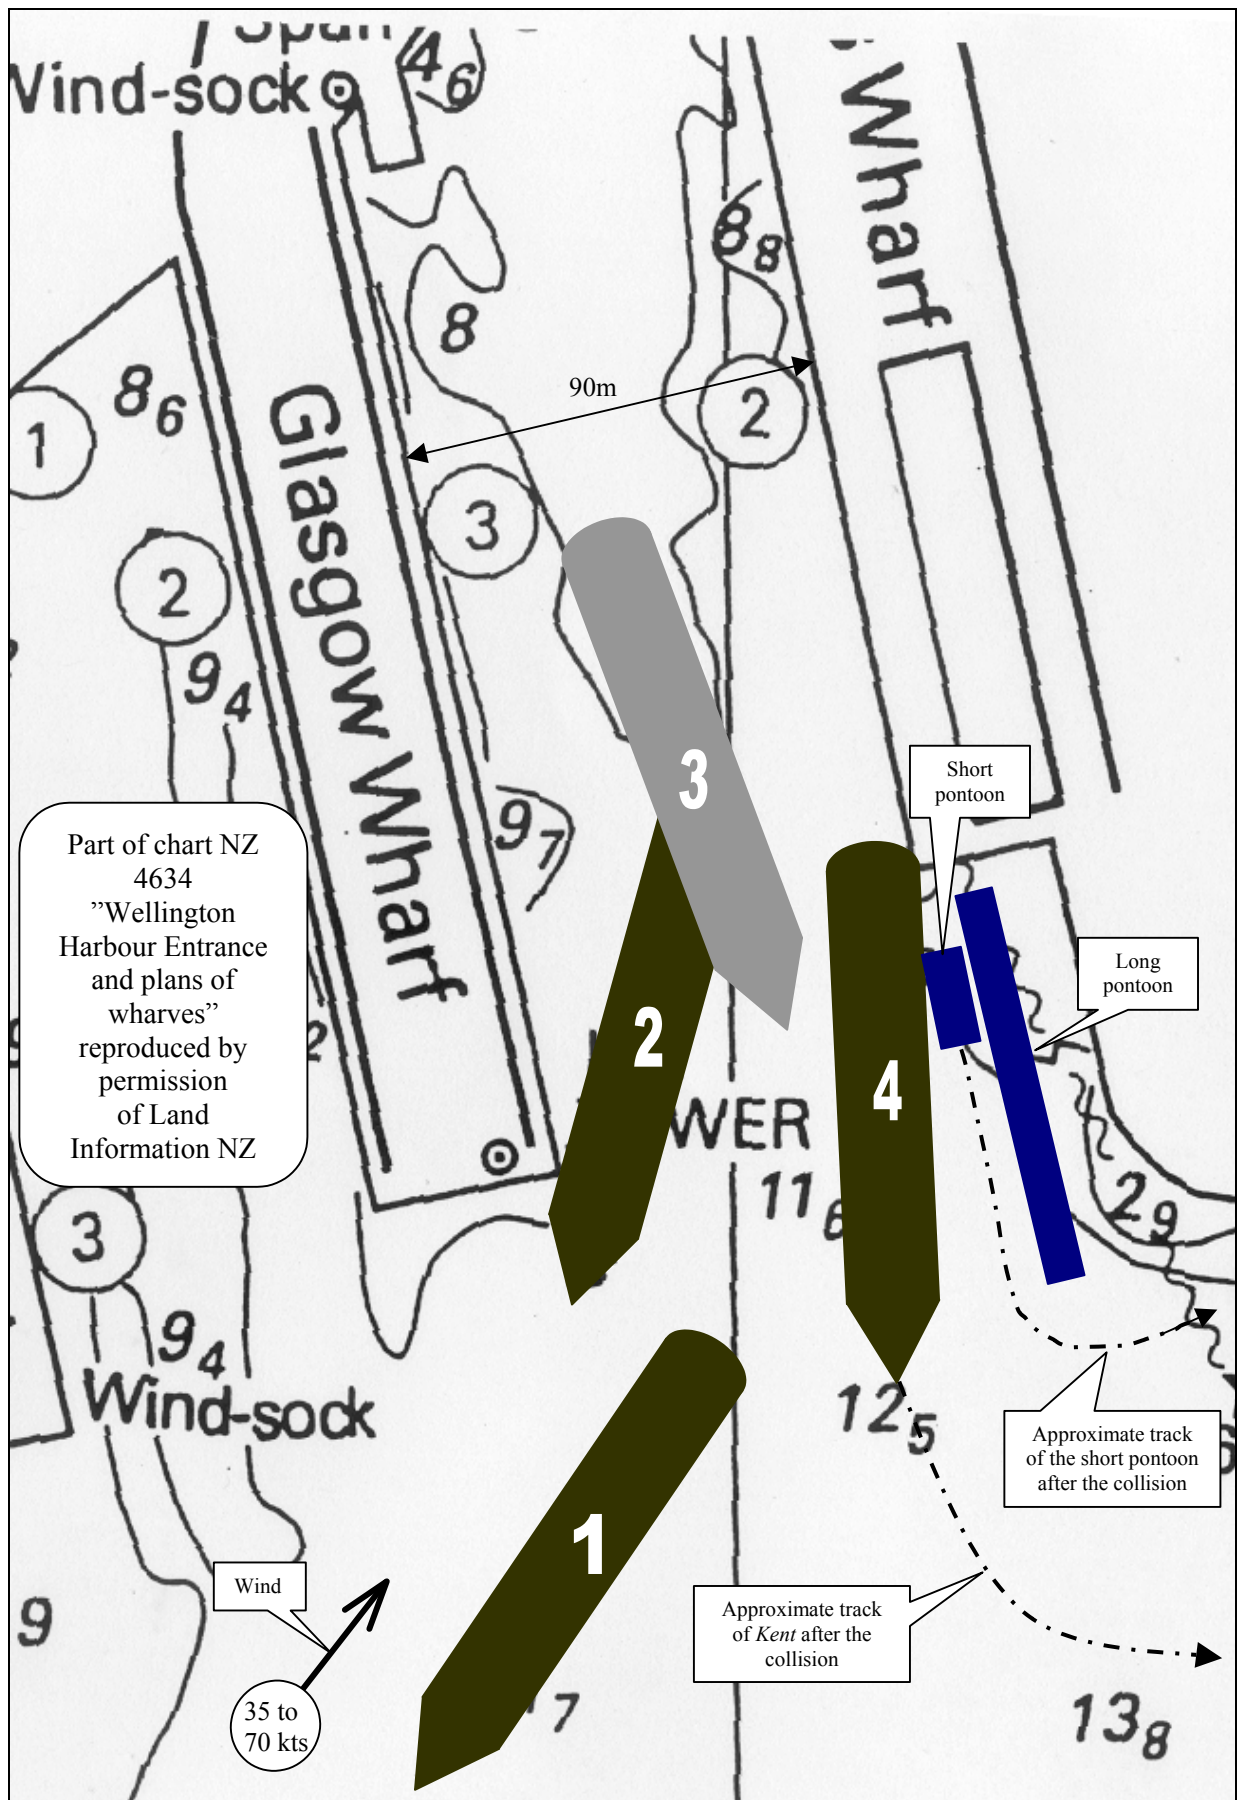
Figure 2
 Section of chart NZ 4634 showing the approximate positions of the *Kent* during the berthing manoeuvre

- 1.1.5 For one or 2 minutes after the mooring line parted, the ship stayed close to the wharf, but then the bow started to pay off to port, towards Kings Wharf. The mate/master instigated his emergency plan, which was to proceed out, clear of the wharves, into Lambton Harbour in order to re-assess the situation. The mate/master ordered the engines to full ahead. By this time the ship's head had fallen off sufficiently for the mate/master to be concerned that the ship would collide with the beacon at the south-west corner of Thorndon Container Terminal, so he applied starboard helm to swing the ship clear of it. The ship's bow swung to starboard and the stern to port, while the ship continued to be pushed by the wind towards Kings Wharf. The master had gone to the port bridge wing and noticed that the stern was swinging towards the 2 pontoons moored off the reclamation at the southern end of Kings Wharf. He warned the mate/master and advised him to "go to port". The mate/master put the helm hard-to-port but before the action of the rudders could stop the ship swinging, its port quarter made contact with the outer of the pontoons (refer Figure 2 – position 4).
