RAILWAY OCCURRENCE REPORT

03-102

hi-rail vehicle 67425, derailment, near Fordell

10 February 2003

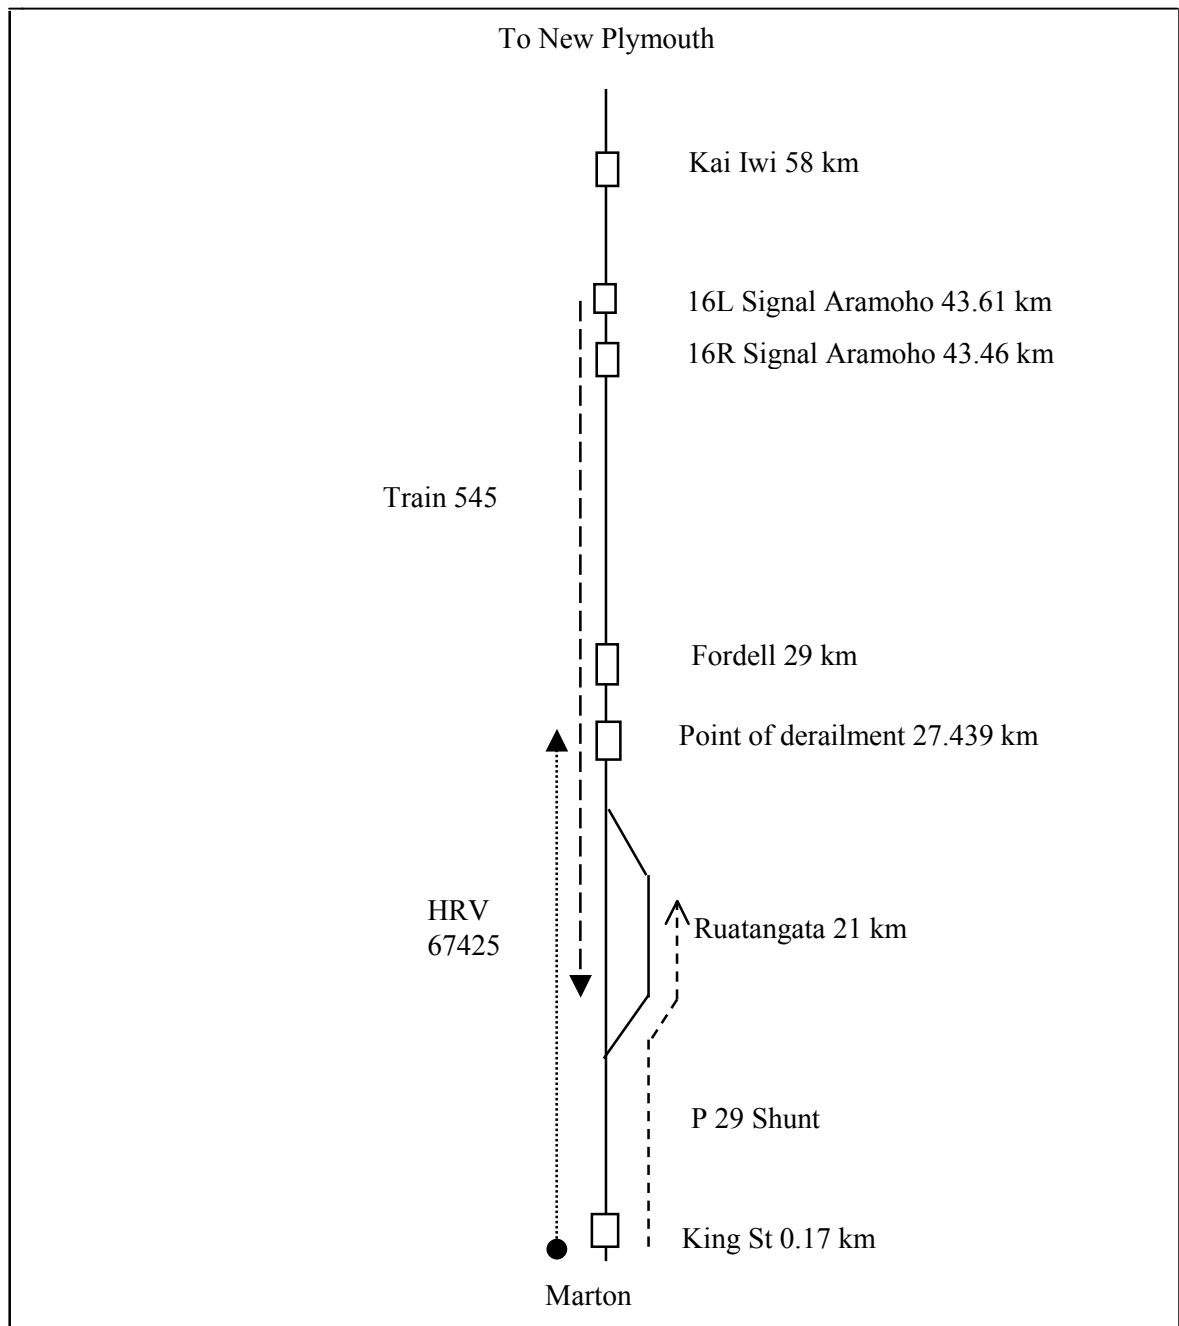
Figure 2
Marton to Kai Iwi track section (not to scale)

- 1.1.8 At 1742, the train controller received a telephone call from the Police advising that a track ganger had been involved in an accident and that his vehicle was trackside somewhere between 25 km and 29 km MNPL. The Police confirmed that an ambulance had been dispatched from Wanganui.
