## RAILWAY OCCURRENCE REPORT

03-109

diesel multiple unit passenger Train 3347, driveshaft failure,  
Meadowbank

27 June 2003

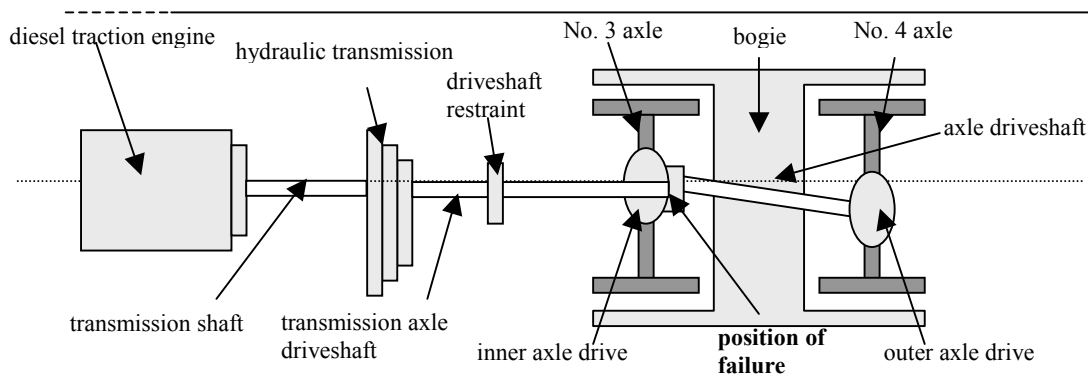
**Figure 2**  
**Schematic of drivetrain**

- 1.3.4 The powered car provided traction for the 2-car consist. The drive from each engine was through a Voith hydraulic transmission unit to an axle-mounted final drive. The Voith transmission included 2 drive systems: one through a torque converter and the second through a fluid coupling (see Figure 2). The transmission engaged the torque converter to move the train from standstill, and automatically change to direct fluid coupling drive according to engine throttle setting and train speed but generally between 50 and 60 km/h.

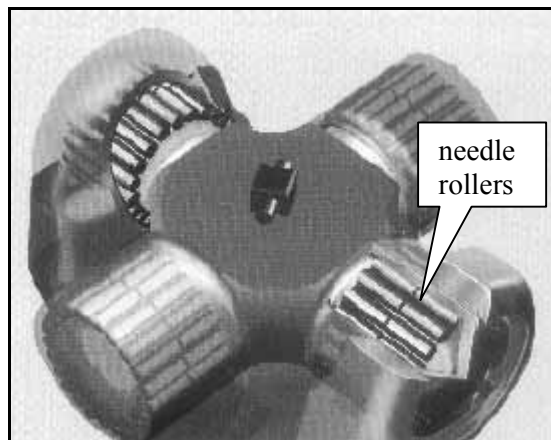
**Figure 4**  
**A GWB universal joint**

- 1.5.2 A GWB catalogue illustrated the general pattern of construction of one of the GWB joint types, including the model 587 (see Figure 4). Each bearing consisted of 2 rows of needle rollers.
