M A R I N E O C C U R R E N C E R E P O R T

03-207

fishing vessel *Solander Kariqa*, fire, 300 nautical miles west of
Suva, Fiji

5 May 2003

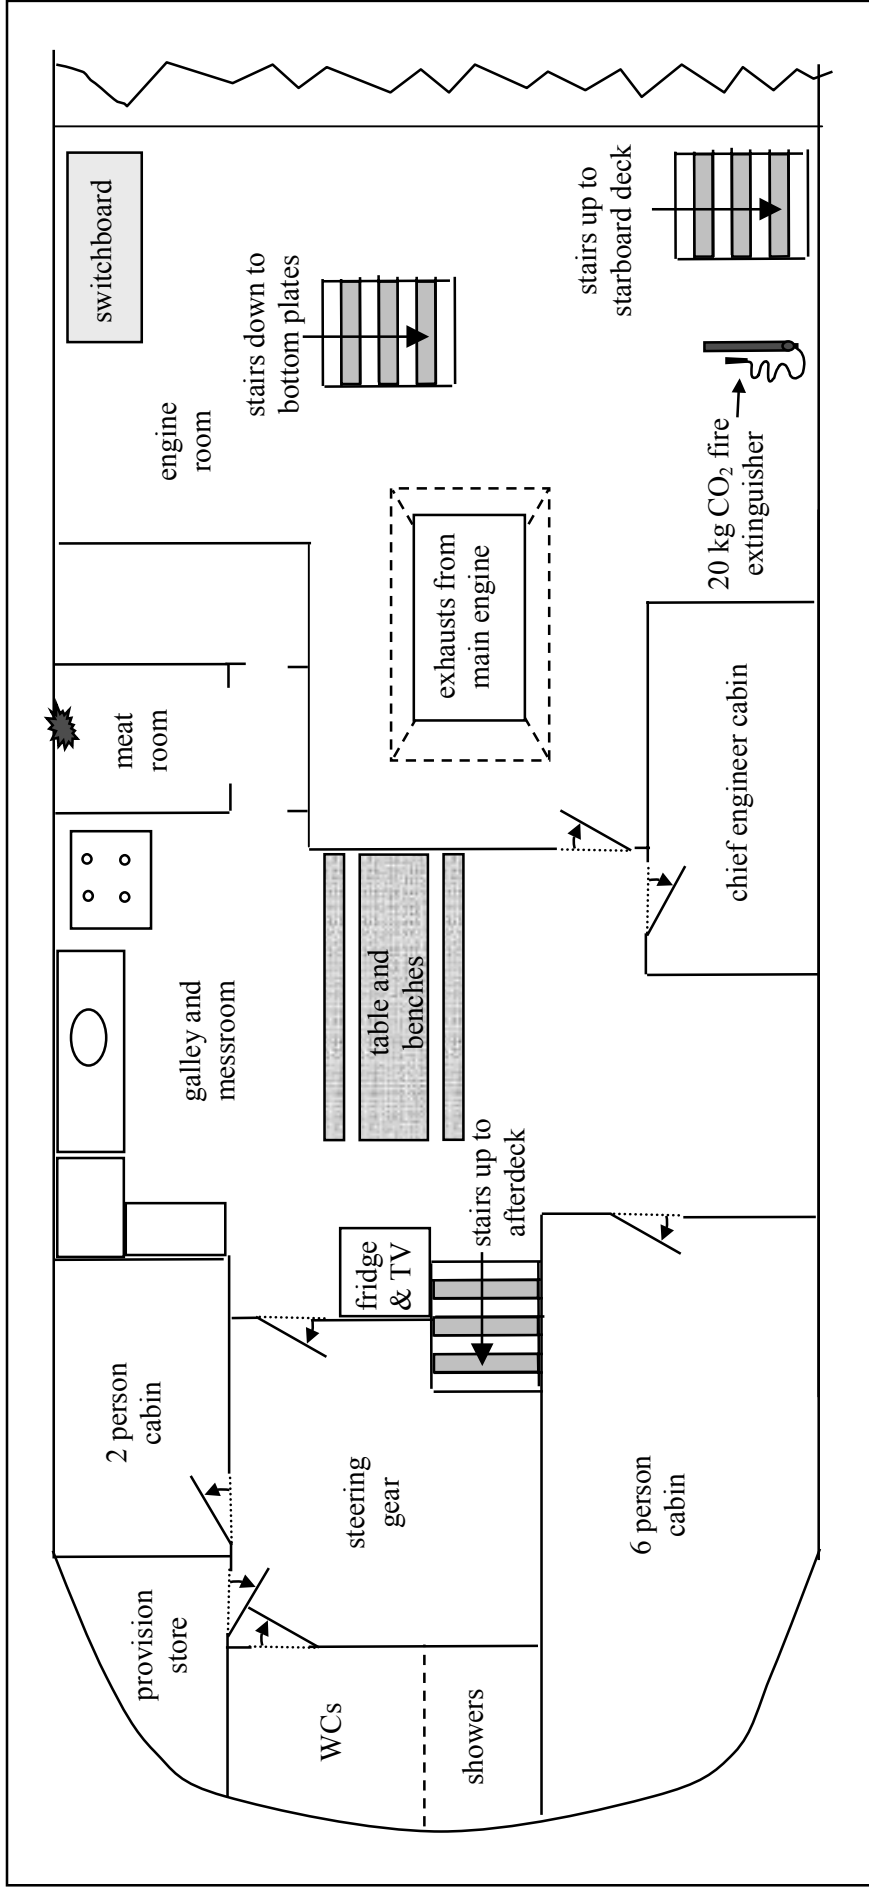
Figure 2
Plan of accommodation area on *Solander Kariqa*

- 1.6.5 Once on deck, the chief engineer collected the fire crew outfit and CABA, from the laundry area, and started to don them. Meanwhile the rest of the crew were battening down the galley/messroom area by closing the ventilator flaps. When he had the CABA on, the chief engineer entered the engine room through the door on the starboard side of the after deck. On the upper flat of the engine room there was a semi-portable 20 kg CO₂ extinguisher (see Figure 2), which the chief engineer dragged into the messroom and uncoiled the extension hose to again attack the fire in the meat room. By this time the galley/messroom area had filled with thick black toxic smoke reducing visibility to a minimum. The heat had increased sufficiently to prevent access right into the refrigeration space. The chief engineer could not see any flames and so he stayed in the entrance to the refrigeration space and aimed the flow of CO₂ in the general direction of the meat room. Once the extinguisher was fully discharged, the chief engineer returned to the deck through the engine room, making sure all the cabin doors were closed as he went but omitted to close the door between the messroom and the steering gear.

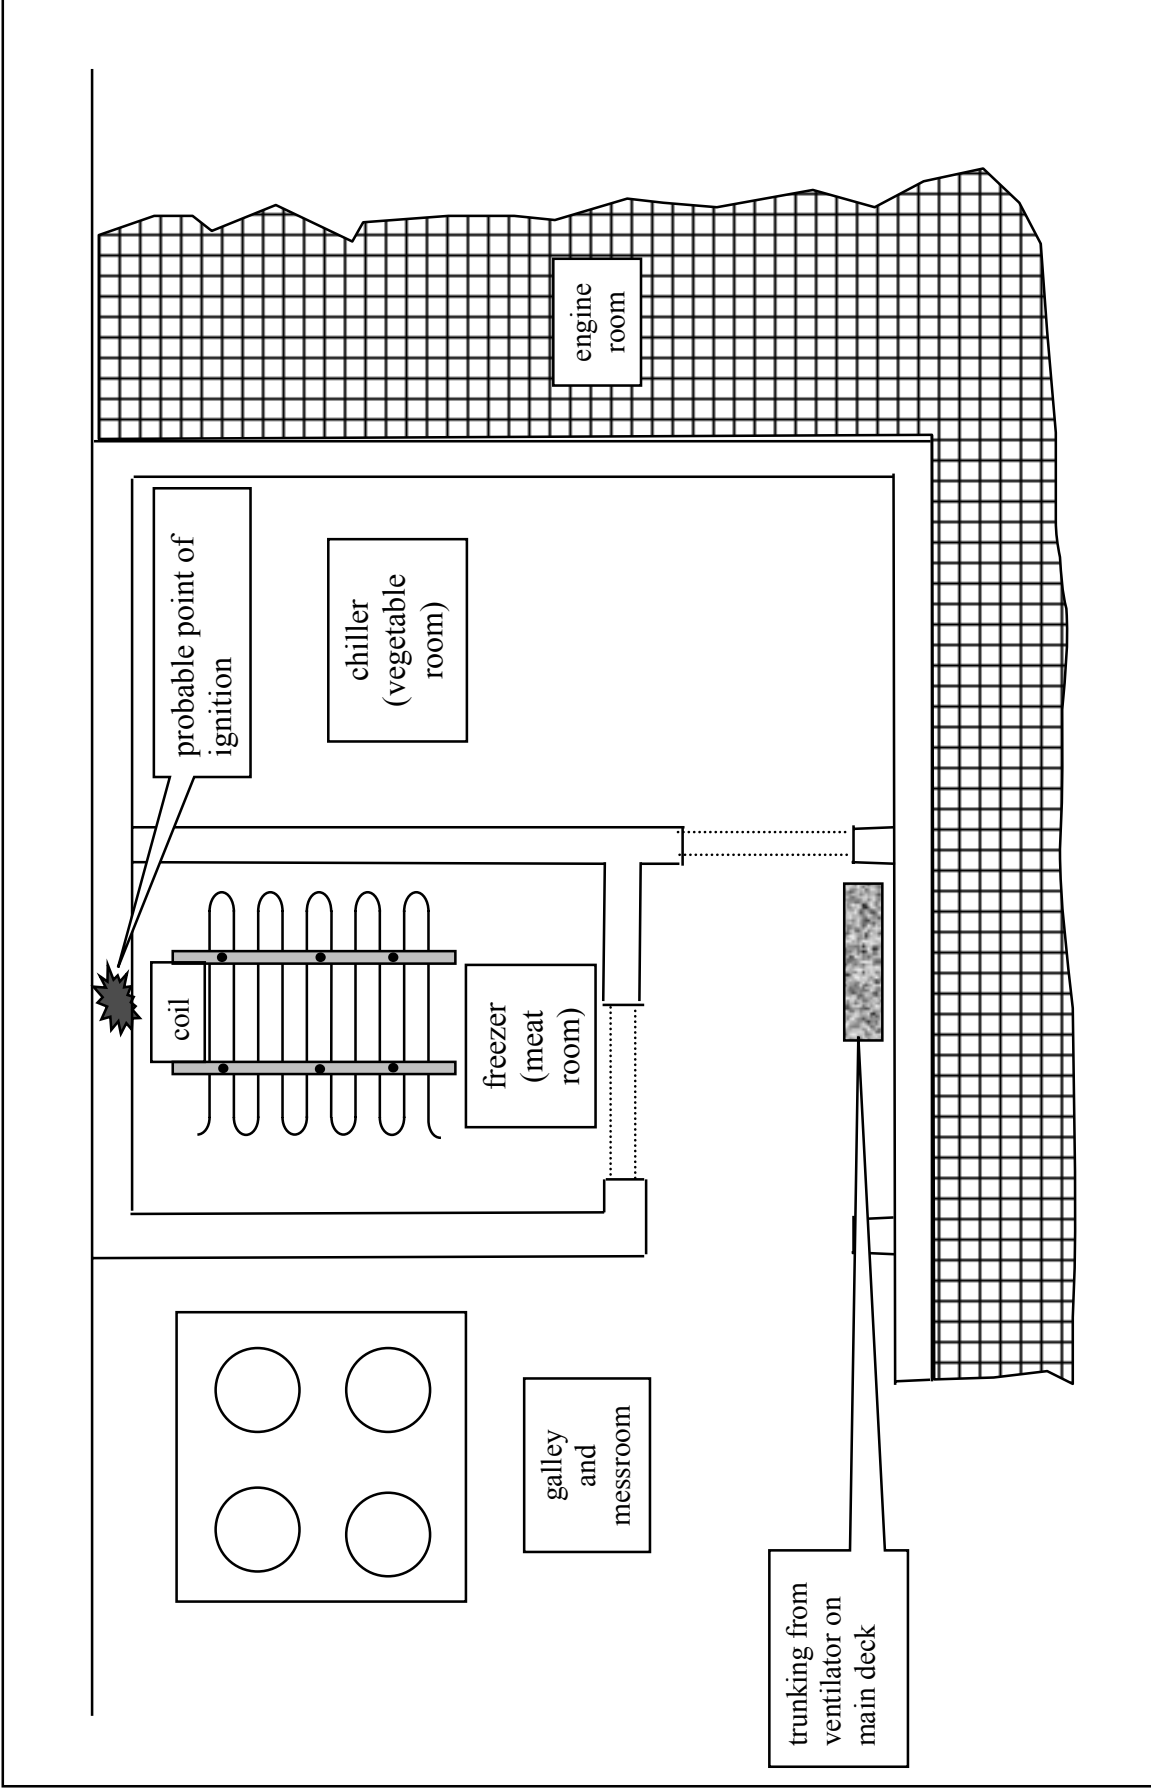
Figure 3
Plan of refrigeration spaces

- 1.1.3 On Sunday 4 May, during his usual engine room watch between 0800 and 2000, the chief engineer started to remove refrigeration pipework and wall panelling from the vegetable room of the defunct domestic refrigerated spaces (see Figures 2 and 3). At 2000 that evening, when the second engineer took over the engine room watch from the chief engineer, he was told to continue removing the refrigeration pipework from the meat room, the after of the 2 refrigerated spaces, as his duties and time permitted.

- 1.6.1 The second engineer had been instructed to remove the refrigeration coils from the meat room during his time on watch. He prepared for the task by removing the debris that the chief engineer had put in the meat room during the day. He then started to remove the nuts that were holding the lower of the 2 coils in place. The nuts had been welded in place to stop them vibrating loose, so the second engineer could not remove them using spanners. He opted to cut them off using the oxy-acetylene cutting torch rather than a cold chisel because the noise would have woken the sleeping crew. As a precaution against fire, he took a bottle of water and an aqueous film forming foam (AFFF) extinguisher into the meat room before he started the hot work.

- 1.6.2 After he had cut off the 6 bolts securing the lower coil, he cut the pipe joining the 2 coils and pulled down the lower one. He then continued to cut off the bolts securing the upper coil. After removing 4 of the bolts he stopped so that he could carry out his engine room rounds. Before leaving the area he said that he checked for signs of fire and found none.

- 1.6.3 About 30 minutes later, the second engineer saw smoke on the upper plates of the engine room and, after checking for fire in the engine room, went to the refrigeration space where he found fire in the panelling of the port bulkhead of the meat room. He initially tried to extinguish the fire using the AFFF fire extinguisher, squirting the foam through the various holes in the panelling. However, as soon as he had smothered one area, flame was visible through another hole further along the panel. When the master arrived at the refrigerator space, the fire extinguisher being used by the second engineer ran out and it became apparent to the second engineer that he had lost control of the situation. He informed the master that the fire was getting out of hand, so the master woke the crew, starting with the chief engineer.
