RAILWAY OCCURRENCE REPORT

04-103 Report 04-103, shunting service Train P40, derailment, 43.55 km 16 February 2004
near Oringi, 16 February 2004

Report 04-103
shunting service Train P40
derailment
43.554 km
near Oringi
16 February 2004

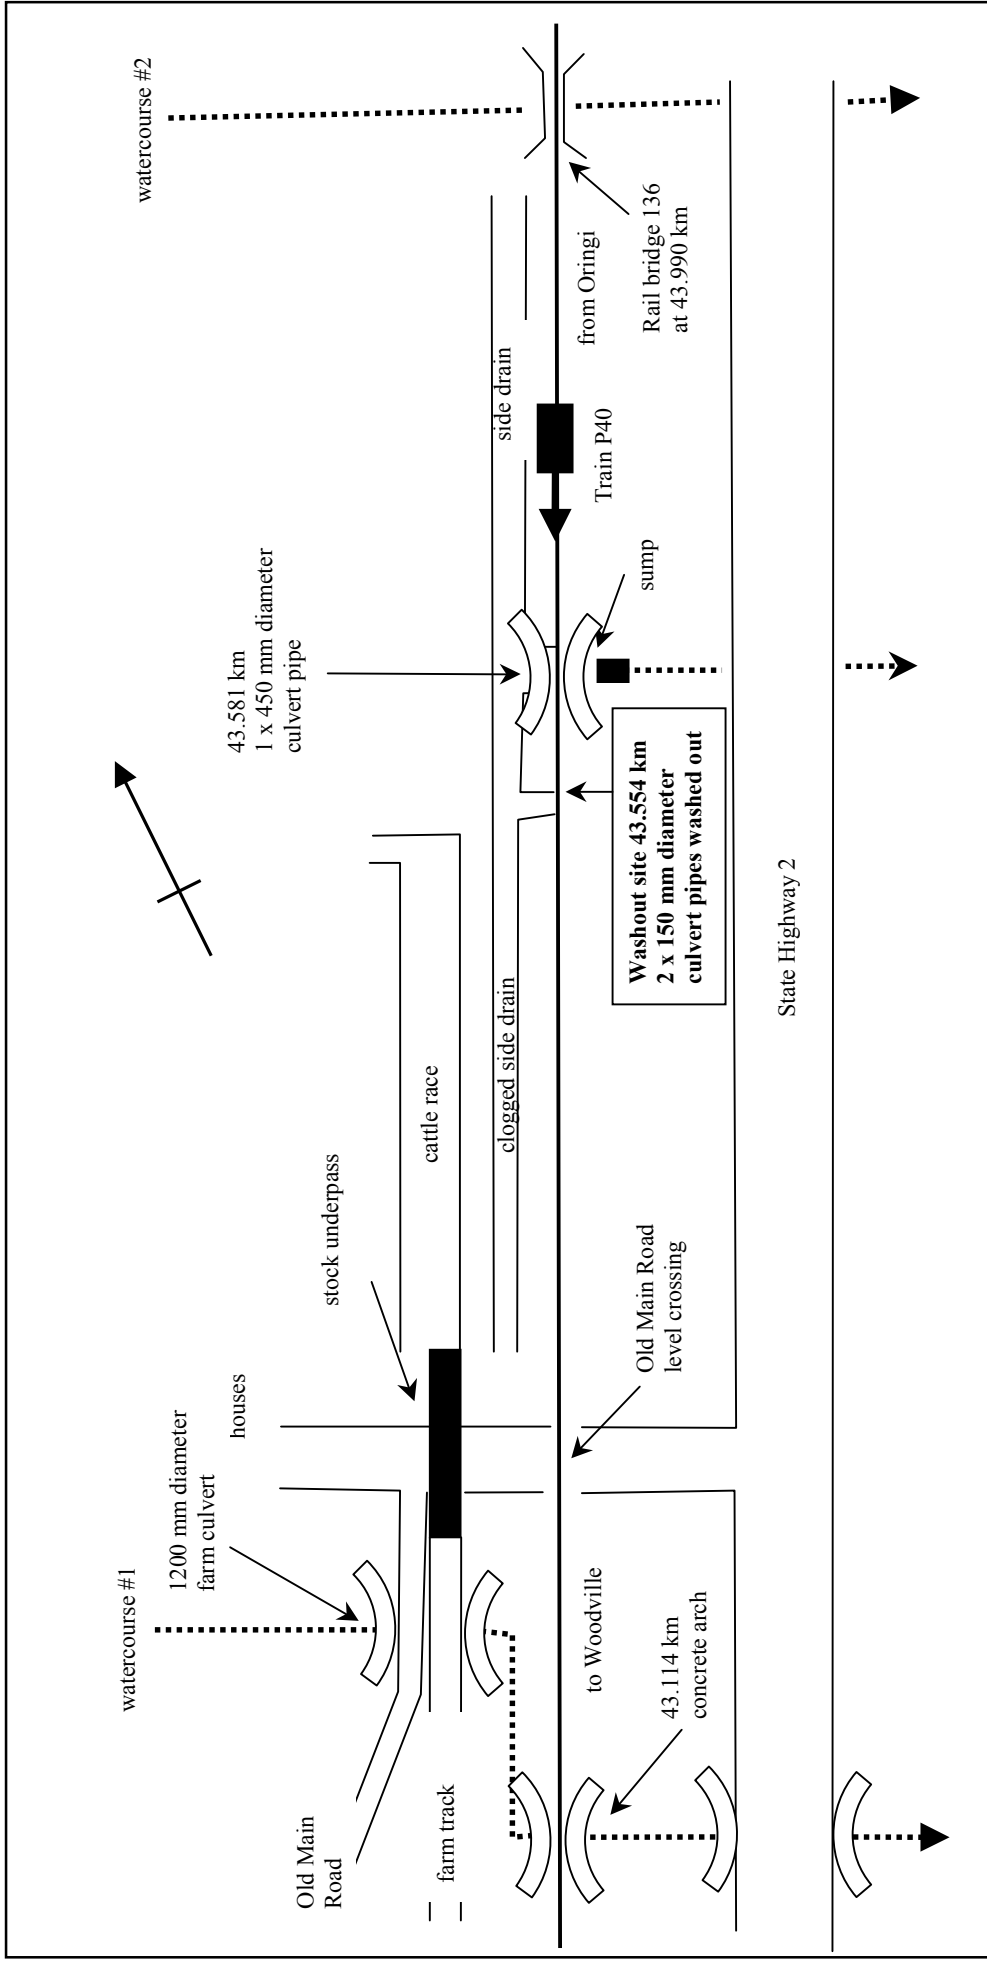
Figure 1
Washout site (not to scale)

- 1.2.8 A 1200 mm concrete pipe culvert carried watercourse #1 beneath Old Main Road and the southern approach to the stock underpass (see Figure 1). After exiting this culvert (see Figure 2) watercourse #1 continued on and passed under the rail formation through culvert 43.114.

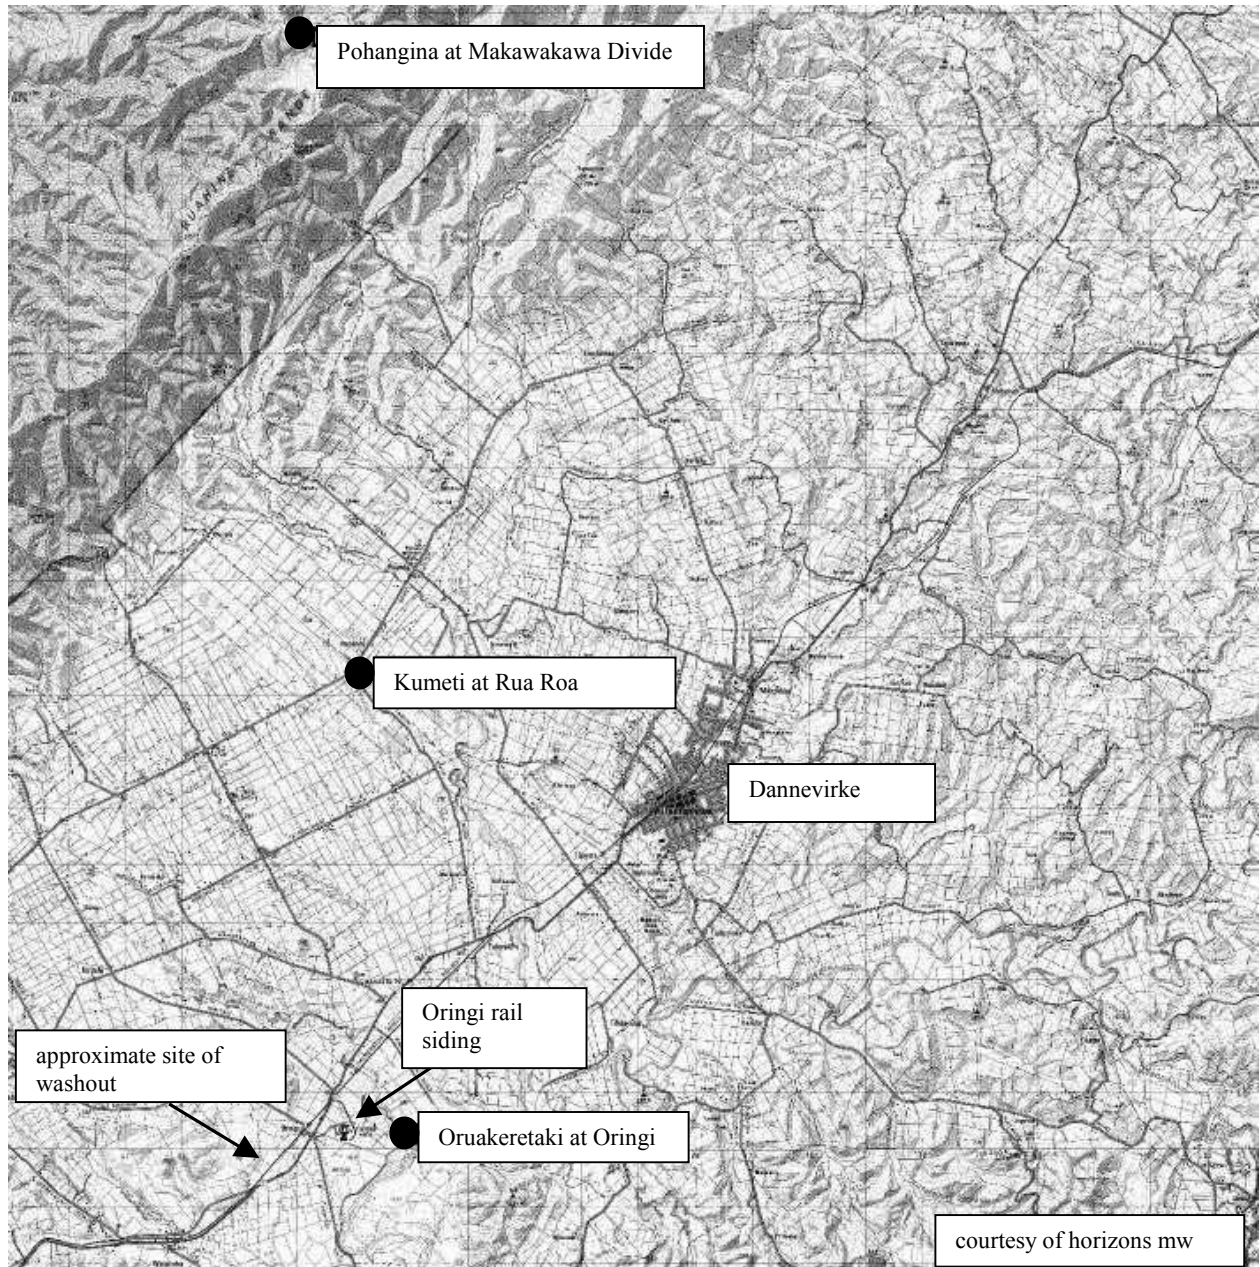
Figure 14
The locations of the rainfall measuring stations in relation to the washout

1.4.1 Rainfall figures for Sunday 15 and Monday 16 February from 3 measuring stations surrounding the washout site were supplied by horizons mw (see Figure 14).

1.4.2 The rainfall in the Oringi area both for the 12 and 24-hour periods leading up to the washout were assessed to be greater than a 150-year return period.

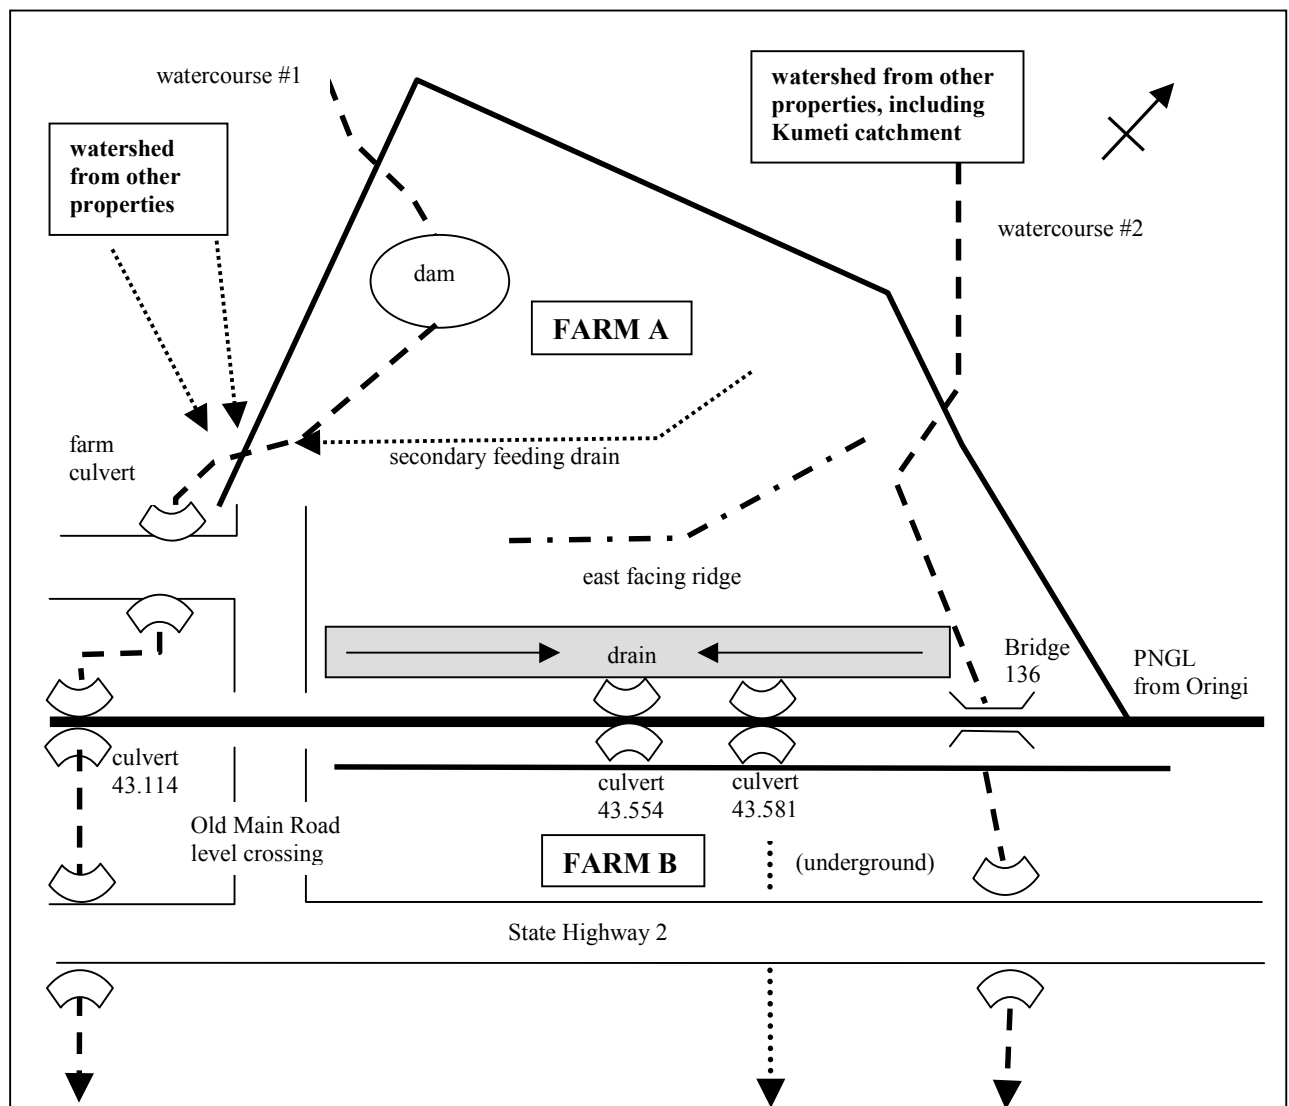
Figure 15
Drainage patterns in the vicinity of the washout
 (not to scale)

- 1.5.1 Watercourse #1 carried the runoff from several properties including Farm A. It flowed in an easterly direction, crossing the western boundary of Farm A before flowing into a dam. After leaving the dam the watercourse continued to meander through Farm A before it turned south briefly then west again to run down the boundary to the farm culvert and ultimately to culvert 43.114.
- 1.5.2 Upstream of the farm culvert, runoff from adjoining properties and from another drain from Farm A had flowed into watercourse #1 faster than the watercourse and downstream culverts could discharge it. The resulting floodwaters overflowed onto paddocks and ponded against the farm culvert before entering the stock underpass and continuing on to 43.581 (see Figure 15).
