RAILWAY OCCURRENCE REPORT

04-107 express freight Train 237, derailment, near Kopaki

24 March 2004

TRANSPORT ACCIDENT INVESTIGATION COMMISSION
NEW ZEALAND

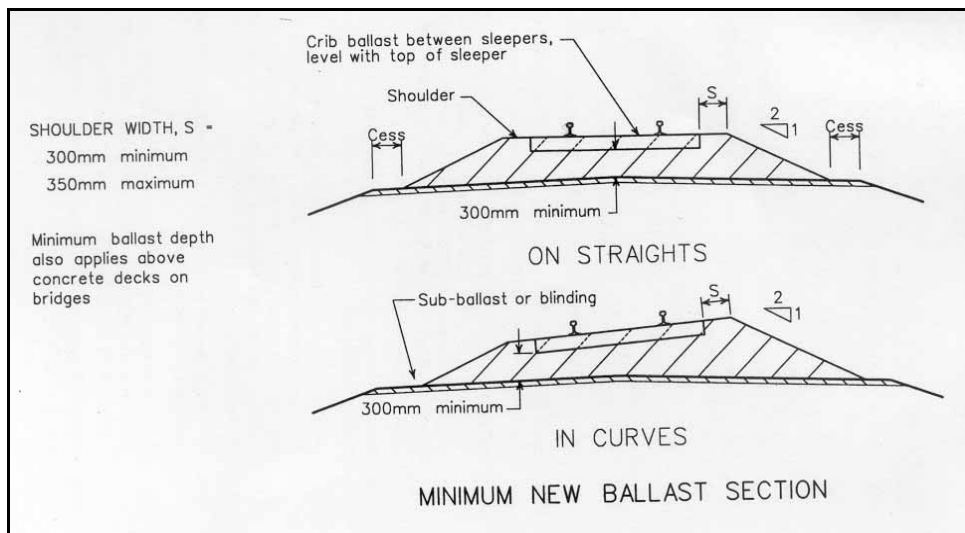
Figure 4

- 1.5.2 The concrete sleepers with Pandrol fastenings on the derailment curve were less than 2 years old and in near new condition. The sleepers were supported by clean ballast to a depth of 300 mm at the POD. The cribs were full and there was a 600 mm ballast shoulder at the sleeper ends. Tranz Rail's minimum ballast profile is shown in Figure 4. The track machine group last carried out tamping and lining on the derailment curve in June 2002 following the installation of the concrete sleepers.

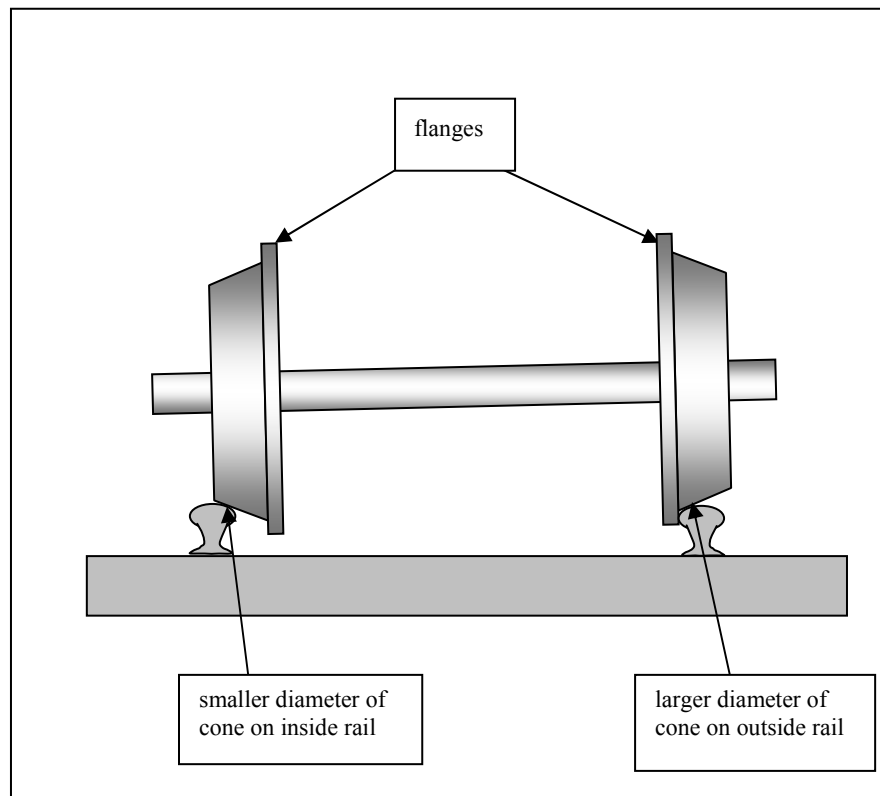
Figure 5
Wheel and rail interface (not to scale)

1.7.2 On a high-speed rail network, wheel flanges do not generally touch the rails (see Figure 5). Flanges are only a last resort to prevent the wheels becoming derailed. The wheel tyre was coned at a 1 in 20 angle and the railhead was slightly curved. On curved track, the outer wheel has a greater distance to travel than the inner wheel and to compensate for this, the wheel set moves sideways in relation to the track. Thus a larger tyre radius on the inner edge of the wheel is in contact with the outer rail of the curve, and a lesser tyre radius on the outer edge of the wheel is in contact with the inner rail of the curve.

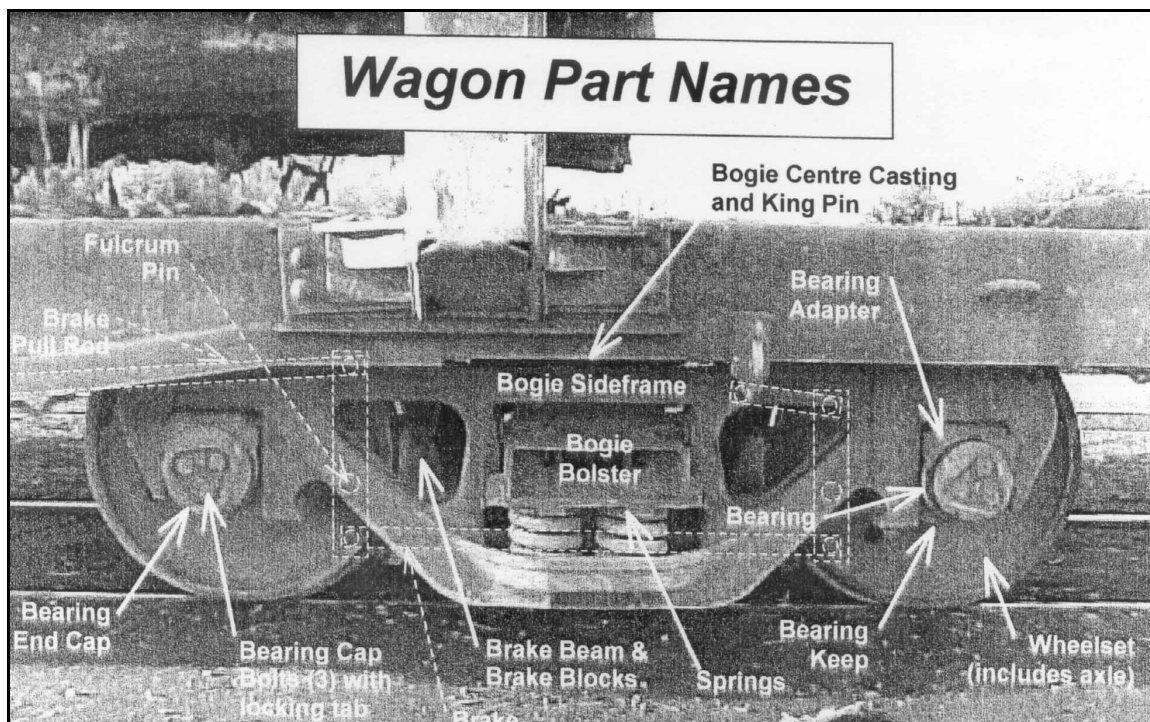
Figure 6
Identification of wagon parts

Springs	in place, secure and intact
Bearing keeps	held securely in place
Liners	secure and not broken
Wedge heights	within limits (use Snubber gauge if in doubt)
Bearing adapters	in place and no visual sign of damage
Dampers	secure
	no excessive oil leaks
Horns	not bent or loose
Bearings	no sign of overheating
	cap bolts in place
	backing rings secure
	no excessive grease leakage
Brake blocks	within wear limits.

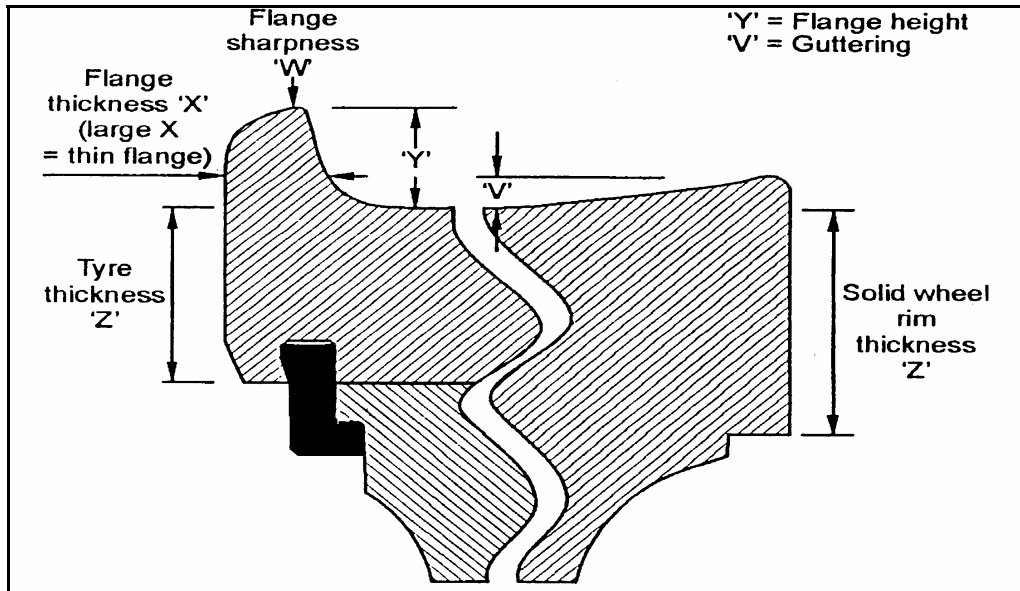
Figure 7
Wheel profile

need to remove the wheel sets from the bogie. A wheel profile gauge was used to record critical wheel dimensions of:

- flange sharpness (W)
- flange thickness (X)
- flange height (Y)
- rim thickness (Z).

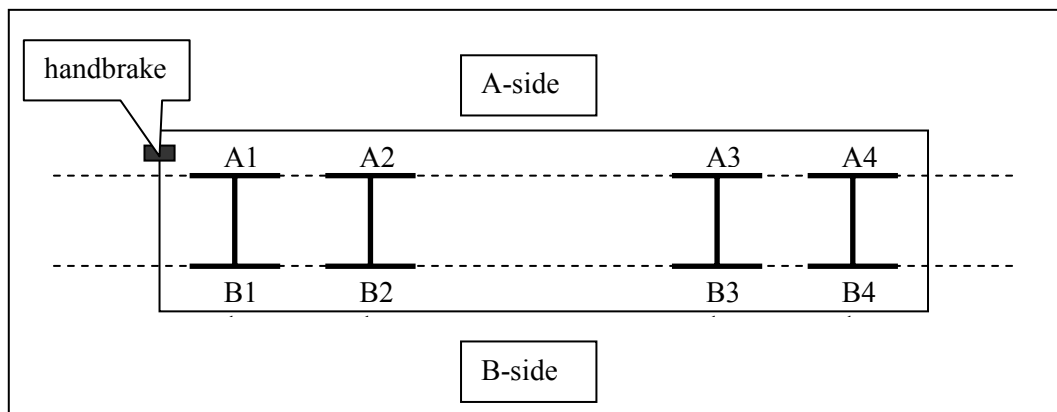
Figure 8
Wheel identification

1.8.10 Wagon axles were numbered from 1 to 4, starting at the handbrake end of the wagon. The handbrake side of the wagon was classified as the A-side and the non-handbrake side was the B-side. The wheel closest to the handbrake was therefore identified as A1 (see Figure 8). Axle No. 2 was the leading axle of the trailing bogie at the time of the derailment.
