RAILWAY OCCURRENCE REPORT

04-109 passenger express Train 804, *Tranz Alpine*, stalled and slid back, Otira Tunnel 28 March 2004

Report 04-109

On Sunday 28 March 2004, at about 1541 shortly after entering the Otira Tunnel Train 804, the Greymouth to Christchurch *Tranz Alpine* passenger express, with 268 passengers and 6 crew on board, stalled and slid backwards. The locomotive engineer eventually brought the train under control but when he attempted to move forward again the locomotives could not develop traction and the train stopped.

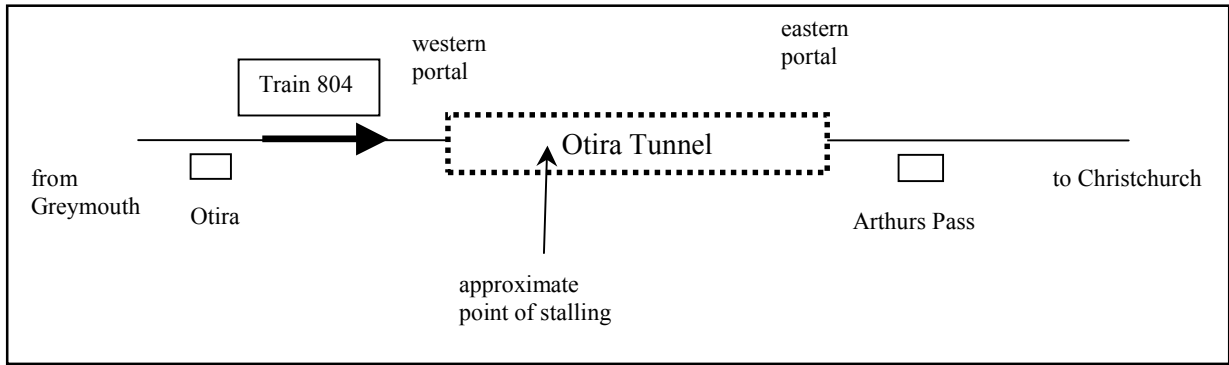
Figure 1
Location of the Otira Tunnel (not to scale)

- 1.2.1 The Otira Tunnel was situated on the Midland Line between Otira, at the western end, and Arthurs Pass at the eastern end (see Figure 1).

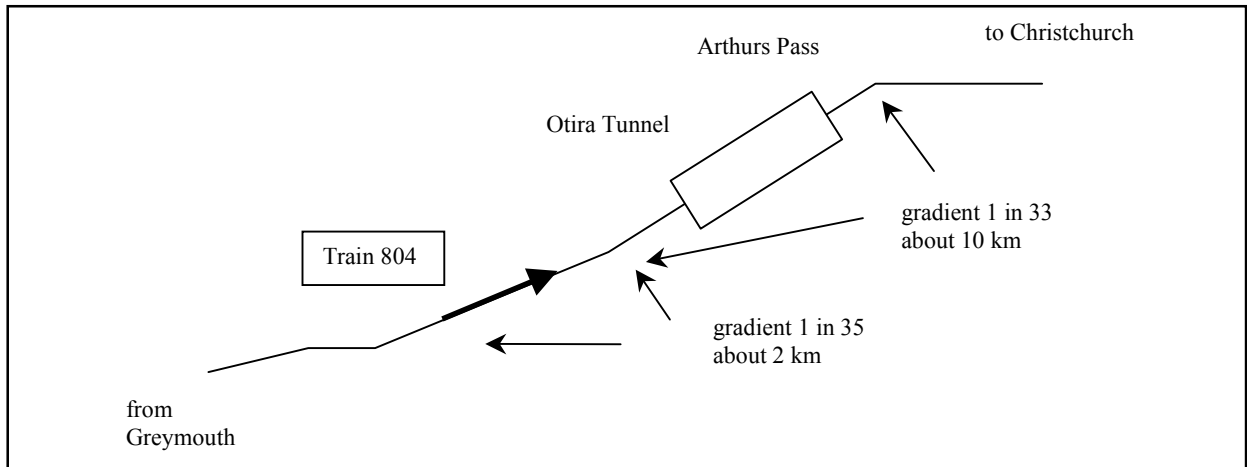
Figure 2
Gradient diagram Otira to Arthurs Pass (not to scale)

1.2.2 Eastbound trains climbed a 1 in 35 gradient from Otira towards the tunnel, but the gradient increased to 1 in 33 about 1 km before the western tunnel portal. The 8.5 km long tunnel was on a uniform 1 in 33 gradient from the western portal to Arthurs Pass (see Figure 2).

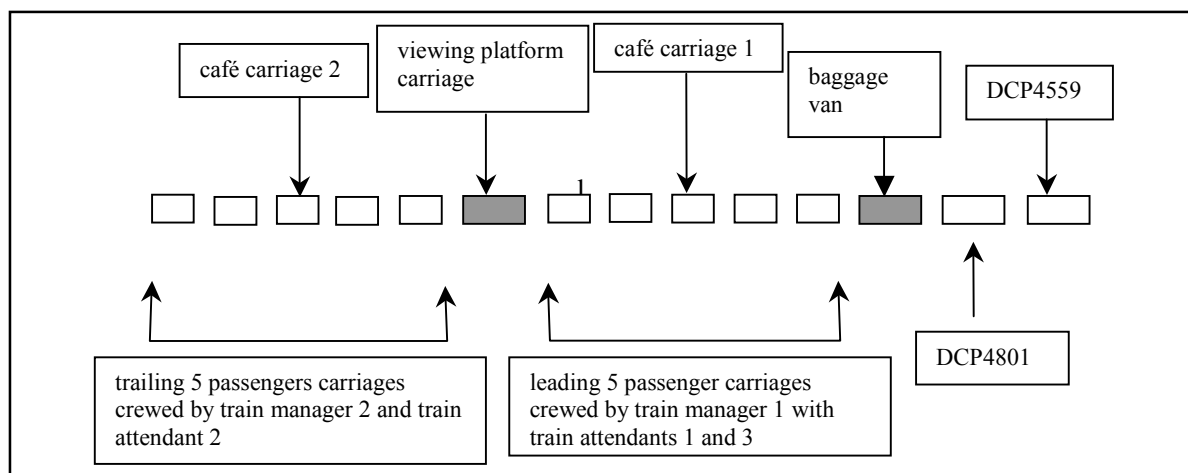
Figure 5
The make-up of Train 804 eastbound *Tranz Alpine* passenger express (not to scale)

- 1.4.4 Train manager 1 had been in the role for nearly 9 years and was experienced on the *Tranz Alpine* route.
- 1.4.5 When Train 804 entered the tunnel, train manager 1 was riding in café carriage 1, the third passenger carriage from the front of the train, with train attendant 1 and train attendant 3 (see Figure 5). He felt the train was not travelling as fast as normal when it climbed the grade towards the western portal.

- 1.4.23 Train manager 2 had been in the role for nearly 5 years and was experienced on the *Tranz Alpine* route.
- 1.4.24 She was riding with train attendant 2 in café carriage 2, the eighth passenger carriage from the front of the train, when it entered the tunnel (see Figure 5).
