RAILWAY OCCURRENCE REPORT

04-110 Wagon runaway, Owens siding, Onehunga industrial line 5 April 2004

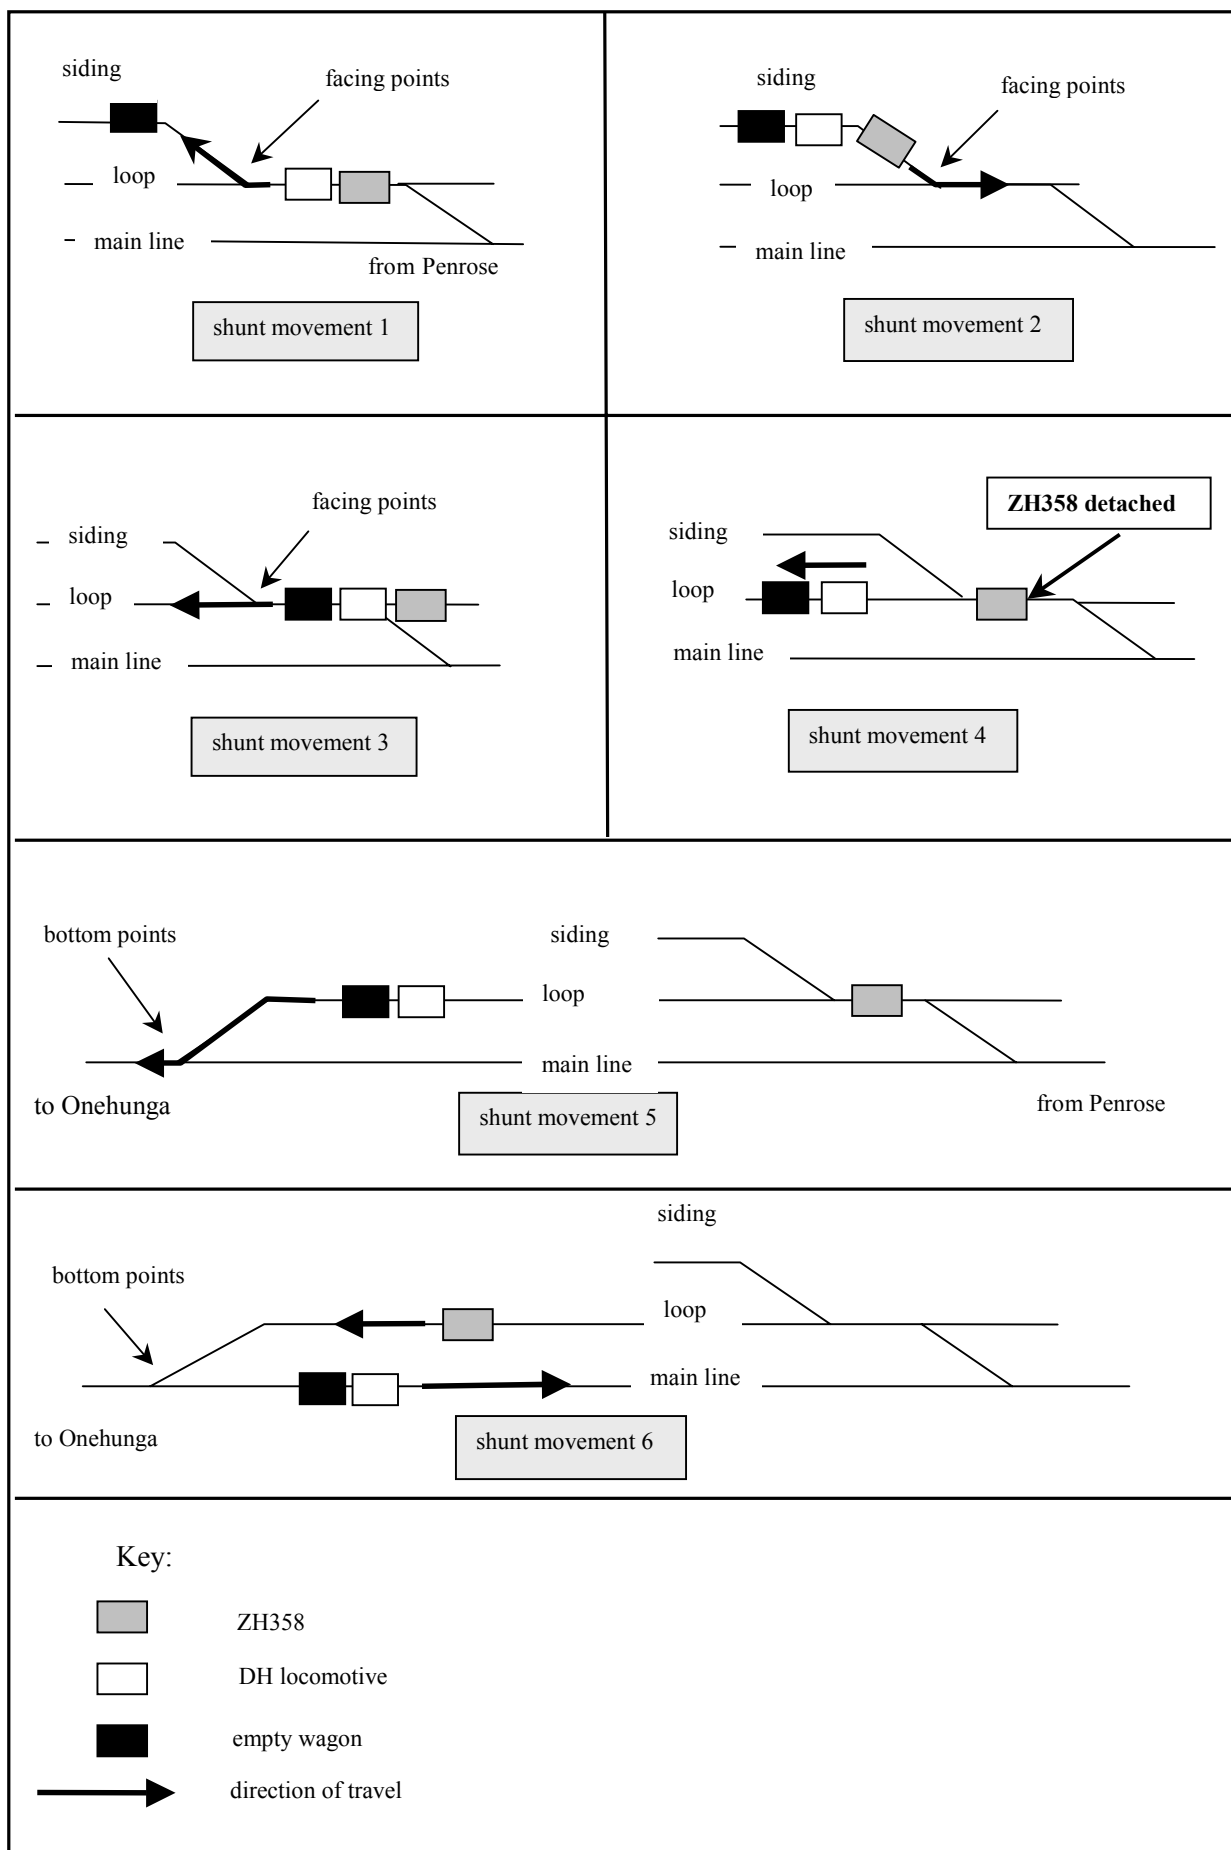
Figure 1
Shunt movements

- 1.1.2 At about 0625 Train L9, which had travelled from Westfield and shunted Penrose enroute, arrived at Owens siding on the Onehunga industrial line to place ZH358 to a customer's siding for discharge. An empty wagon in the siding was required to be moved to another load out facility, so the locomotive, with ZH358 attached, entered the siding under the direction of the rail operator and caught on to the empty wagon (see Figure 1, shunt movement 1).

- 1.1.3 The locomotive, now with a wagon attached at each end, reversed out of the siding (see Figure 1, shunt movement 2) and on to the loop where the consist stopped clear of the facing points (see Figure 1, shunt movement 3).

- 1.1.4 The rail operator then set the facing points to normal and directed the consist forward until the locomotive and the empty wagon were clear of the facing points where he stopped the movement and detached ZH358 (see Figure 1, shunt movement 4). The locomotive, with the empty wagon attached to the front, then moved down the loop, leaving ZH358 where it had been detached clear of the facing points (see Figure 1, shunt movement 5).

- 1.1.5 At the bottom end of the loop, the locomotive travelled through the points and on to the main line, where it stopped while the rail operator set the points for the main line. After this was done he directed the movement back up the main line with the empty wagon now trailing behind the locomotive (see Figure 1, shunt movement 6).

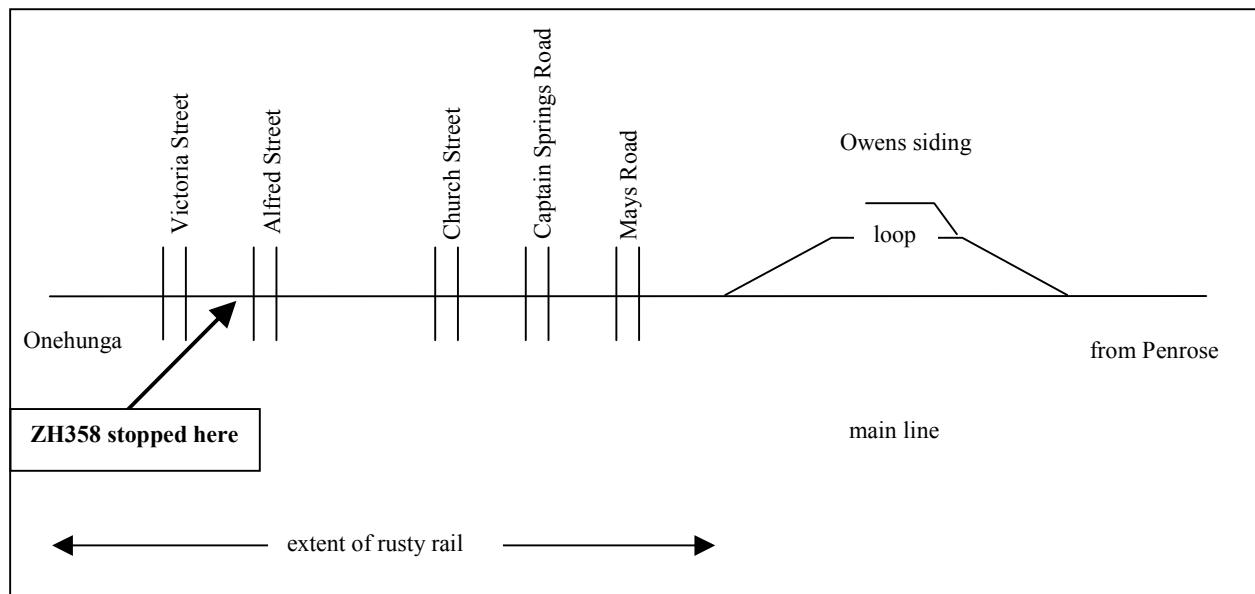
Figure 2

Site diagram of Onehunga industrial line showing location of Owens siding (not to scale)

- 1.2.4 There was no derailing block on the loop to prevent runaway wagons from entering the main line and running down towards Onehunga.
- 1.2.5 There were no scheduled train services operating beyond Owens siding on the Onehunga industrial line and there had been none for a number of years. The absence of trains caused a build-up of rust on the unused rails beyond Owens siding. The layer of rust had the potential to insulate the wheels of any rail vehicles from the track circuits, resulting in unreliable operation of level crossing alarms from and including Mays Road to the end of the line (see Figure 2).
