RAILWAY OCCURRENCE REPORT

04-112

Diesel multiple unit passenger Train 2146, fire auxiliary engine, Boston Road

16 April 2004

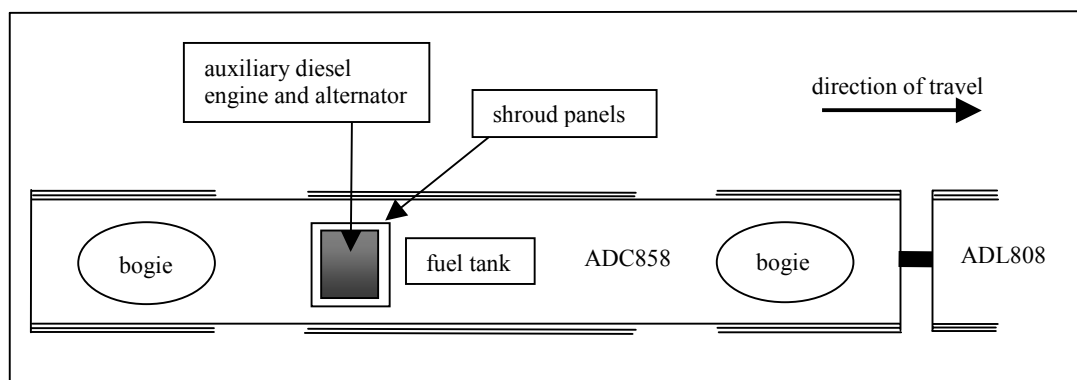
Figure 2
Under-floor plan of ADC 858 showing location of auxiliary engine
(not to scale)

1.7.2 The auxiliary engine was manufactured by Detroit Diesel in the United States of America. It was a model 471T, 4-cylinder in-line diesel engine and was fitted with a Garrett turbocharger. The unit had been supplied by Detroit Australia as a standby generator and had been installed on ADC858 DMU during its construction.
