## RAILWAY OCCURRENCE REPORT

**04-123    Electric multiple unit traction motor fires,    7 May 2004 – 30 September 2004**  
**Wellington Suburban Network**

**TRANSPORT ACCIDENT INVESTIGATION  
COMMISSION NEW ZEALAND**

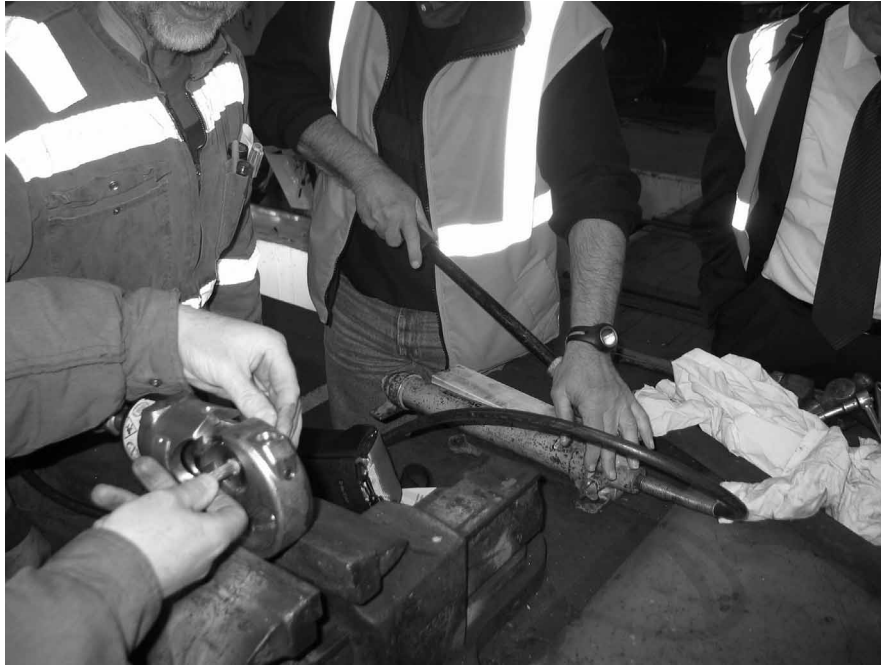
**Figure 9**  
The hydraulic crimping tool in use at the EMU depot

5.6.2 All crimp connections observed during the investigation all had some element that reduced the quality of the joint. The crimp tools, cable size and type, and crimp lugs were not matched for the application on any of the observed joints. Some products were from Utilux but new stock lugs were sourced from a different supplier and in the 50 mm<sup>2</sup> size only. Utilux would not guarantee the completed connections if alternative products were used.
