## RAILWAY OCCURRENCE REPORT

04-125      collision between an over-dimensioned road load and rail over road      2 October 2004  
bridge No.98 on Opaki-Kaiparoro Road, between Eketahuna and  
Mangamahoe

**Report 04-125**

**collision between an over-dimensioned road load**

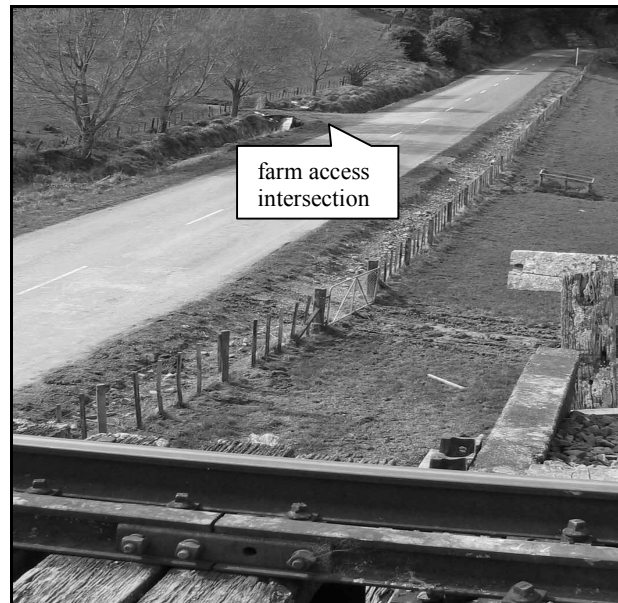
1.1.2 The bulldozer was loaded and secured by a truck driver and an owner of the machine before leaving the farm access intersection with the Opaki-Kaiparoro Road (see Figure 2). The truck and trailer unit travelled for a short distance, and the truck driver said it was travelling at a speed of about 15 km/h when it reached bridge No.98. He heard a loud noise and stopped the unit at about 1015.

**Figure 2**  
**Opaki-Kaiparoro Road from top of bridge No.98 looking south to the farm access**

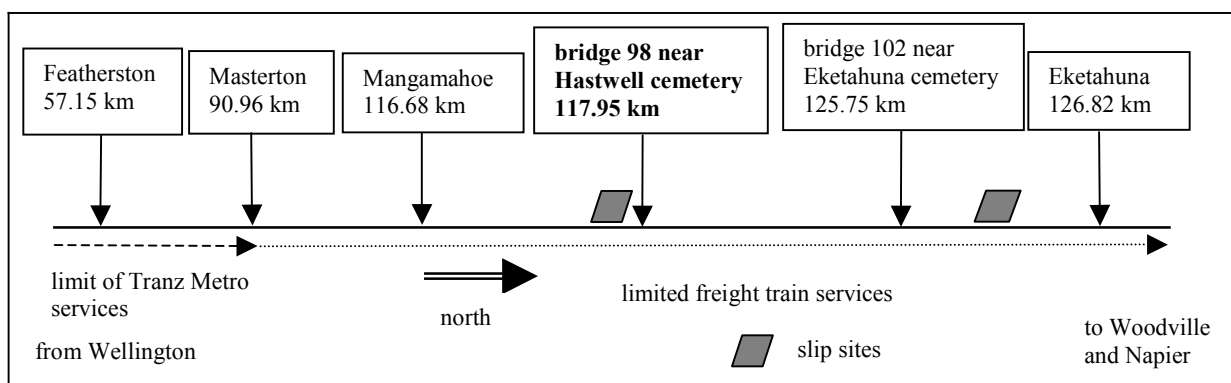
**Figure 3**  
**Site plan of Wairarapa Line (not to scale)**

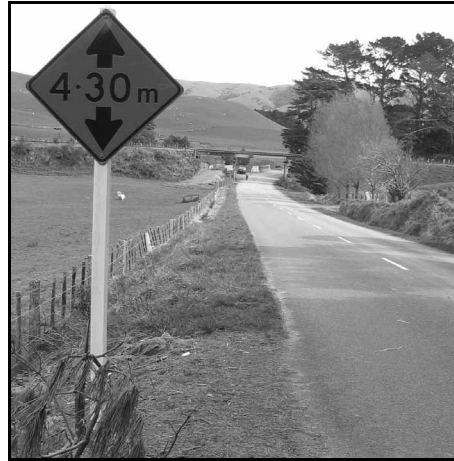
- 1.4.5 Land Transport NZ and its predecessor LTSA were responsible for the erection of clearance warning signs. The procedures required that where an overhead soffit clearance on any structure was less than 4.40 m, then signs were to be erected on the structure itself. Signs were also to be erected at least 120 m in advance of the structure to provide approaching drivers with an uninterrupted view in rural areas (see Figure 8). The policy also required that the posted measurement be rounded down to the nearest 100 mm.

**Figure 8**  
**Looking north along Opaki-Kaiparoro Road towards bridge No.98**
