RAILWAY OCCURRENCE REPORT

04-130 **express freight train derailments due to axle bearing failures, various locations**

**5 November 2004-
21 March 2005**

**TRANSPORT ACCIDENT INVESTIGATION COMMISSION
NEW ZEALAND**

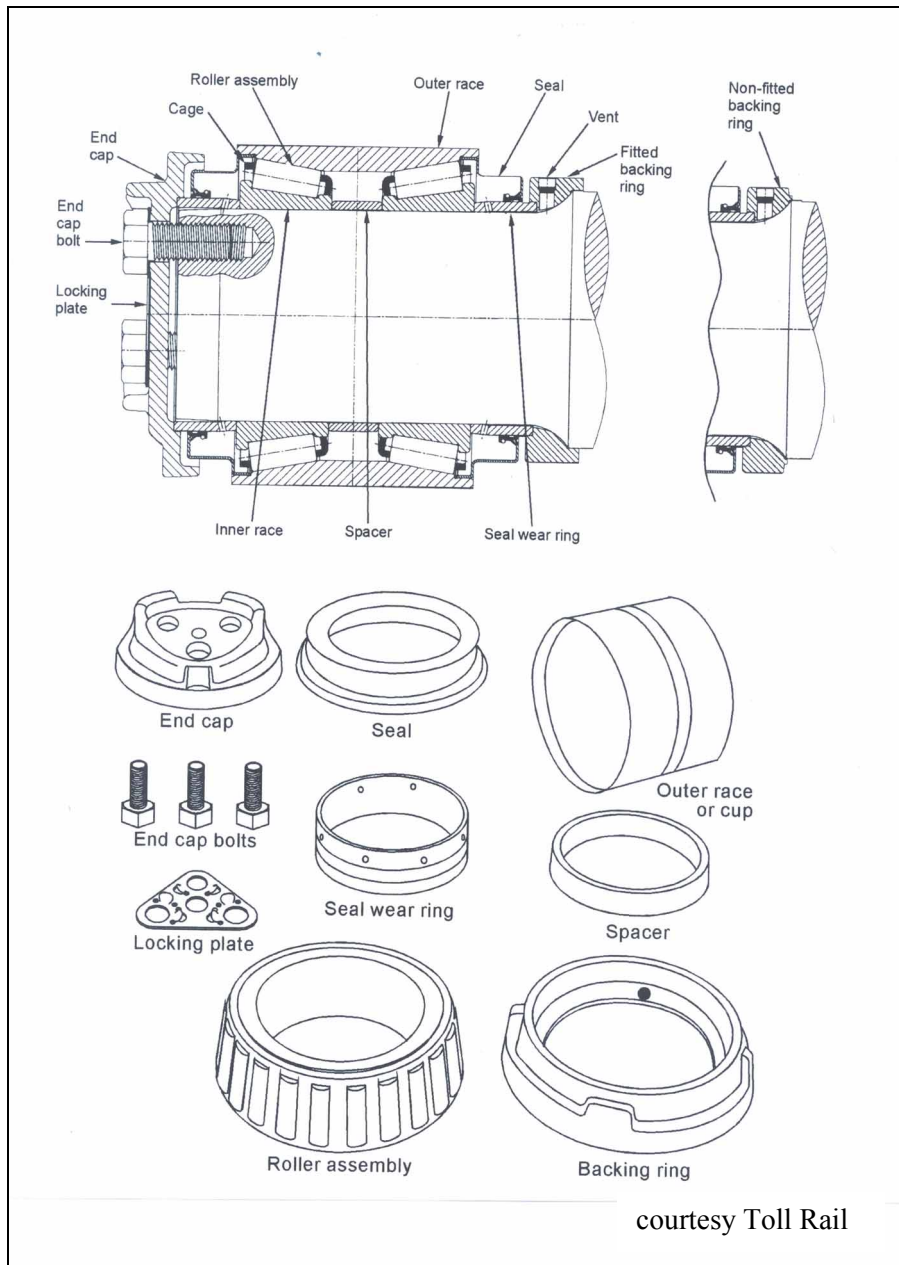
Figure 1
Package bearing components

2.1.1 Roller bearing units (RBUs) are fitted to the axle journal ends outside each wheel. Two tapered roller bearings and associated bearing elements are combined into one self-contained assembly and fitted to each axle journal (see Figure 1). The RBU is fitted over the axle journal, the cylindrical portion of the axle, and retained and located by an end cap. The “interference fit” of the inner race on the journal and the lateral clamp provided by the end cap bolts prevent rotational creep between the inner race and the axle. The RBU is then located and retained on the wagon bogie side frame pedestal by a bearing adapter casting.
