## M A R I N E   O C C U R R E N C E   R E P O R T

04-208

jet boat *CYS*, propulsion failure and capsize, Waimakariri River

13 May 2004

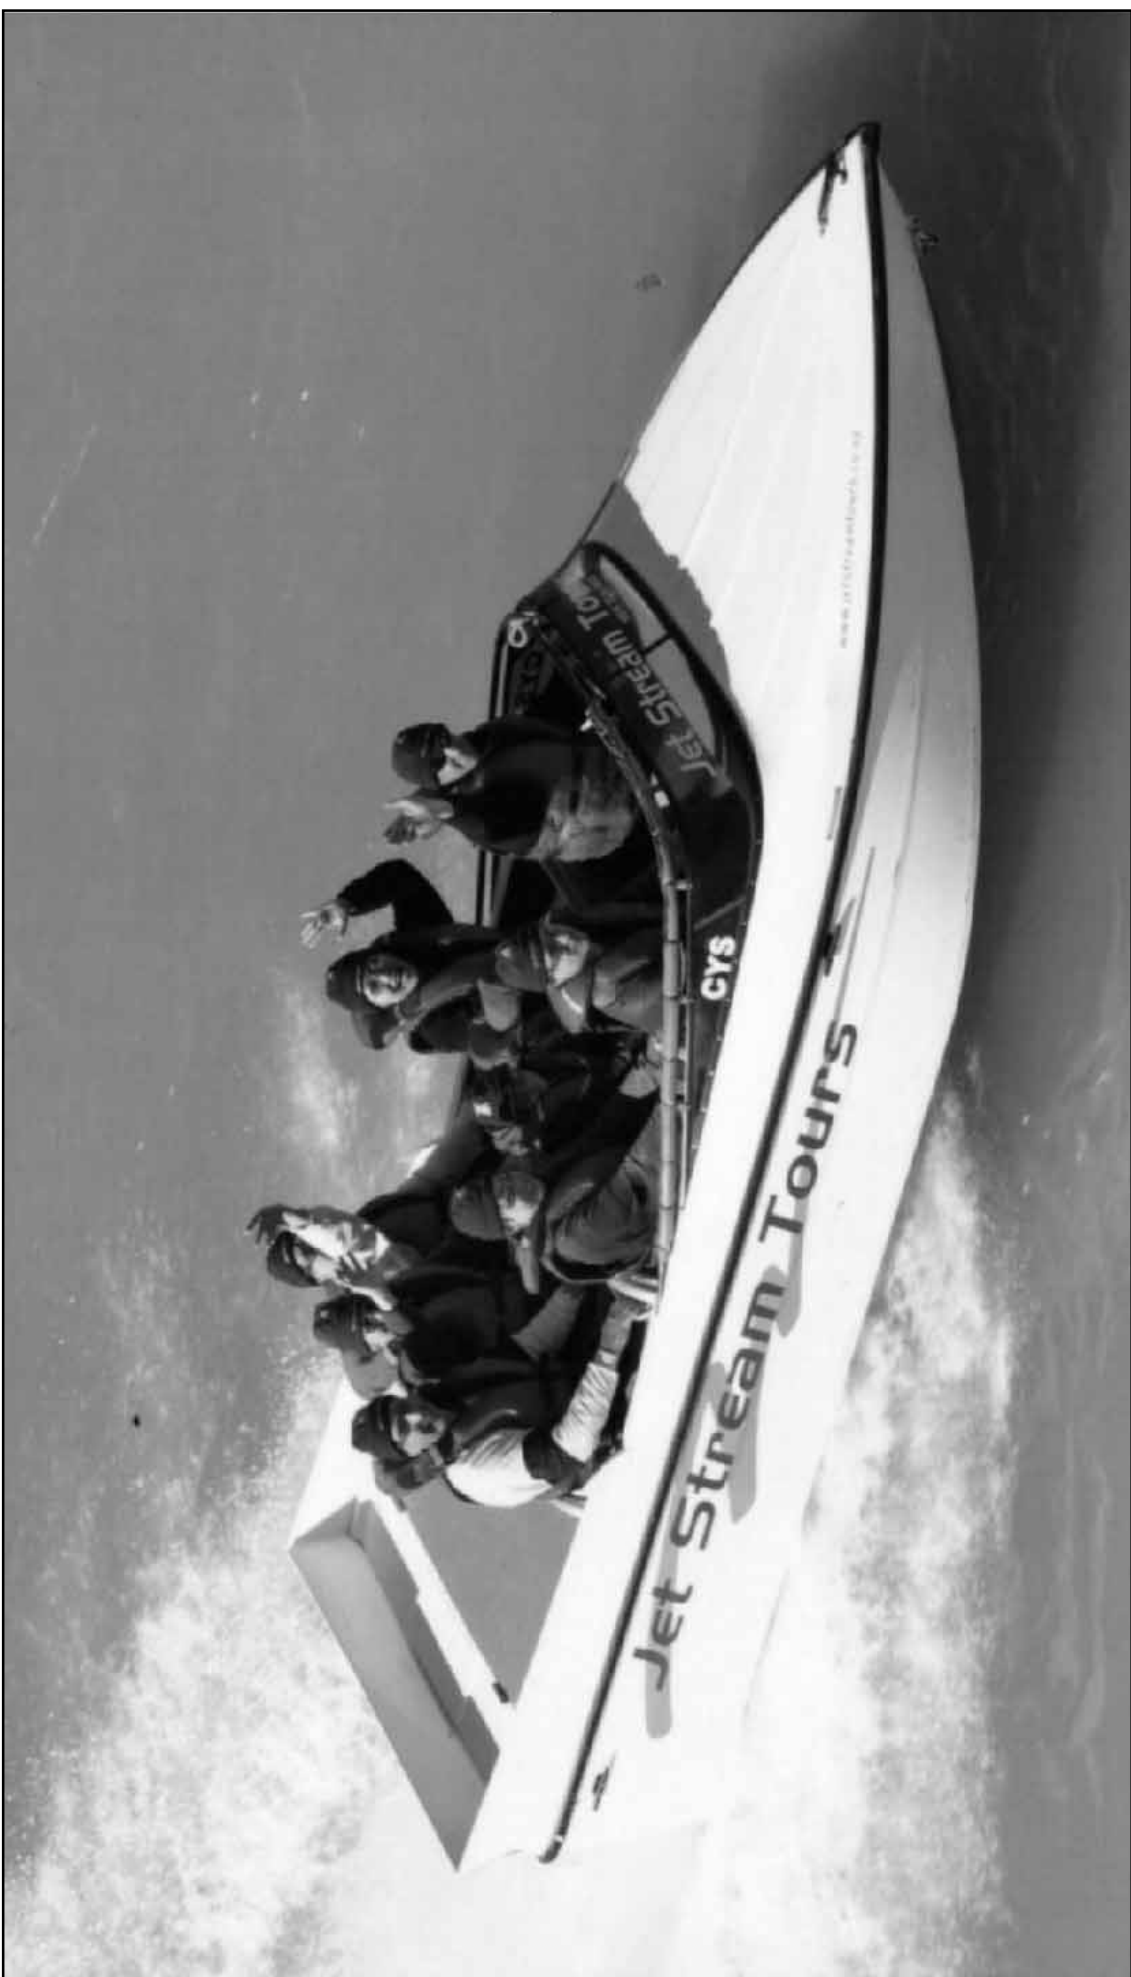
The CYS (*white*) jet boat

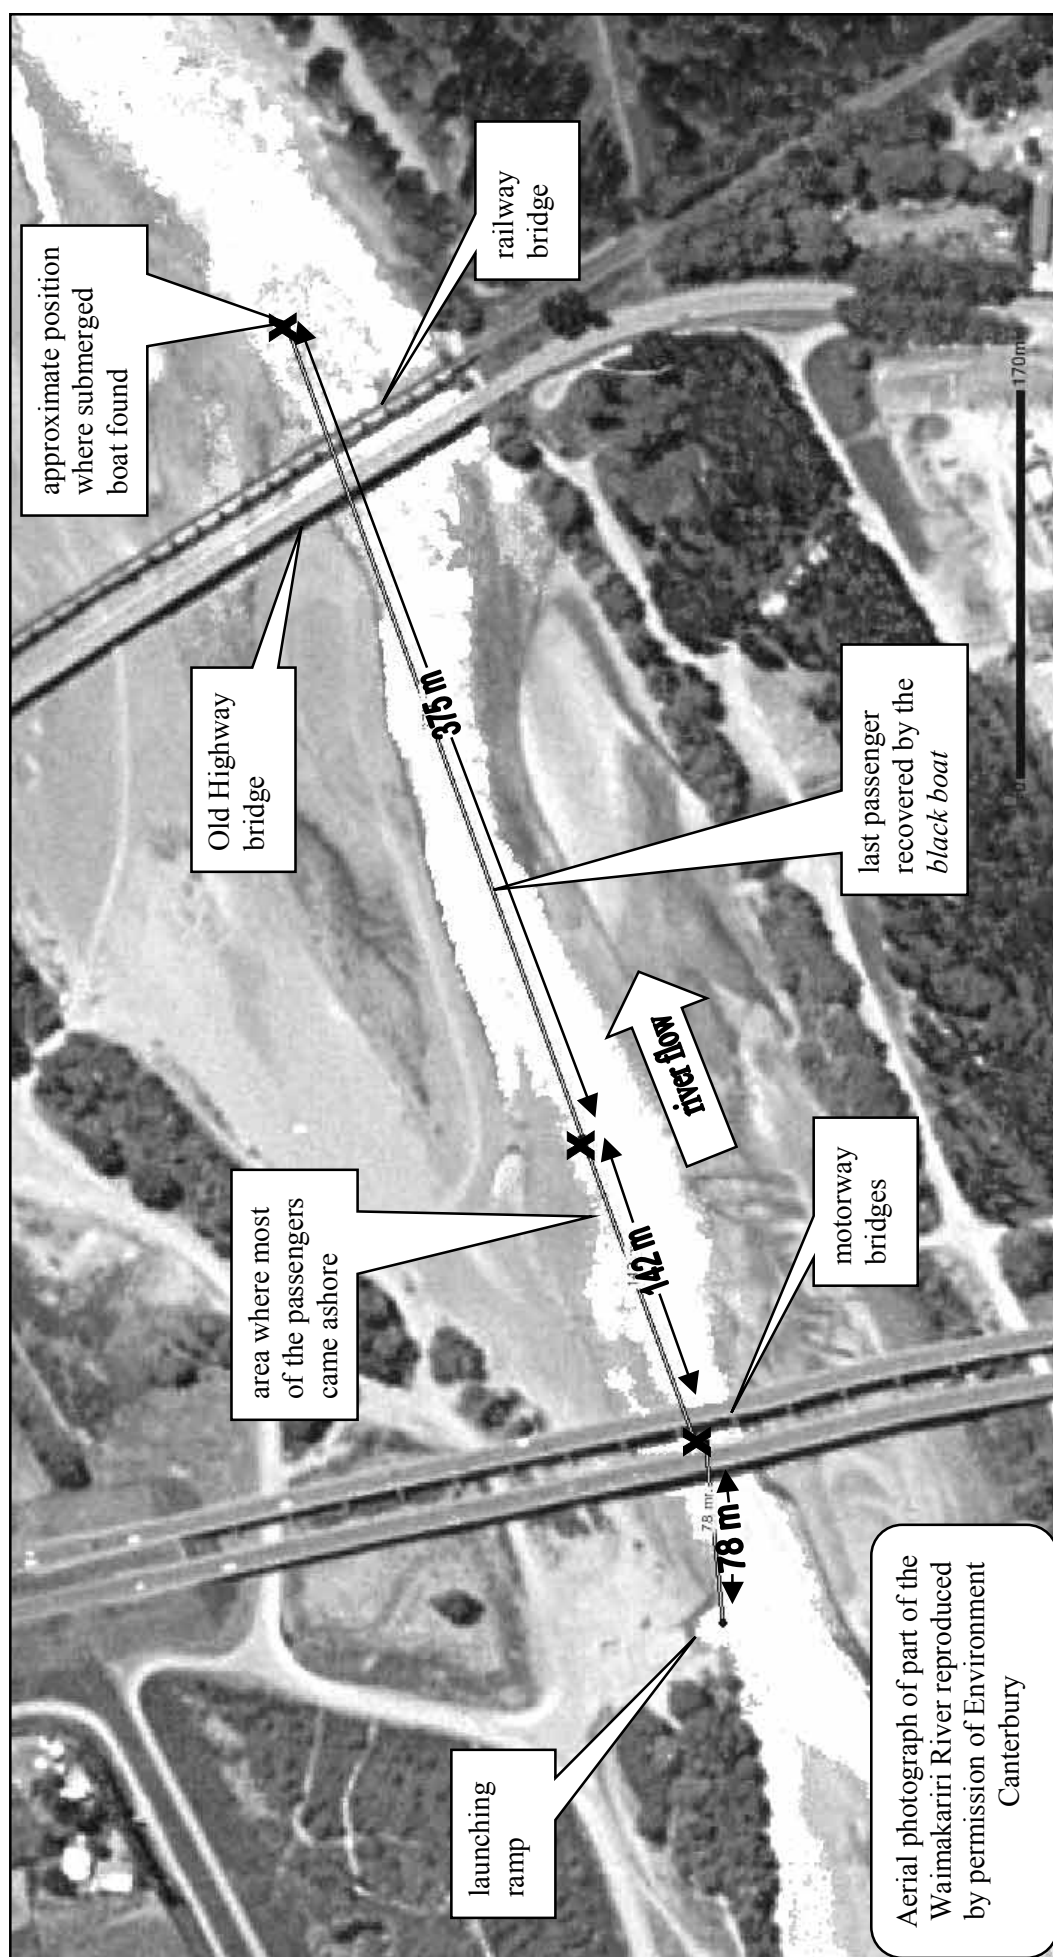
**Figure 1**  
Aerial photograph showing part of the Waimakariri River

- 1.1.10 The boat was swept towards the motorway bridge (see Figures 1 and 2). The driver initially thought that the boat would pass between the 2<sup>nd</sup> and 3<sup>rd</sup> sets of piers, but the current pushed the boat towards the downstream of the 2 piers in the 3<sup>rd</sup> set. Before they made contact the driver warned the passengers and expressed a hope that they would just bump into the pier and then be pushed clear. However, the boat initially made contact on its starboard side just behind the front row of seats, and the strength of the current was such that the starboard side rode up the pier causing the after port corner to be submerged allowing water to enter the boat. As it filled with water, the boat started to flip and the driver and passengers were thrown into the water.

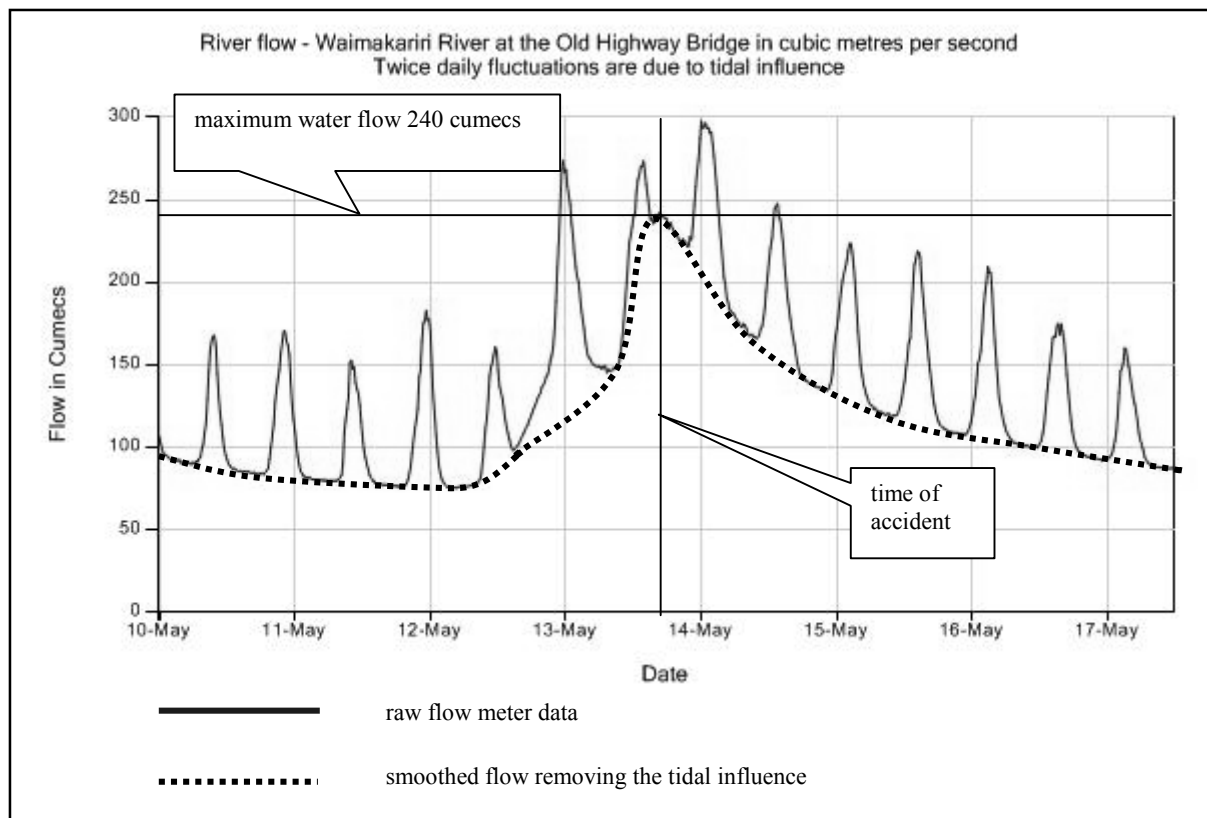
**Figure 4**  
**River flows at the Old Highway Bridge for the previous week as shown on the Environment Canterbury website on 17 May 2004**

and river flow, called a rating curve. This allowed a simple calculation to provide water flow from the more easily measured water level. The continued reliability of the rating curve depended on a number of factors, the most significant being the shape of the channel. A water level recorder was sited at the Old Highway Bridge, about 500 m downstream of the launching ramp. The rating calculation was applied to the recorded levels and the resultant water flows were posted on the ECan website both in tabular and graph form (see Figure 4).

- 1.4.4 The Old Highway Bridge was close enough to the sea for the river to be subject to tidal fluctuations and the readings from the water level recorder showed twice-daily maximum fluctuations around the time of high water. When the water level data was subjected to the rating calculation it incorrectly showed the water flow increasing around the time of high water. The water flow graph on the website did carry a warning that there were twice daily fluctuations due to tidal influence (see Figure 4). On 13 May 2004, the information on the website showed tidal peaks at midnight and midday, high water was at 2345 on 12 May and 1206 on 13 May 2004. The peak flow of about 270 cumecs occurred at about midday. When the tidal peaks were smoothed, the resultant peak flow was about 240 cumecs in the afternoon.

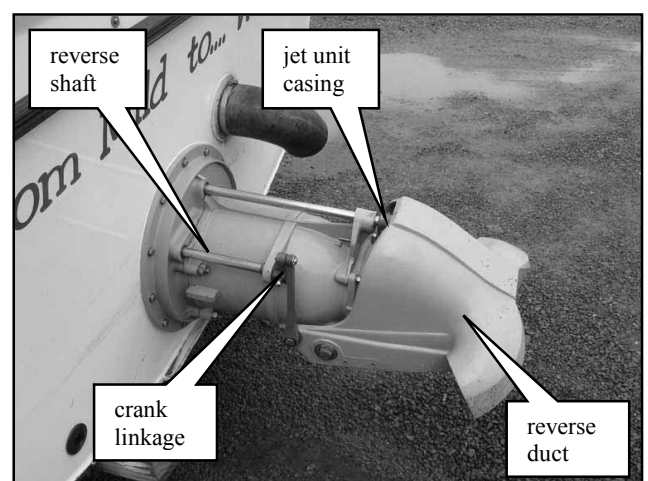
**Figure 7**  
**The reverse duct showing the reverse shaft and crank linkage**

- 1.7.1 The *white boat's* engine ran on a mixture of 80% 96 octane unleaded petrol and 20% 100 octane leaded petrol.
- 1.7.2 The jet unit was a Hamilton HJ 212, which was commonly used in small commercial or private jet boats. The jet unit was a single stage water pump, which was connected to the engine by a drive shaft. The jet unit drew water through an intake grill under the hull and expelled it under high pressure through a steerable nozzle. A split deflector reverse duct was provided to give astern propulsion (see Figure 7).

- 1.7.3 Speed and reverse thrust were achieved through a combination of throttle setting and a cable operated split deflector reverse duct. When the reverse duct was fully open the water efflux was rearwards, thrusting the boat forward. As the duct was lowered, an increasing amount of the water jet was deflected downward and forward, progressively changing the resultant thrust from forward to reverse. The engine throttle, also cable operated, was independent of the reverse duct.

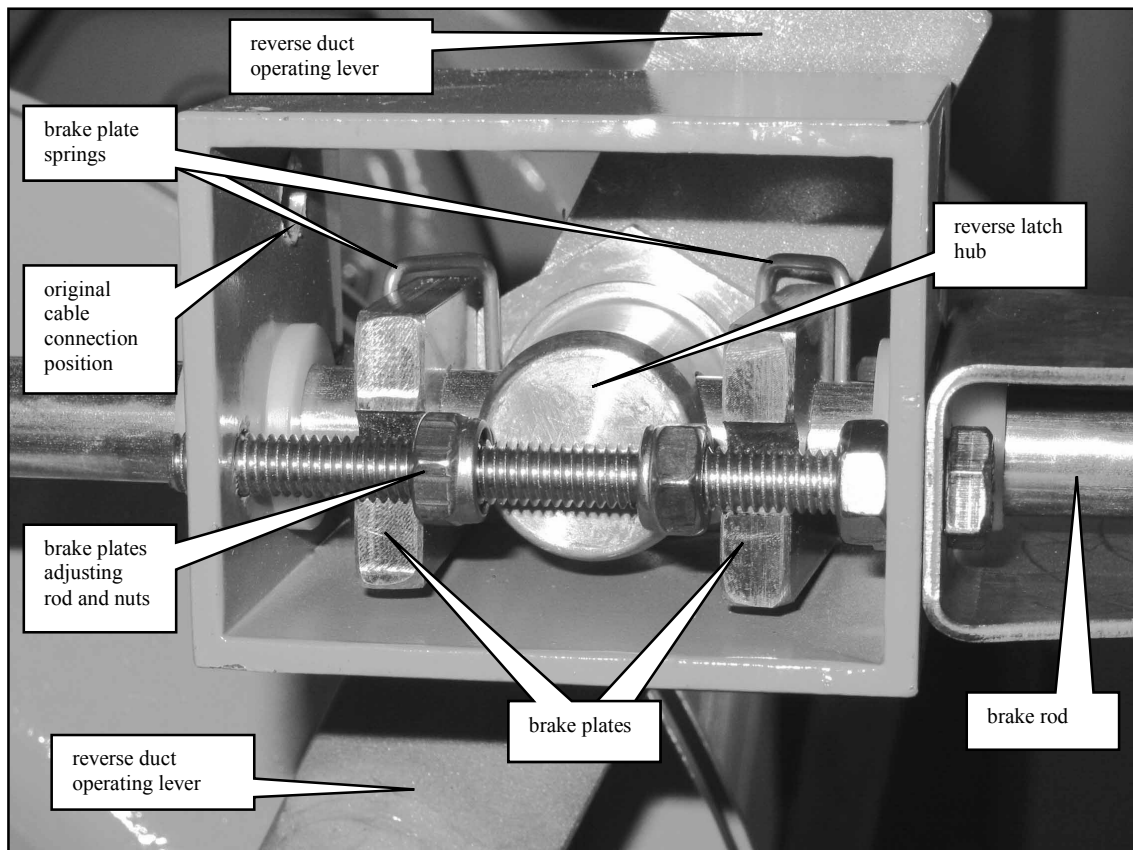
**Figure 9**  
**A new reverse latch, in elevation**

- 1.7.5 Within the latch assembly were 2 brake plates, tensioned by springs and set at an oblique angle to the brake rod, which kept the reverse duct in the position set by the driver. Without the latch, the weight of the duct would cause it to drop into the reverse position. The amount of friction exerted by the brake plates could be adjusted using the adjusting rod and nuts (see Figures 9 and 11).

- 1.7.7 The smaller Morse 64C cable was designed to be fitted directly to the latch assembly through pre-drilled holes (see Figure 9) and the brass cable end tube was connected to the brake rod by a clamp with a ball and socket type joint. The larger D0499 cable was too big to be fitted in this way, instead, a connection, also with a ball and socket type joint (see Figure 8), was mounted onto the top of the reverse latch assembly and connected to the cable end rod. A larger clamp, with a ball and socket type joint was used to connect the brass cable end tube to the brake rod. The new clamp and connection increased the distance between the axis of the brake rod and the axis of the cable from 18 mm in the original design to about 50 mm (distance "A" in Figure 8).

- 1.7.8 CWF Hamilton and Co Ltd commented that a number of tour boats had been set up with the larger cable and control lever but the clamp at the end of the brass cable end tube was attached to the transom of the boat rather than the brake rod. In this way no load was applied to the brake rod and bending at the detent would not occur. The reverse latch assembly on the *black boat* was of this type.
- 1.7.9 The ball and socket joints on the clamp and cable end rod connection were necessary to allow for the vertical movement of the latch assembly caused by the radial movement of the reverse duct operating lever (see Figures 6 and 9).
