M A R I N E O C C U R R E N C E R E P O R T

04-215 restricted limit passenger vessel *Southern Winds*, grounding,
Charles Sound, Fiordland

15 October 2004

**TRANSPORT ACCIDENT INVESTIGATION COMMISSION
NEW ZEALAND**

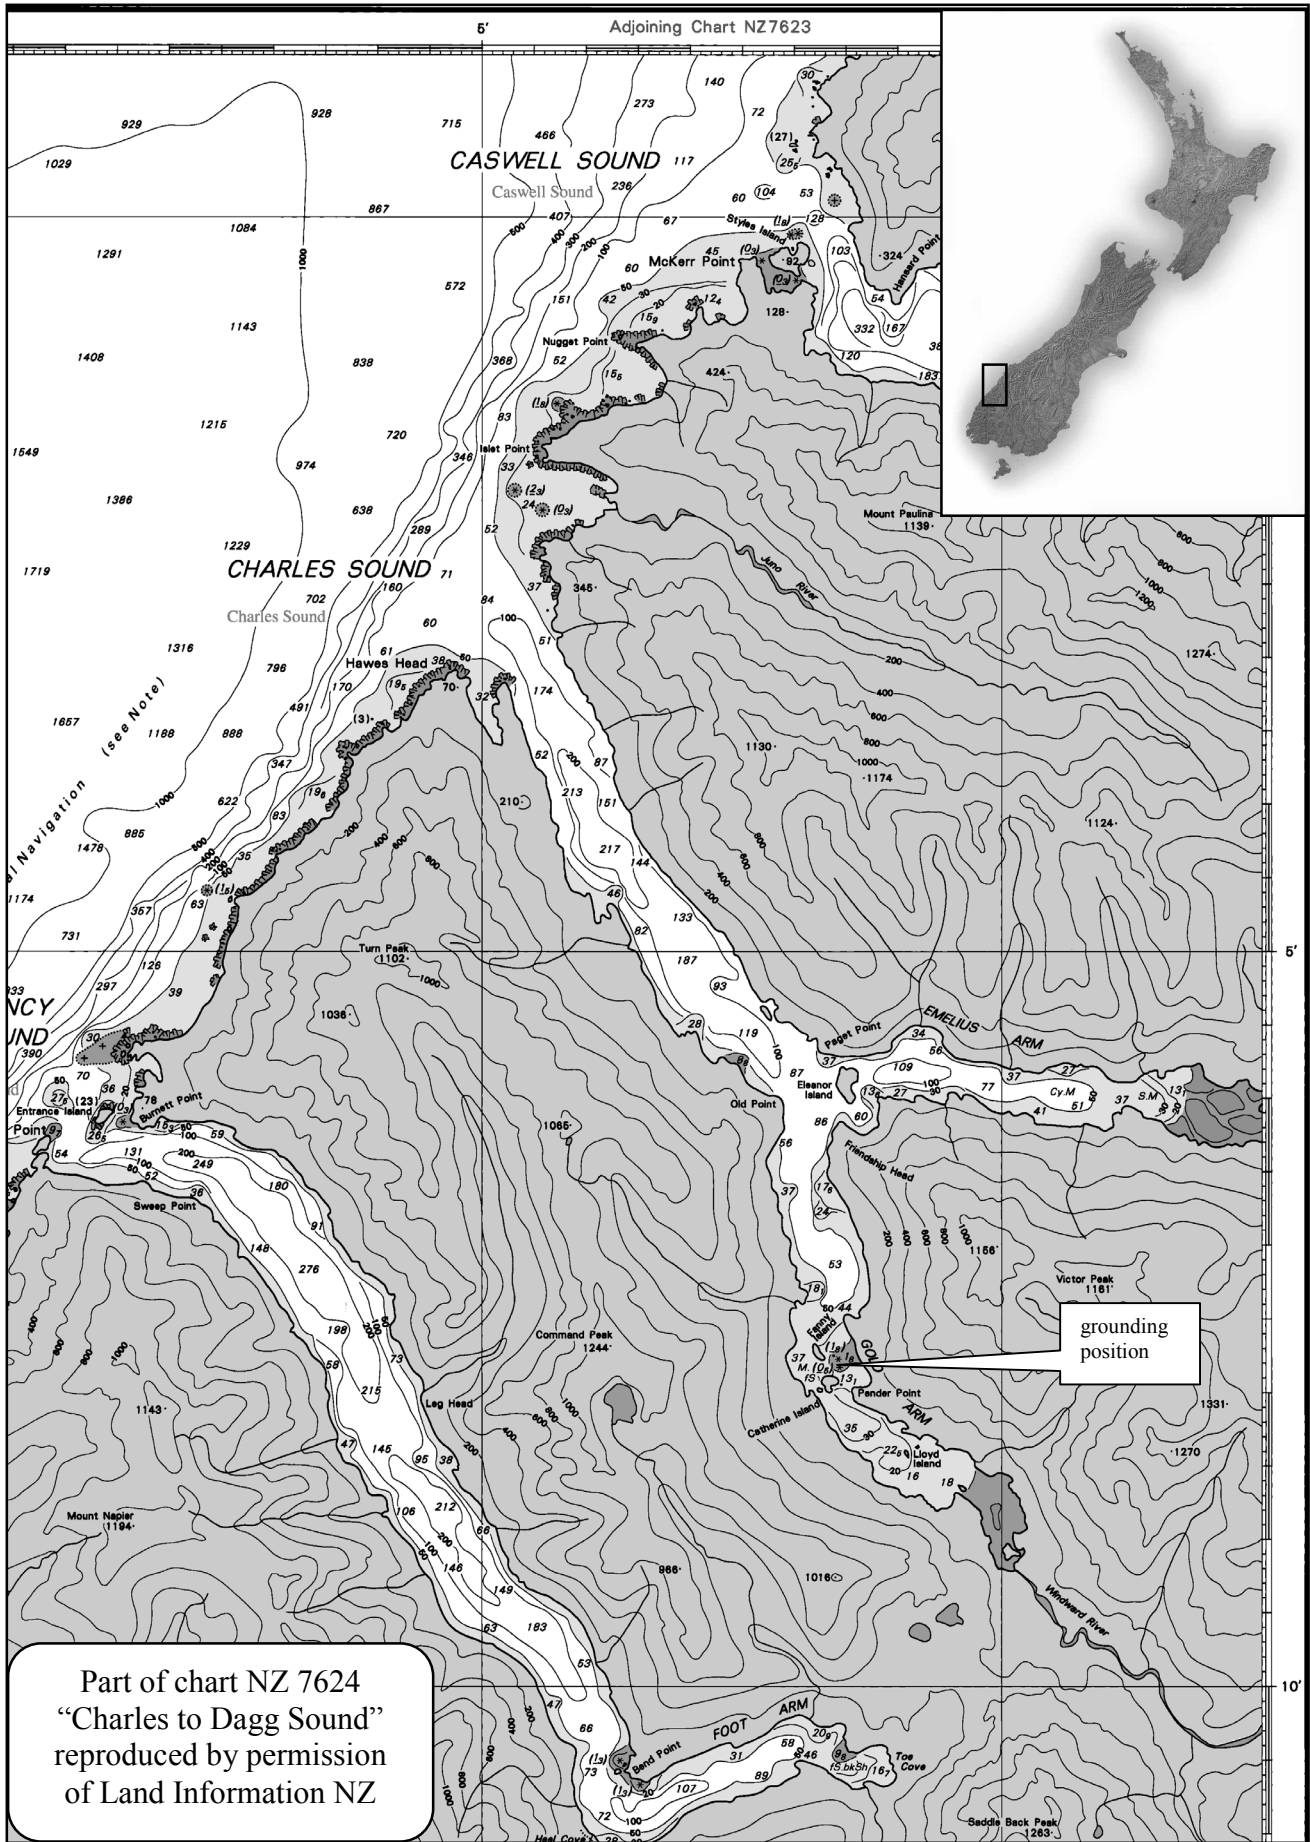
Figure 1
Part of chart NZ 7624 Charles to Dagg Sound

- 1.1.5 The following day they carried out work in Thompson, Nancy and Charles Sounds before going to anchor in Gold Arm, the more southerly of the 2 arms of Charles Sound. The Master said that he mainly navigated the boat by eye but he also used the radar and the track plotter. In heading into the inner part of Gold Arm he passed down the middle of the sound, leaving Fanny Island to starboard, passing close to the shoal ground before altering course to port and then starboard around Catherine Island. He then continued past Pender Point and brought the boat to anchor behind Lloyd Island in 9 fathoms [16.5m] of water (see Figures 1, 2 and 3).

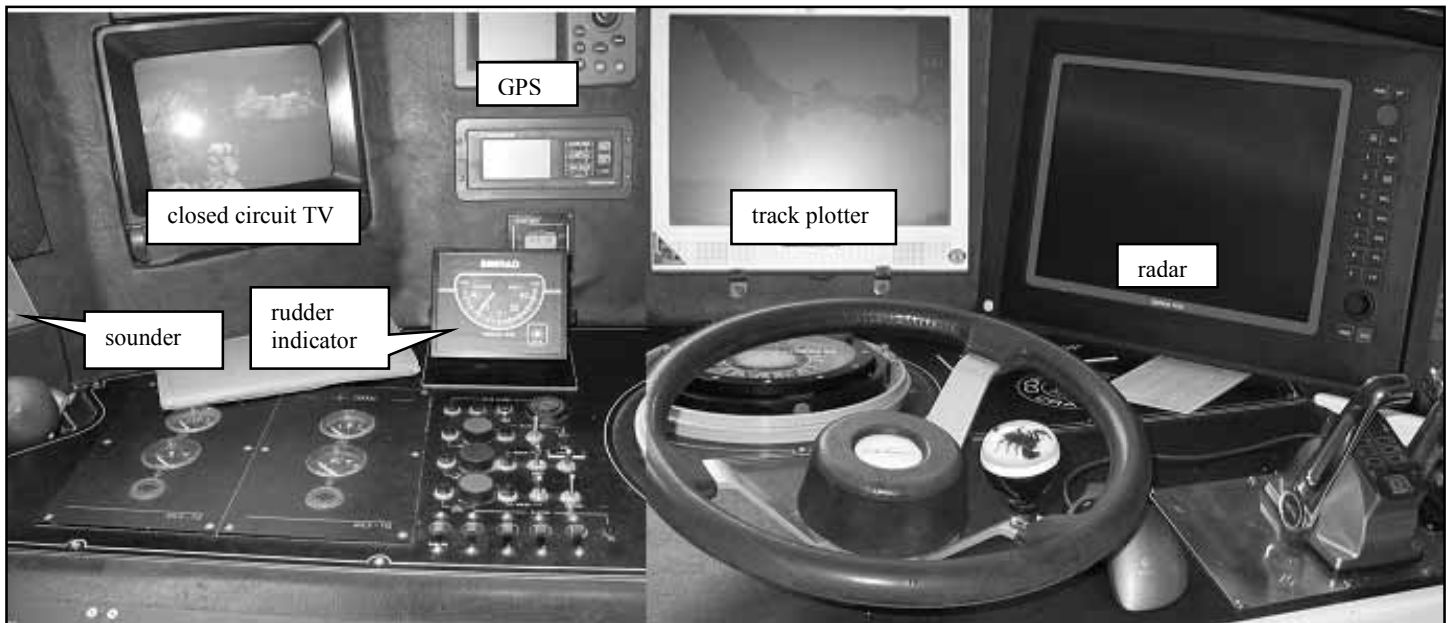
Figure 9
Bridge console

- 1.3.4 The navigation aids were displayed on a console situated immediately in front of the steering position (see Figure 9). New navigational and communication equipment was installed before the boat was commissioned. Part of that equipment was an Olex 4.1, 7/6-2002 track plotter connected to a JRC JLR-10 GPS compass, which was set to WGS84 datum. C-MAP vector charts were installed on the track plotter. The Olex system had a bottom mapping facility that updated the vector charts when a sounding different from that shown on the electronic chart was recorded and verified as the boat passed over it. In order to produce accurate soundings, an XTide tidal calculation module was included as part of the mapping facility.

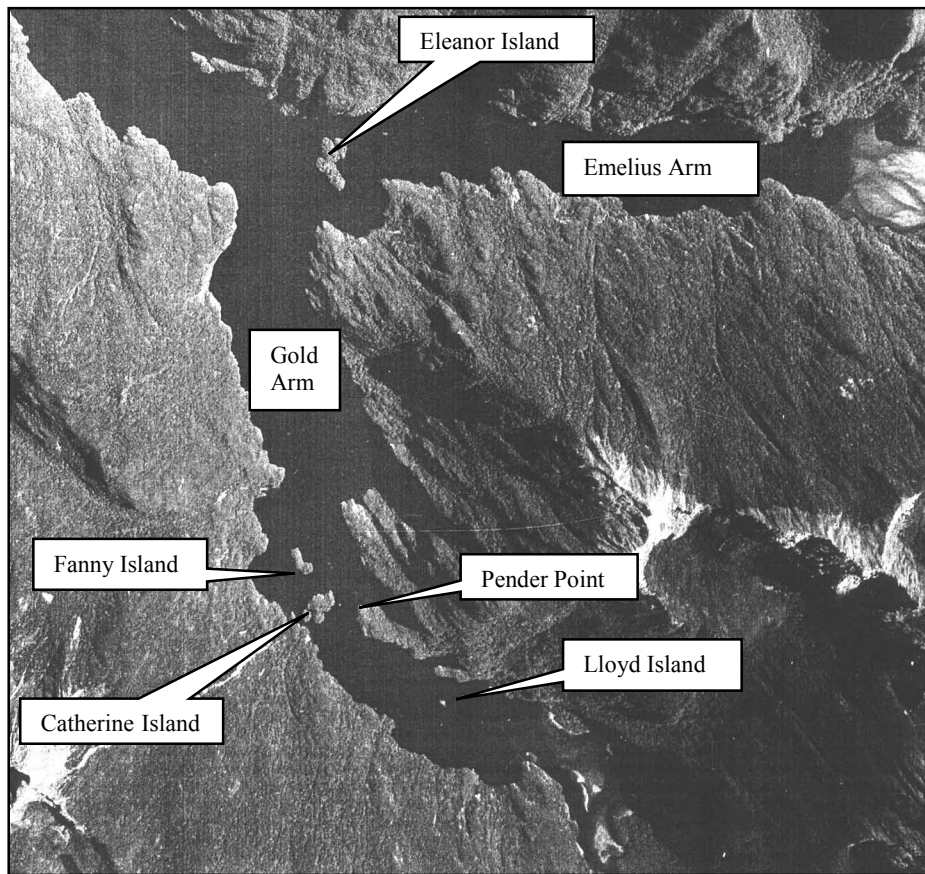
Figure 13
Aerial photograph of Charles Sound

- 1.7.2 Charles Sound is one of the smaller sounds and is situated about midway between Milford Sound and Preservation Inlet. A little over 4 nm inside the sound it divides into 2 arms, Emelius Arm, which extends to the east, and Gold Arm, which extends to the south (see Figure 13). The New Zealand Pilot (Admiralty Sailing Directions NP51) stated that good anchorage could be obtained in Emelius and Gold Arms but the latter was not easily accessible.

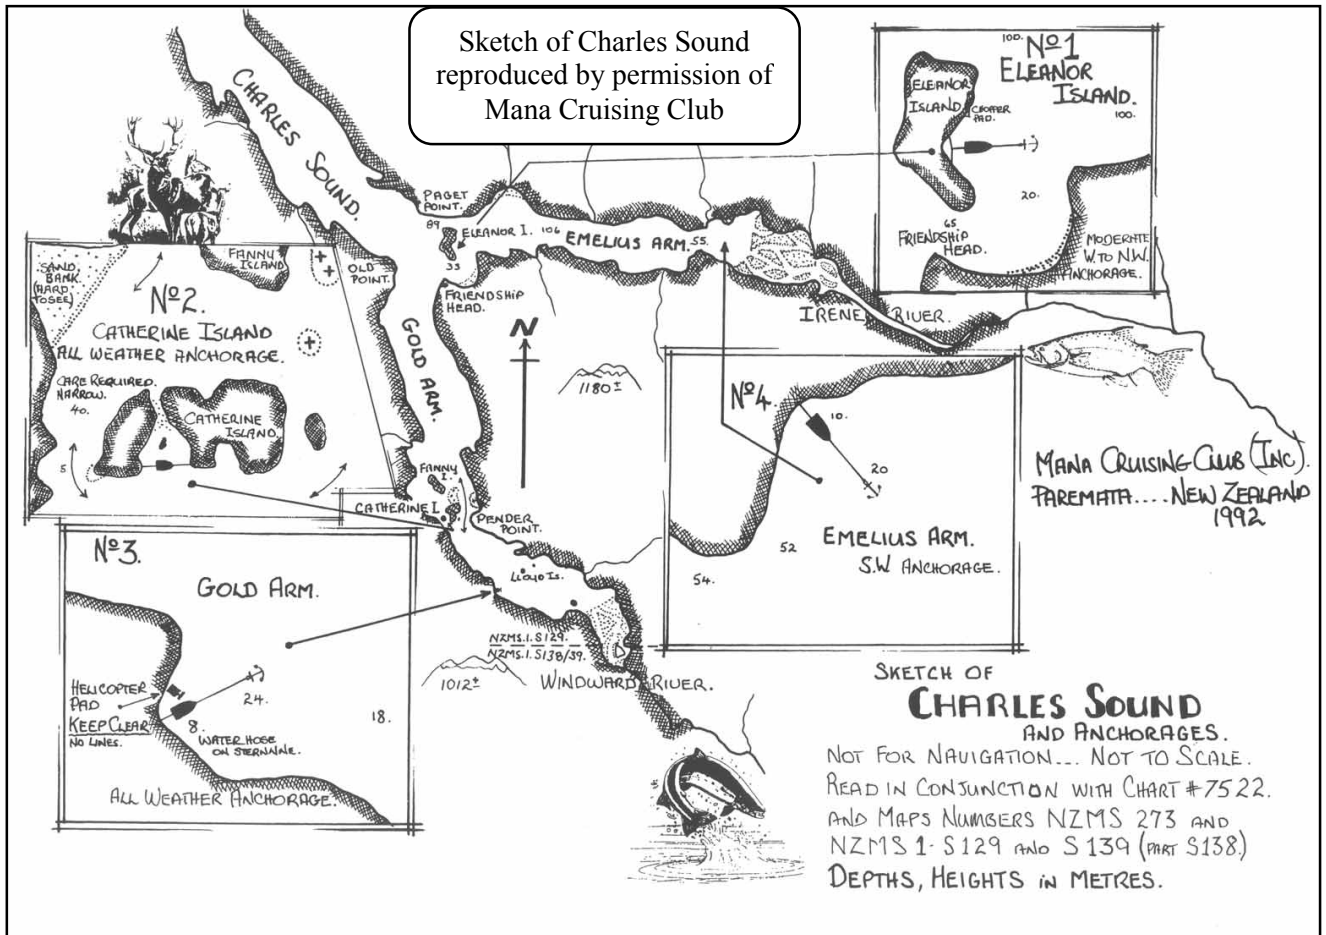
Figure 14
Sketch of Charles Sound from a boaties' guide to Fiordland

- 1.7.7 Anchorages were shown in sketches accompanying the text. The guide recommended that where possible stern lines be run to the shore to make the anchorages more secure. In many places a permanently rigged line was available to be used to secure the stern (see Figure 14).

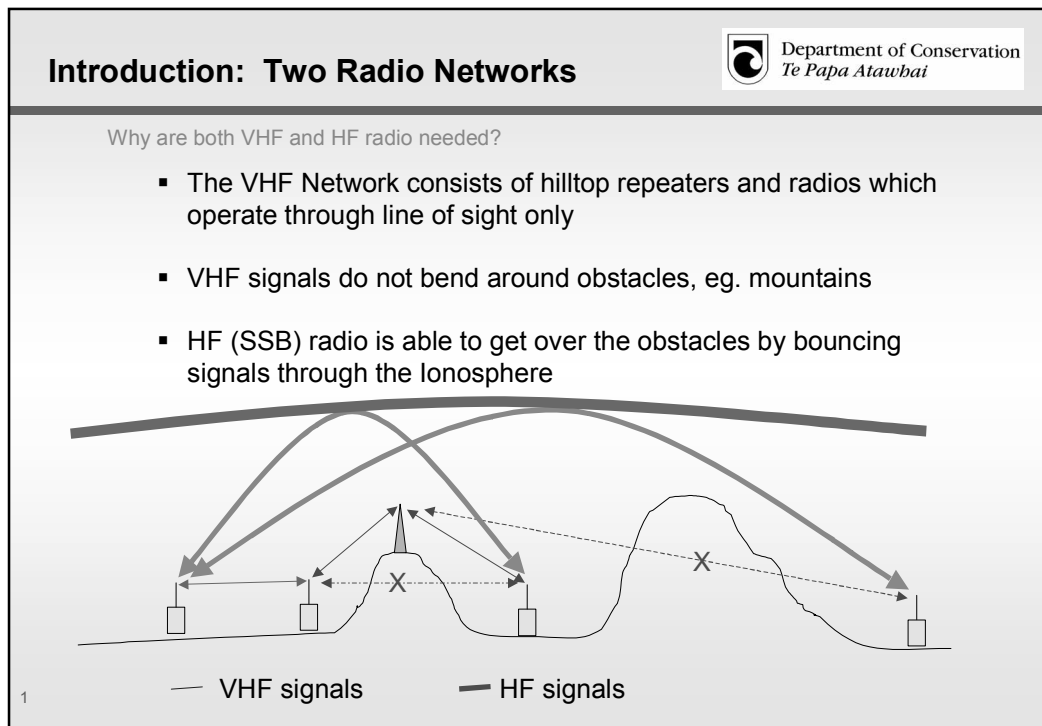
Figure 16
Diagram showing the difference between VHF and HF radio wave propagation

1.10.2 It was recognised that VHF radio waves travel in a straight line and do not bend around obstacles, such as mountains. So, if VHF were to be used, an extensive system of repeater stations on high points, like mountaintops, would be required. Such a system was occasionally used for specific local projects, but on a national scale a more reliable and flexible system was needed. It was accepted that HF radio would provide good coverage over the majority of the intended operating area for the greatest percentage of the time. HF radio uses the ionosphere to reflect (or bounce) the radio waves, making it more likely that a signal would be able to bounce over an intermediate obstacle (see Figure 16).

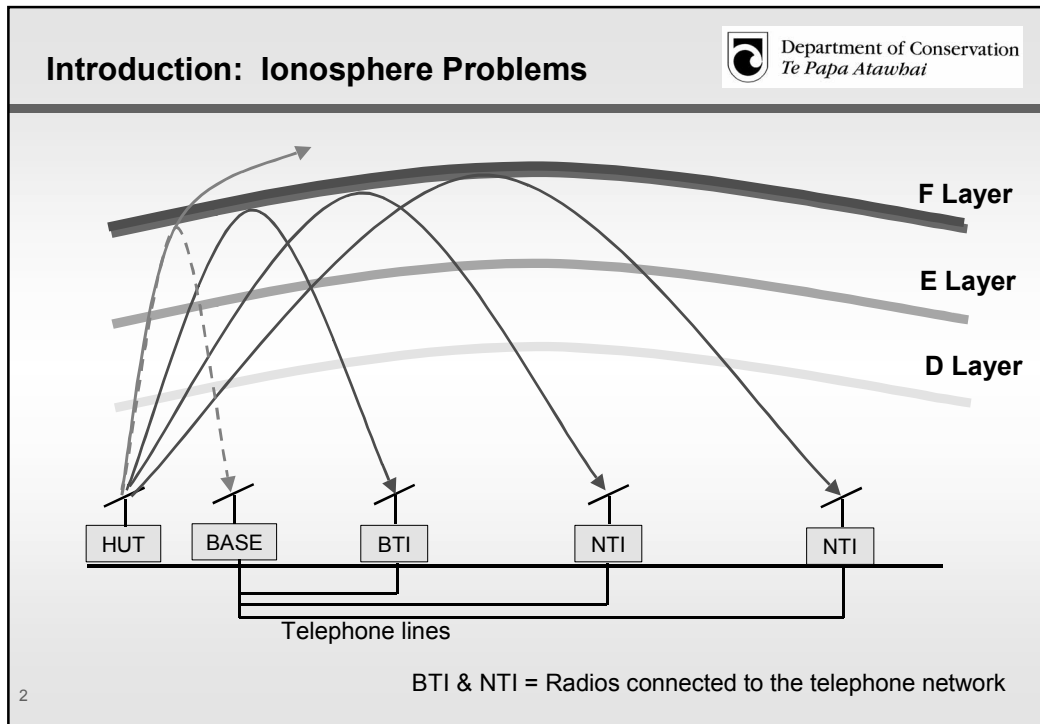
Figure 17
Ionospheric problems of HF propagation

- 1.10.3 A project to improve HF communications throughout the country and to provide good coverage was launched in 2000. Primarily the communications strategy was to provide a system to summon help in the event of an emergency, but it had the second functionality of being used for rural fire fighting. The system was sufficiently comprehensive that it was also used for operational and administrative purposes, and it was for this purpose that it was used most often. The project management team decided to use a selective calling (selcall) system, where one station can transmit the identification signal of the station to which it wishes to talk and that station is automatically alerted rather than rely on open communications. The main part of the communications system was the positioning of national (NTI) and local base stations (BTI), which allowed different distances between transmitter and receiver to help overcome the propagation problem of the transmitter and receiver being too close to one another (see Figure 17).
