M A R I N E O C C U R R E N C E R E P O R T

04-217 fishing vessel *San Rochelle*, fire and foundering, about 96 nm 27 October 2004
north-north-west of Cape Reinga

Report 04-217

**fishing vessel
*San Rochelle***

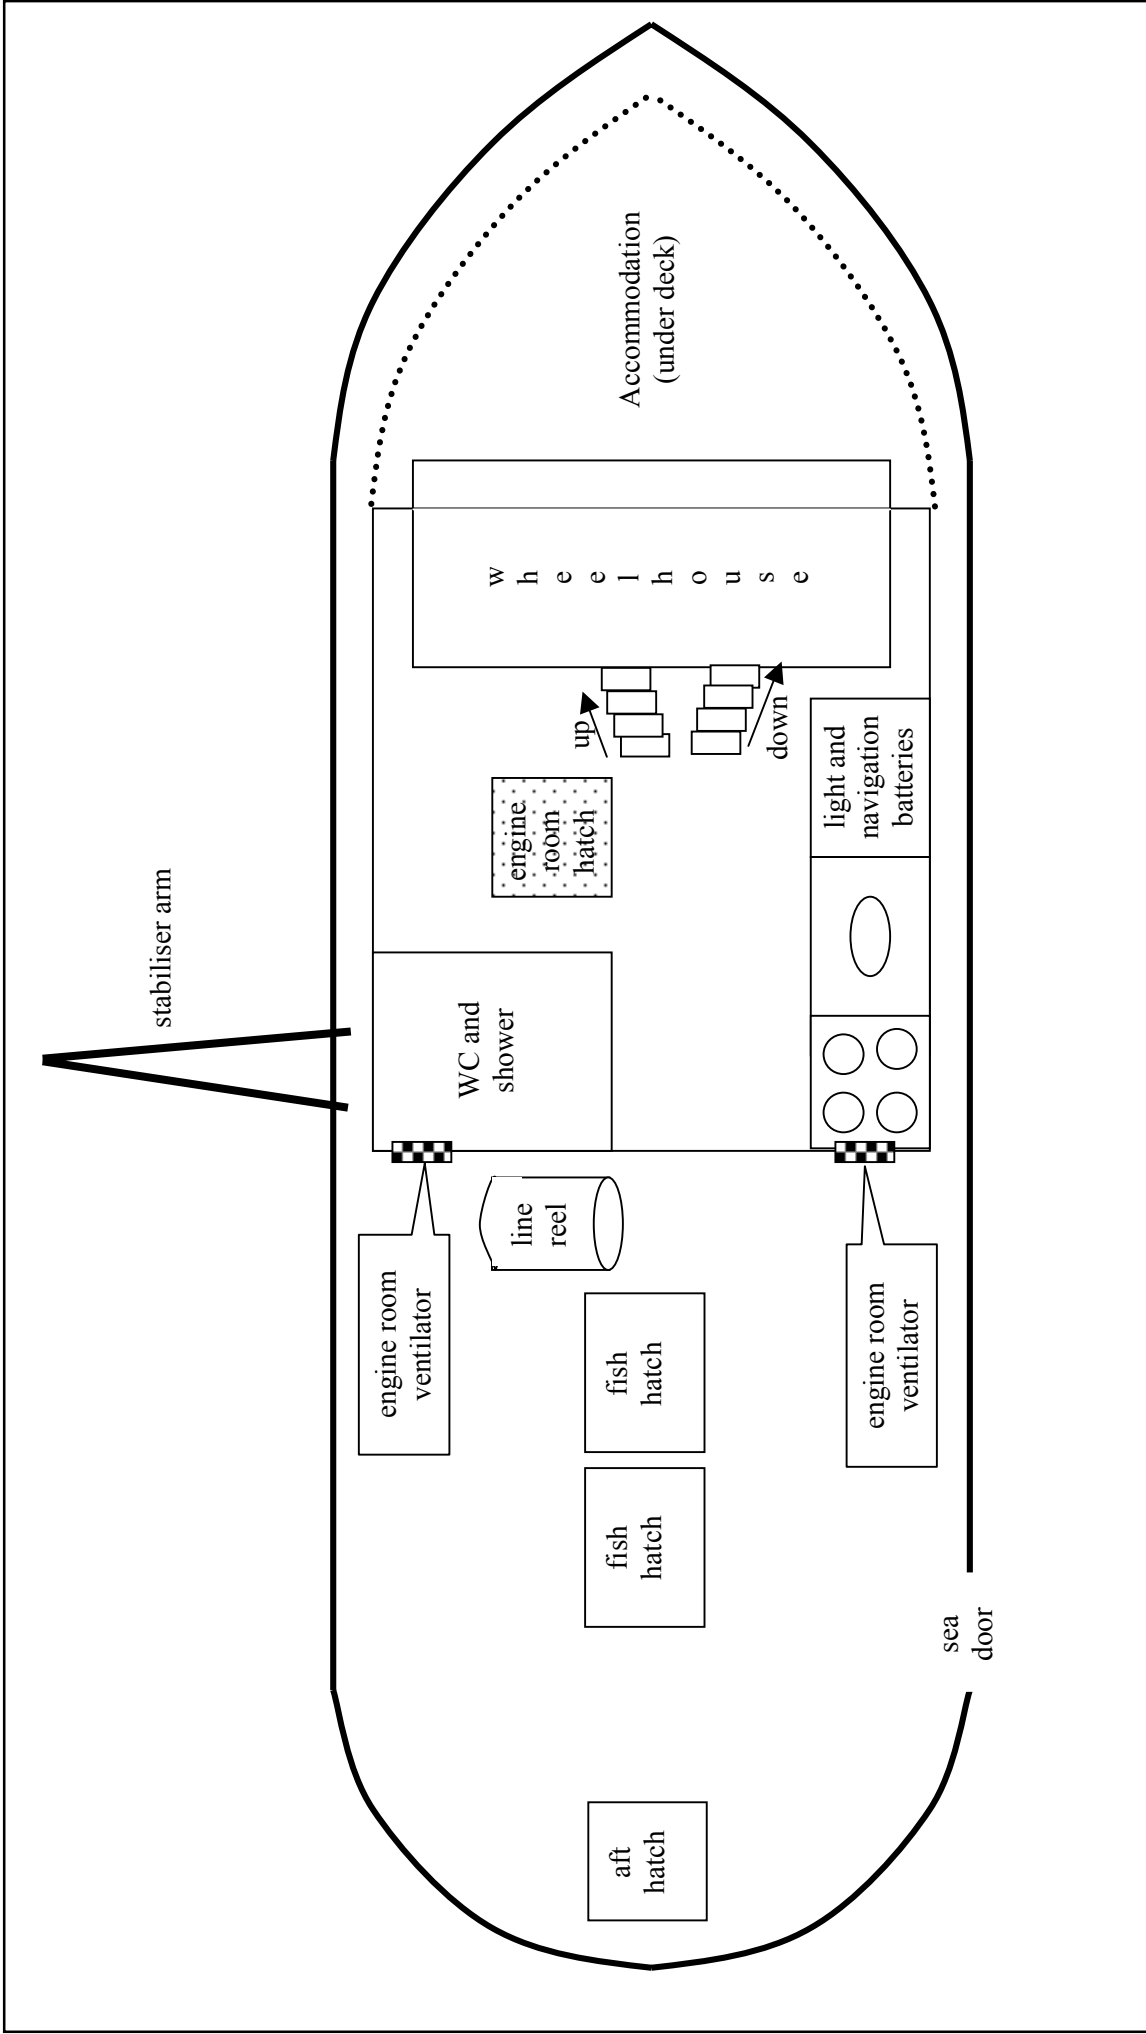
Figure 3
Plan of the *San Rochelle*

- 1.1.4 At about 0345, with the gear about two-thirds set, the Master, who was on the after deck watching the line being set, noticed grey smoke coming from the ventilator at the after end of the engine room. He entered the accommodation and lifted the engine room hatch (see Figure 3), which was at the forward end of the engine room. He saw flames and smoke coming from the after port side so he closed the hatch. He went to the wheelhouse and reduced the engine revolutions and put the engine into neutral, but left it running.

- 1.2.8 The hydraulic system had a history of problems. In 2002, a variable delivery hydraulic pump connected to the crankshaft at the front of the main engine had caused the crankshaft and a number of main bearings to fracture. The owner thought that this had occurred on at least 2 other occasions, but there were no records to support this. In an attempt to prevent a further recurrence of the engine damage, 2 Brevini gearboxes had been interposed between the crankshaft and the hydraulic pump, but this modification was unsuccessful with the gearboxes failing on the engagement of the pump. Recently, a further modification had been made with a fixed displacement hydraulic pump being directly mounted onto the front of the engine. The hydraulic system operated at 2500 pounds per square inch [172 hPa] and was available whenever the engine was running. There were 2 common hydraulic oil tanks, one on each side of the engine room on the forward bulkhead. The port tank held 180 litres and the starboard one 150 litres (see Figure 4).

1.5.2 In early September 2004 a crack had developed in the starboard stainless steel expansion bellows between the main engine and the exhaust system (see Figure 4). The crack had allowed hot exhaust gases to escape into the engine room. Soot marks were evident on the insulation on the exhaust pipe some distance above the bellows (see Figure 5). The crack had been temporarily repaired during the maintenance period by removing the insulation, wrapping thin steel plate around the bellows and securing it with jubilee clips before the insulation was replaced. The exhaust bellows had cracked in this area twice previously. A permanent repair was due to be carried out when a different type of bellows could be sourced from Australia.
