RAILWAY OCCURRENCE REPORT

05-108

diesel multiple unit passenger Train 3334, fire, Auckland

23 February 2005

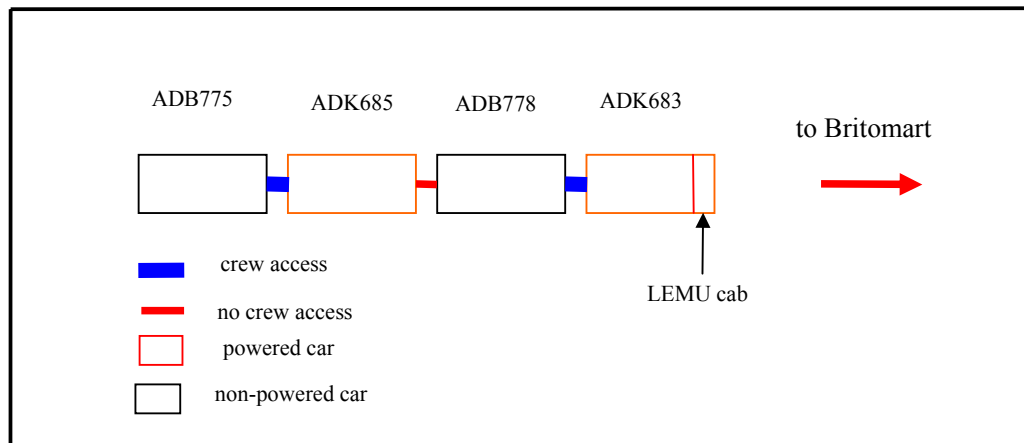
Figure 2
Consist of Train 3334 departing from Papakura (not to scale)

- 1.1.2 Train 3334 consisted originally of powered car ADK683 with non-powered car ADB778 coupled. However, because preceding Train 3030, the scheduled 0735 Papakura to Britomart via Newmarket passenger service, was cancelled due to a mechanical failure, the locomotive engineer multiple unit (LEMU) and the train manager of Train 3334 decided to attach a spare diesel multiple unit (DMU) set, ADK685 and ADB775, to the original consist to accommodate the extra passengers. Train 3334 departed Papakura with 2 powered and 2 non-powered cars marshalled as shown in Figure 2. There was no internal access between the DMU sets.

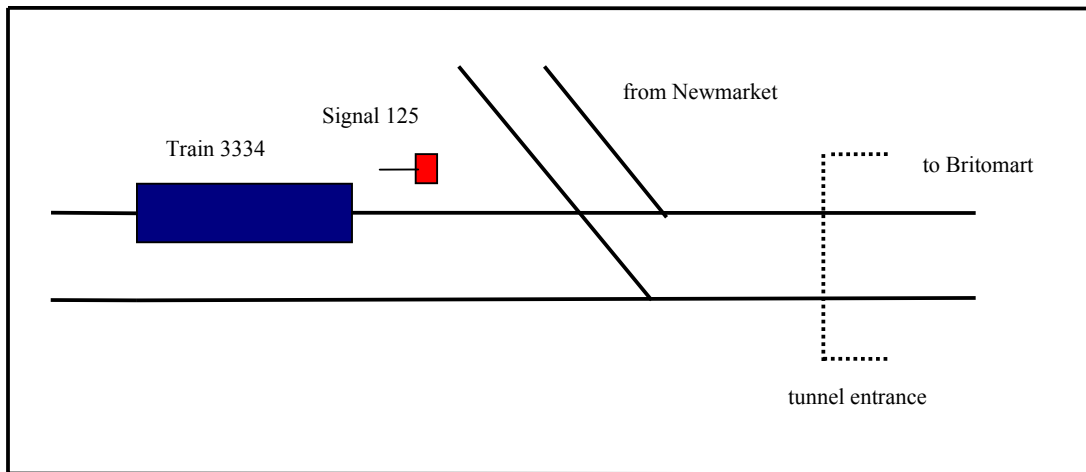
Figure 3
Train 3334 at Signal 125 (not to scale)

- 1.2.1 Signal 125 was the Up directing signal located at 684.863 kilometres (km) on the North Island Main Trunk, about 288 metres (m) before the entrance to the tunnel leading to Britomart (see Figure 3).
- 1.2.2 The signal was within station limits and controlled from Britomart signal panel.

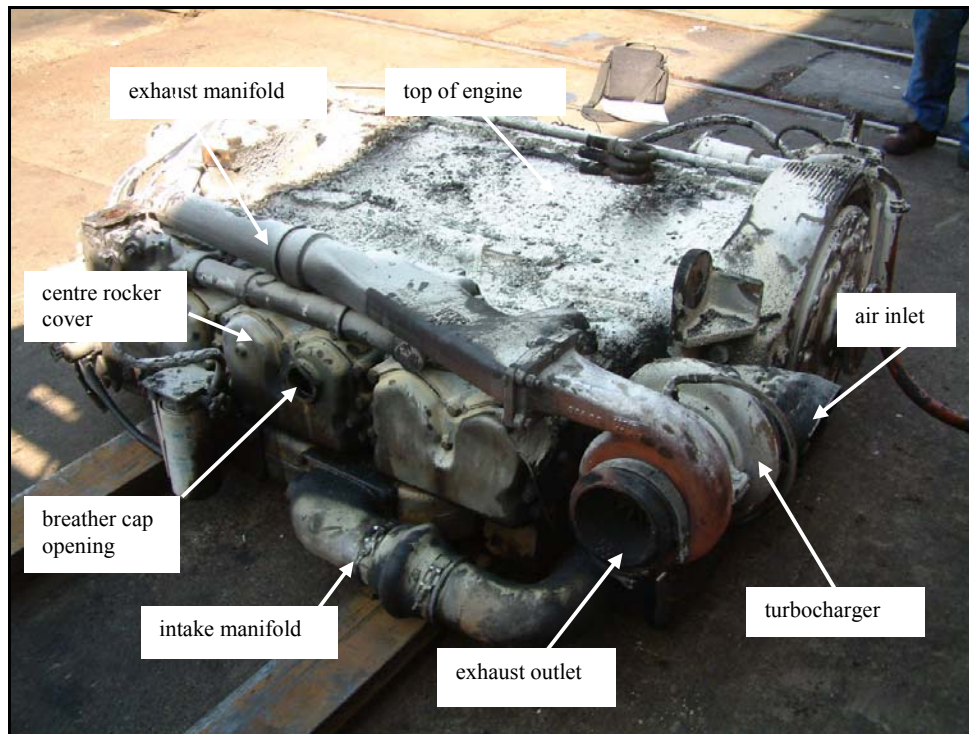
Figure 5
Engine before disassembly

- 1.8.1 The No. 1 engine on ADK685 was date stamped 19 February 1968. Toll Rail was unable to provide records of the number of overhauls, if any, to which the engine had been subjected or the number of hours the engine had operated since any previous overhauls.
- 1.8.2 When the No. 1 engine was removed from under ADK685, the following was noted:
- the breather and oil filler caps were missing
 - the oil dipstick was in place
 - a section of rocker cover gasket both above and below the breather cap on the centre rocker cover was missing
 - dry powder residue from the fire extinguisher was concentrated on the top of the engine (see Figure 5)
 - there was a heavy build-up of dirt, oil and grease on top of the engine
 - there was excessive dust accumulation in the turbocharger inlet
 - there were burnt fuel hoses and electrical cables.
