RAILWAY OCCURRENCE REPORT

05-118

express freight Train 245, derailment, Ohingaiti

27 July 2005

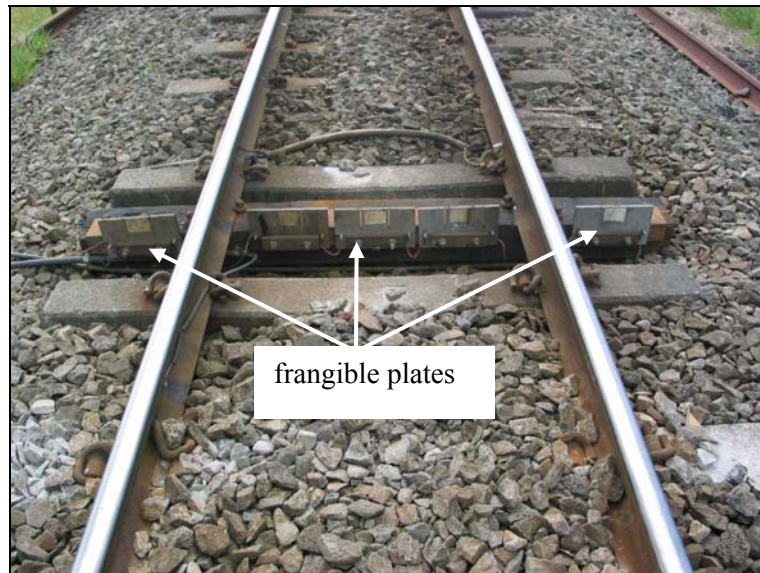
Figure 4
Example of a dragging equipment detector

- 1.5.1 Many dragging equipment detector (DED) units have been installed on the rail network since 1993. Dragging or derailed equipment was detected by frangible plates mounted in 5 sections, 3 between the running rails and one on either side (see Figure 4). This bar formed part of an electrical circuit which provided an alarm output if any section of the bar no longer provided electrical continuity, for example if it was broken by dragging equipment.

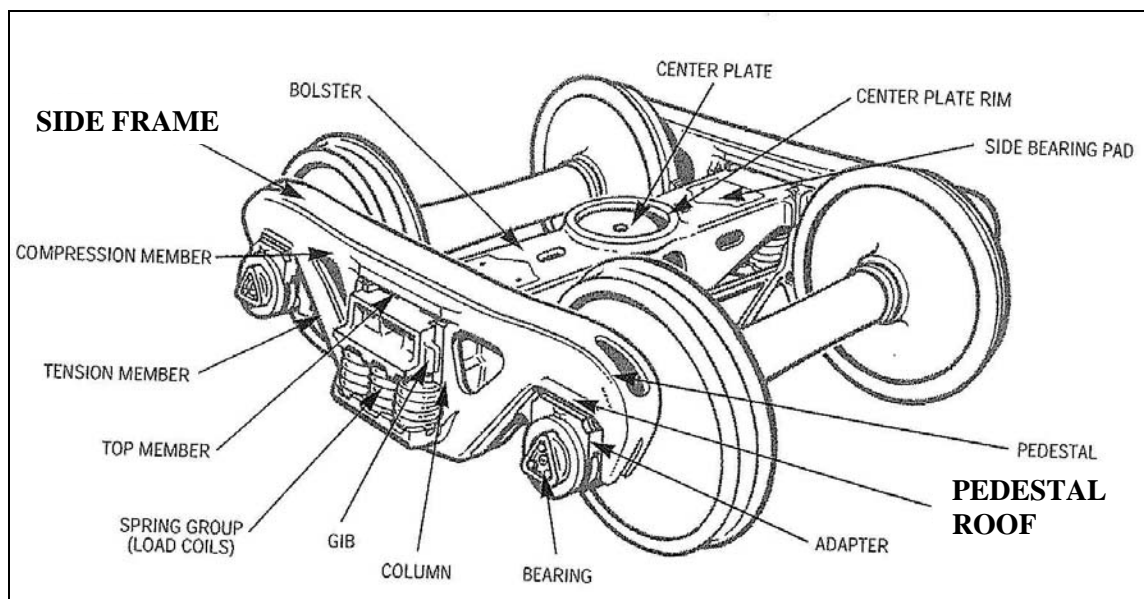
Figure 5
Nomenclature of bogie components

- 1.7.3 ZH519 had standard 3-piece bogies, as used on most freight wagons worldwide. The 3 main “pieces” were one bolster and 2 side frames (see Figure 5). The bolster was supported by 2 sets of coil springs. The larger-diameter coil springs, known as primary suspension, provided vertical support. The smaller-diameter coil springs, known as wedge springs, applied pressure to a friction wedge to provide wagon damping².
