RAILWAY OCCURRENCE REPORT

05-119

runaway wagons from Waingawa and subsequent collision with motor vehicle, Hodders Road level crossing, 74.35 km between Carterton and Dalefield

29 July 2005

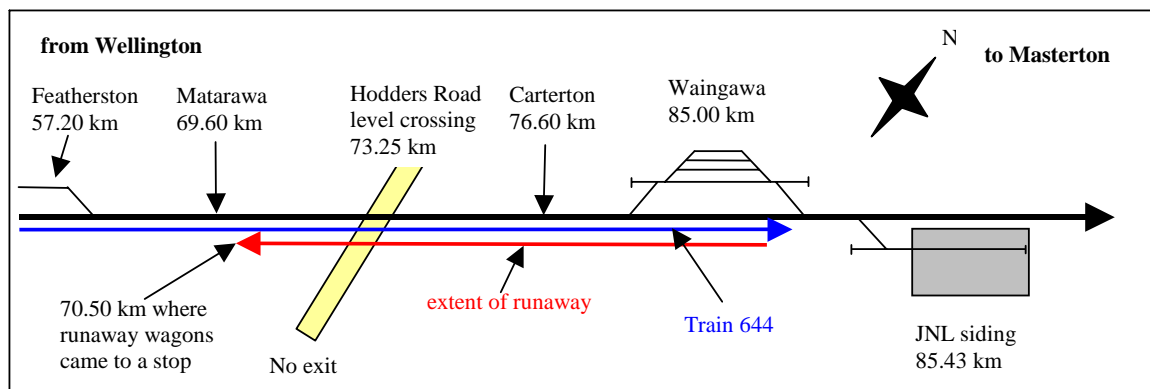
Figure 1
Plan of Wairarapa Line (not to scale)

- 1.1.3 At about 0506, LE 1 berthed Train 644 on the main line at Waingawa with the intention of placing the 9 wagons into Juken Nissho Limited's (JNL's) siding (see Figure 1). LE 2 alighted and cut off the wagons from the locomotives.

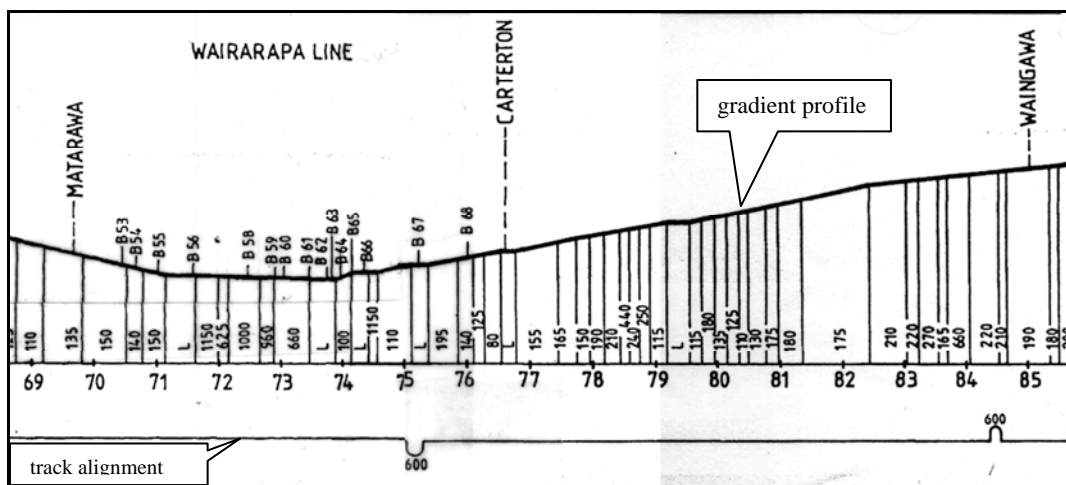
Figure 3
Gradient profile and track alignment detail
 Referenced from ONTRACK’s North Island gradient profile publication

- 1.2.1 The Wairarapa Line ran from Wellington to Woodville over a distance of 171.50 km. The gradient profile descended steadily northwards from Matarawa, levelled out between 71.00 km and 74.00 km, then steadily but gently ascended to Waingawa. The track alignment between 70.50 km and Waingawa was straight except for two 600 m radius curves (see Figure 3).

- 1.2.2 ONTRACK's code required that tracks in yards and sidings be level where possible. The maximum allowable gradient in yards and sidings was 1 in 200 (0.5%). After the incident ONTRACK re-surveyed the gradient on the main line within station limits at Waingawa at 1 in 198.

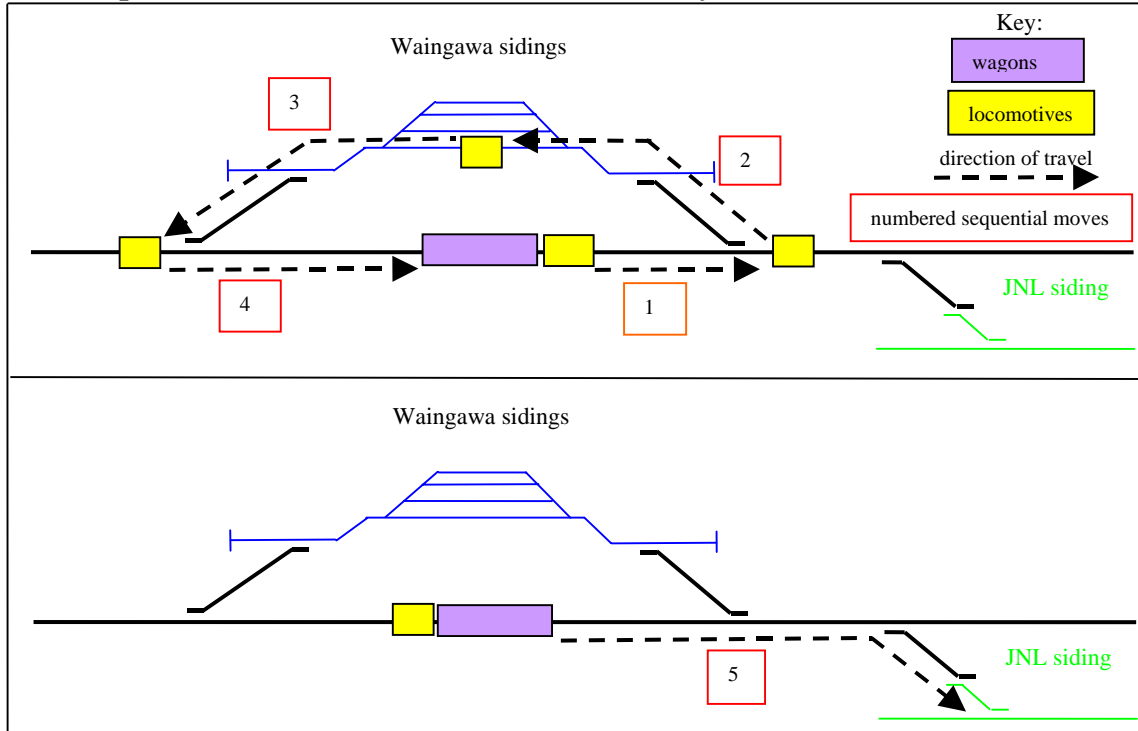
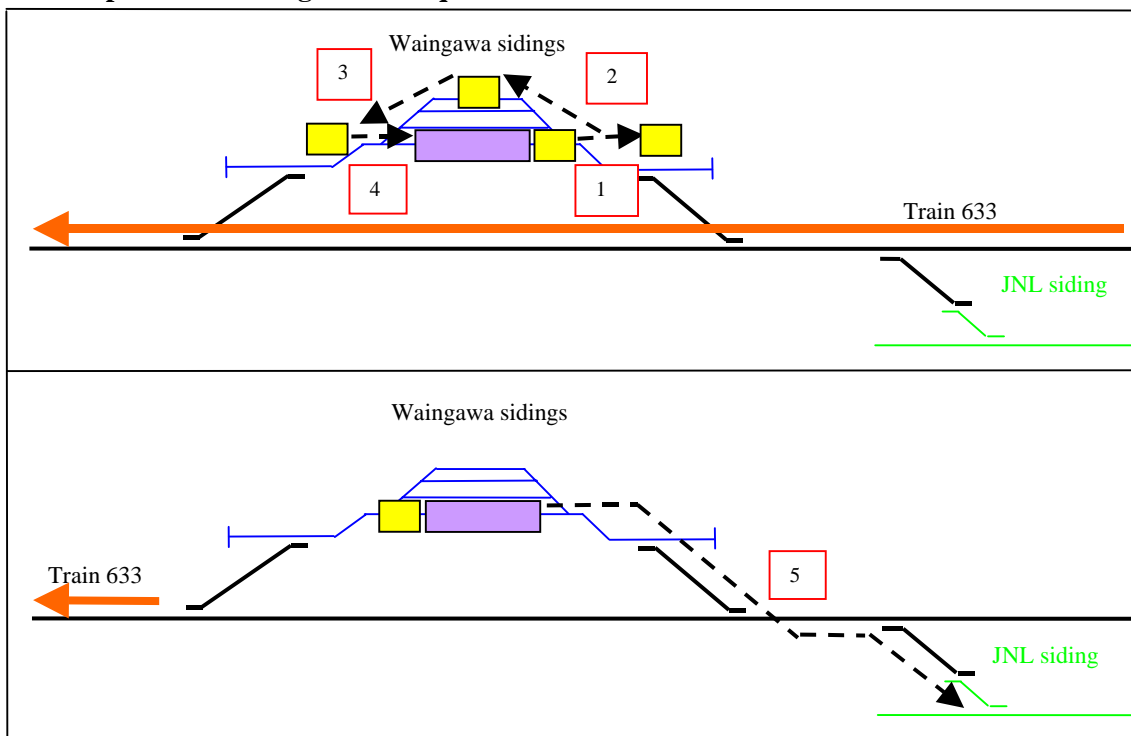
Figure 5
The 2 differing shunt arrangements (not to scale)

- 1.3.3 When shunting at Waingawa, train crews could berth on the main line and run the locomotives around in the sidings, as was intended on the day of the incident. Alternatively, they could berth in the sidings and run around in one of the adjacent siding tracks. In either situation, train crews undertaking the shunt used a local radio channel to communicate with each other. The timekeeping of southbound freight Train 633 determined which berthing and shunting method was used (see Figure 5).

- 1.3.6 After Train 633 had departed from Waingawa, Train 644 could then be authorised to regain the main line and propel the wagons into JNL siding (see Figure 5).

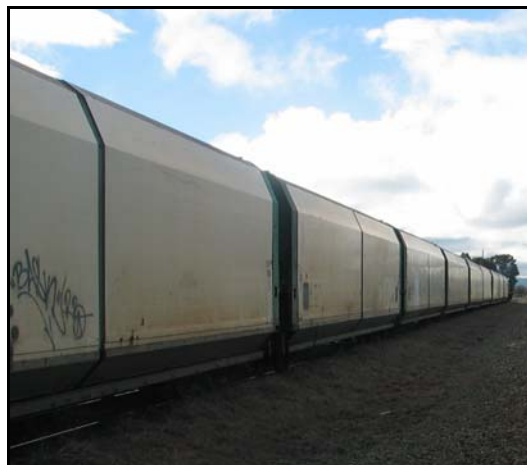
Figure 7
A rake of ZG wagons

- 1.5.10 The ZG class of wagon was a high volume “plug¹⁰” wagon, on a modified UK wagon underframe. The wagon livery was creamy white door sides with light green ends (see Figure 7). The ZG wagon had an average tare weight of 21 250 kg.

- 1.5.11 The wagons were equipped with separate air brake systems to each bogie, negating the requirement for lengthy brake rigging between the bogies. Each wagon had a single handbrake that applied the brakes to one bogie only.
- 1.5.12 None of the 9 ZG wagons was in a “bad order” status at the time of the incident. All the wagons’ code B and C check requirements were current.

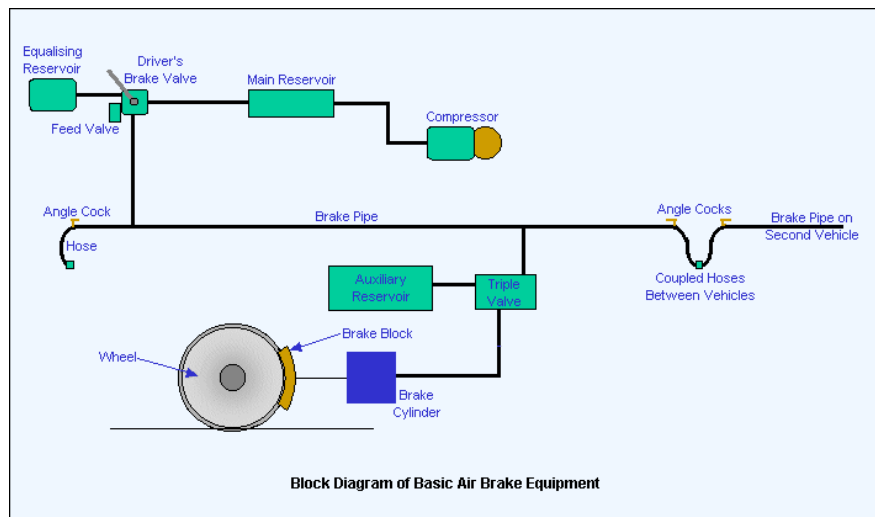
Figure 9
Diagram of basic air brake equipment

- 1.6.3 The braking system uses compressed air as the force to push the blocks onto the wheel treads. The compressed air is transmitted along the train through a brake pipe. Changing the level of air pressure in the pipe causes a change in the state of the brake on each vehicle. It can apply the brake, release it or hold it on after a partial application (see Figure 9).

- 1.6.4 At the ends of each vehicle, brake (angle) cocks are provided to allow the ends of the brake pipe hoses to be sealed when a vehicle is uncoupled. The cocks prevent the air being lost from the brake pipe when vehicles are uncoupled from the train.

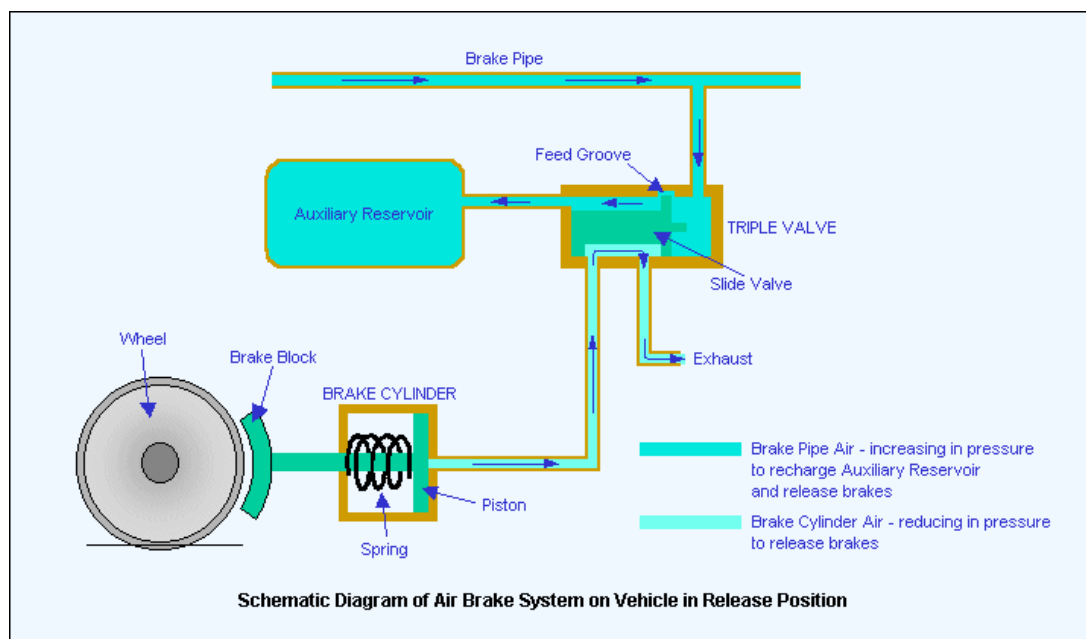
Figure 10
Diagram of air brake system in release position

- 1.6.11 The minimum brake cylinder pressure to ensure all brake blocks were in contact was a release of about 75 kPa, and the maximum (determined largely by brake rigging slack adjustment) was a reduction to about 390 kPa, though these figures could vary from wagon to wagon within limits prescribed by maintenance codes. Permissible air leakage standards in the codes were well below the capacities of locomotive air compressors and main air reservoirs to compensate, and train pipe leakage rates would have to be very large to reduce air pressure in the train pipe sufficiently to initiate a brake application, for example, as in a burst hose situation.

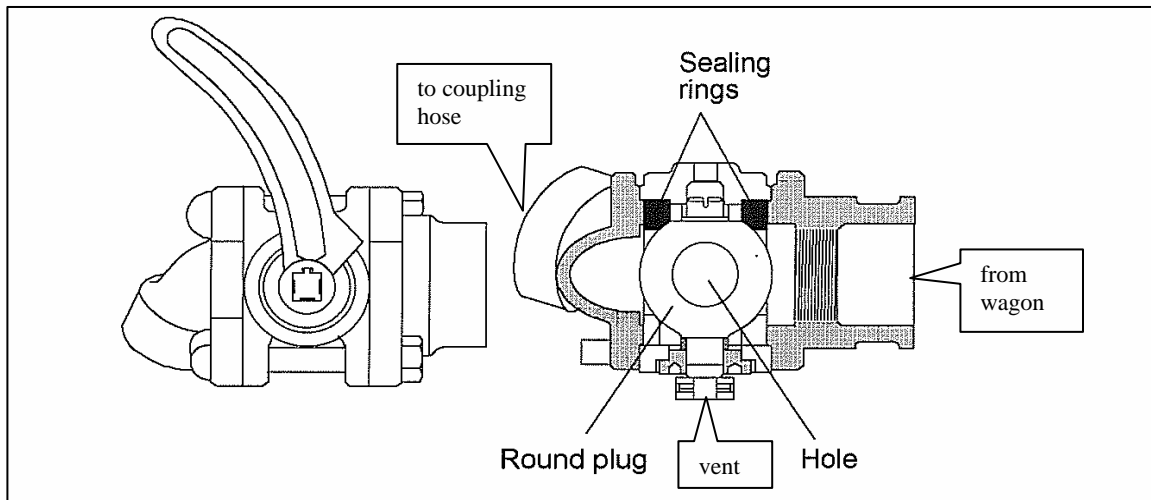
Figure 11
Brake cock detail

- 1.6.12 The purpose of the brake (angle) cock was to open or close the air supply through the brake pipe between 2 rail vehicles, usually to enable coupling and uncoupling.
- 1.6.13 The handle rotated a round plug with a hole through it between 2 sealing rings. When the round plug was rotated to line up the hole with the brake pipe, air flowed from the locomotive, and/or from a locomotive-coupled wagon to another wagon. When the handle was moved 90°, air would not flow through the brake pipe but a vent allowed air pressure to escape from the coupling hose (see Figure 11).
