## RAILWAY OCCURRENCE REPORT

05-120      Report 05-120, express freight Train 142, runaway wagons,      1 September 2005  
Mercer

**Report 05-120**  
**express freight Train 142**  
**runaway wagons**  
**Mercer**  
**1 September 2005**

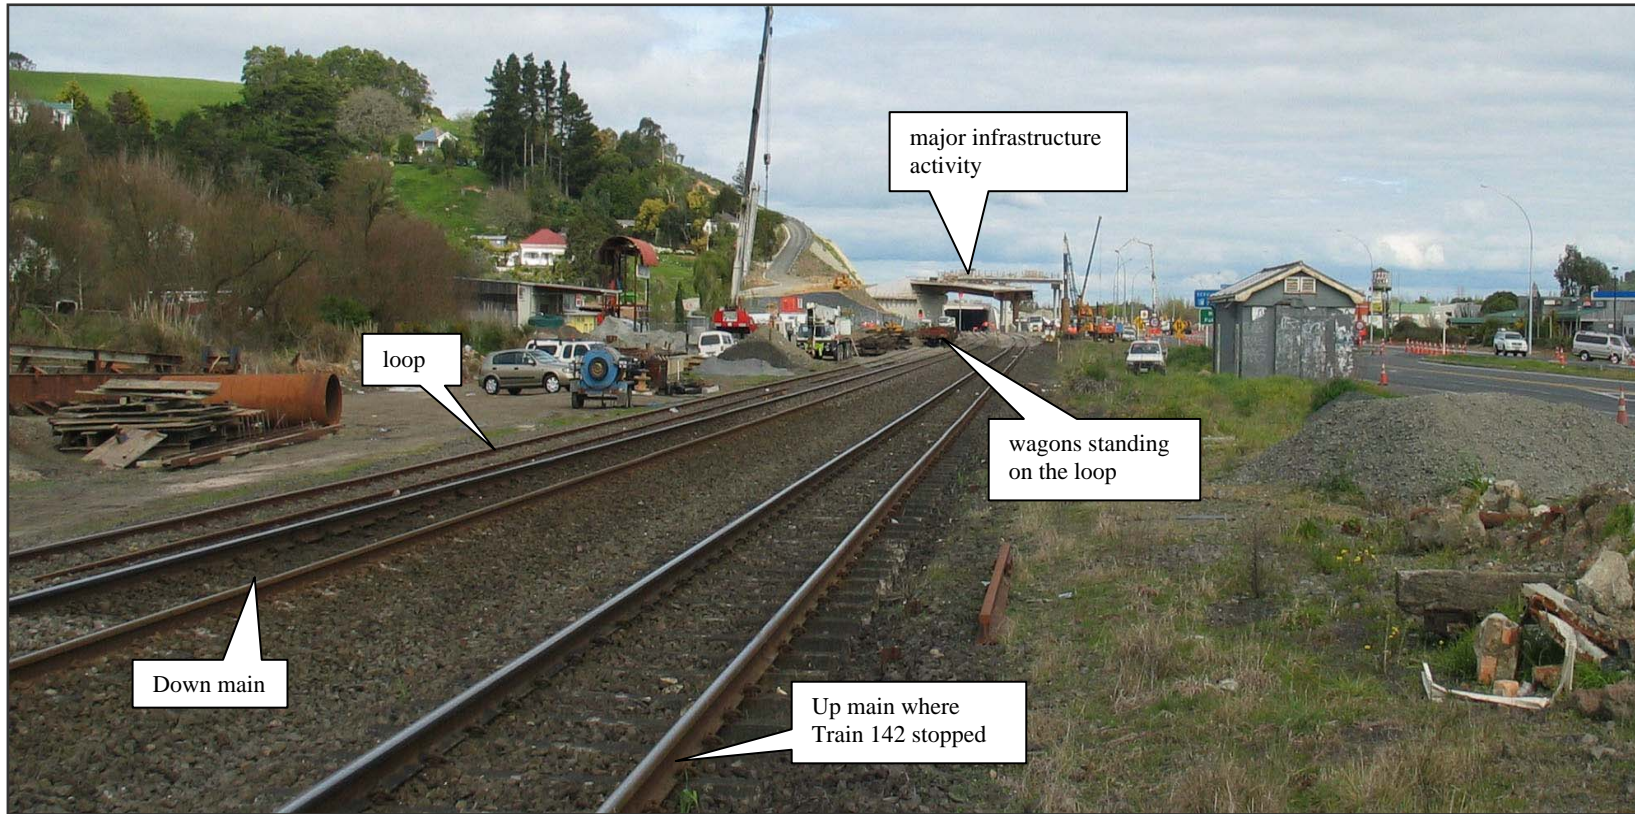
**Figure 1**  
**Mercer, looking south**

On Thursday 1 September 2005 at about 1625, a rake of 6 wagons that was left unattended on the Down main line during a shunting movement within station limits at Mercer, ran away to the south. The wagons were stopped after they had travelled about 450 metres towards Koheroa Road level crossing.

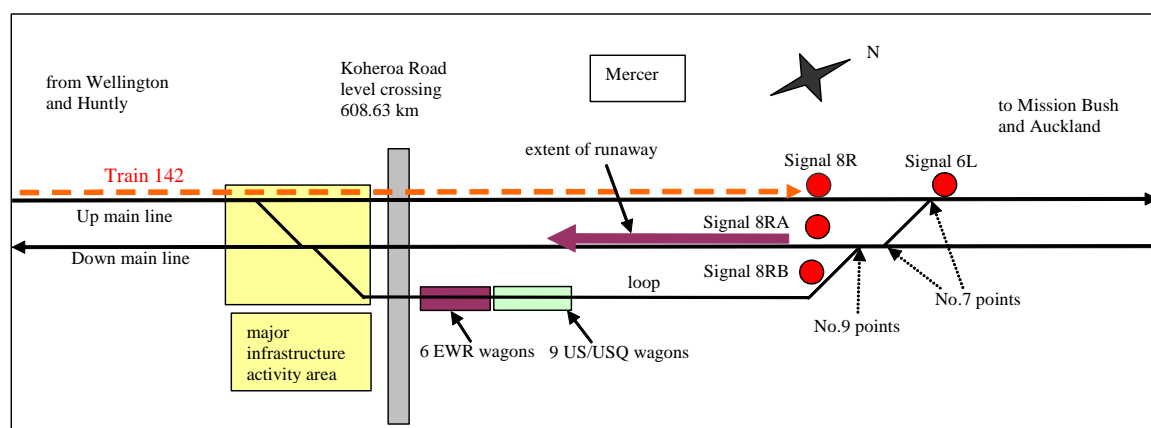
**Figure 2**  
**Site diagram of Mercer (not to scale)**

- 1.1.4 At about 1516, the train stopped on the Up main line at Mercer and the TXO cut off the locomotives from the coal wagons, securing them with both air and handbrakes. The TXO then established from a Transfield Services<sup>2</sup> staff member that a rake of 15 wagons, comprising 6 empty EWR class wagons sitting behind 9 empty US/USQ class wagons, was on the loop. The rake needed to be transposed to bring the 6 EWR wagons to the north end (see Figure 2).

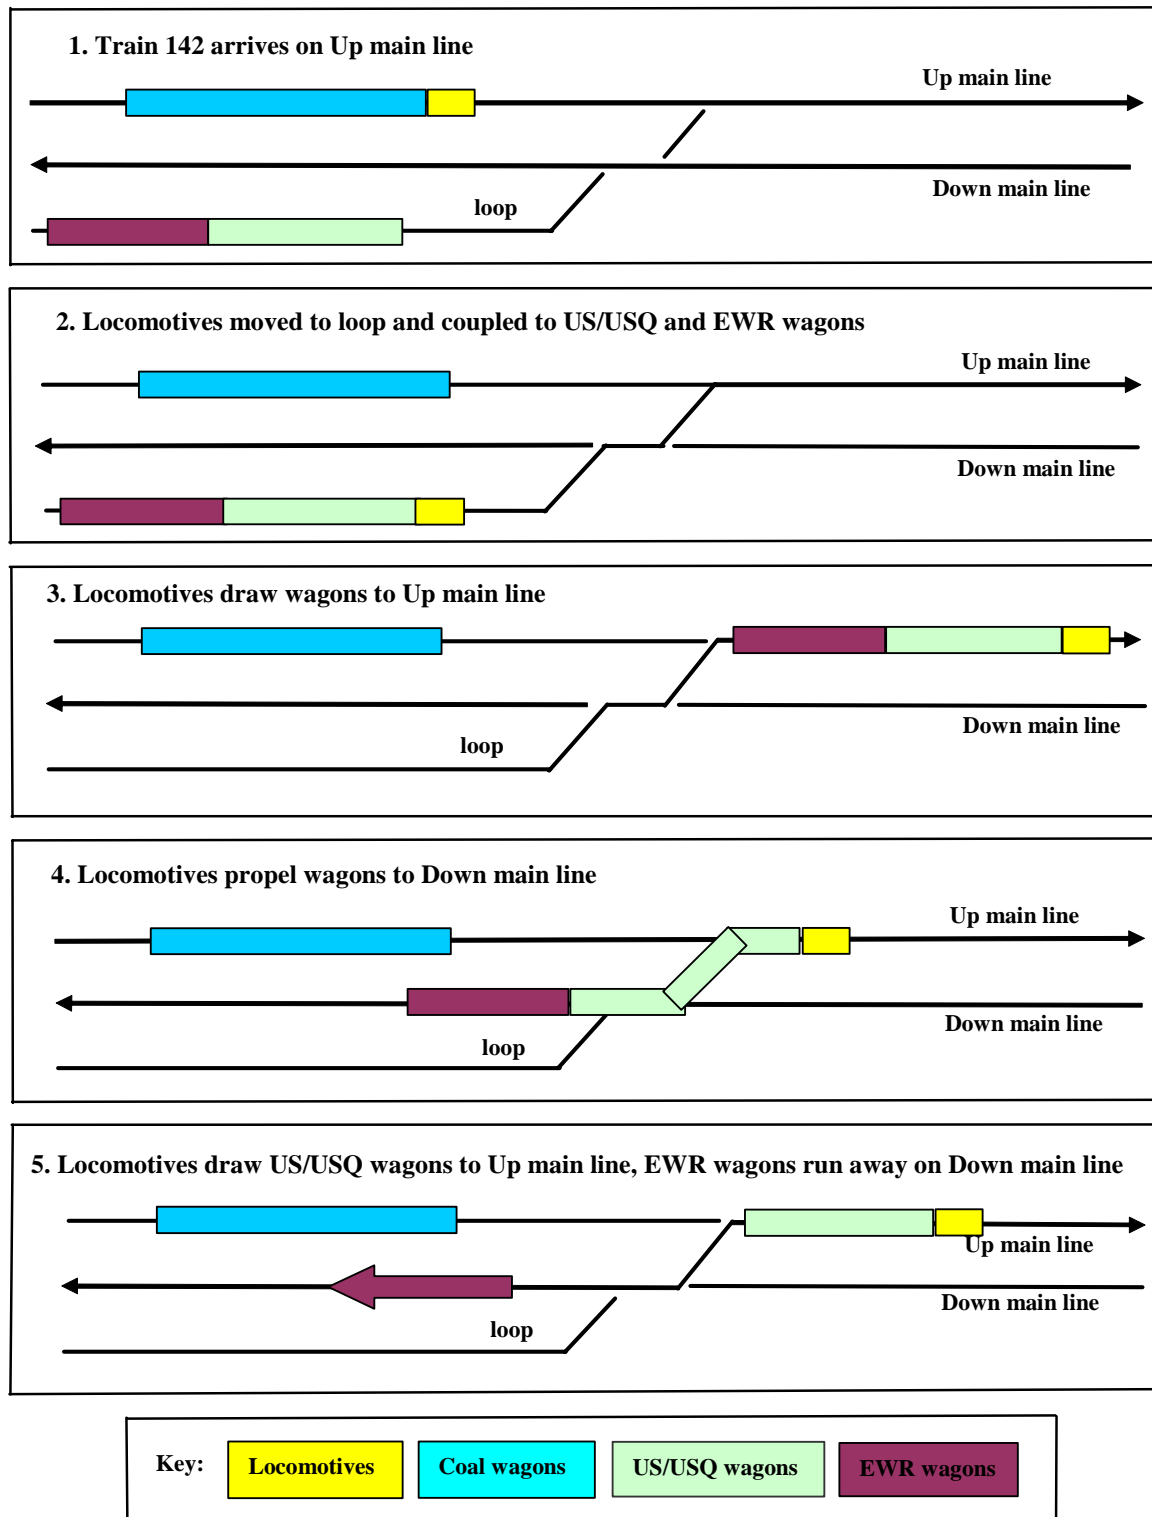
**Figure 3**  
**The shunting movements undertaken at Mercer (not to scale)**

- 1.1.5 At about 1532, the TXO piloted the locomotives onto the wagons on the loop via No.7 and No.9 points. While the air brake system was being pressurised, the TXO checked and released the handbrakes. About 20 minutes later, the TXO piloted the movement from the loop to the Up main line and stopped beyond Signal 6L, where it waited for a southbound train to pass on the Down main line (see Figure 3).
- 1.1.6 At about 1621, the train controller signalled a route and the TXO instructed the locomotive engineer to propel the wagons onto the Down main line. The TXO stopped the movement when the 6 EWR wagons were inside Signal 8RA. The TXO cut off the 6 EWR wagons and reported that he applied the air brakes and one handbrake. The TXO then instructed the locomotive engineer to return to the Up main line beyond Signal 6L with the 9 US/USQ wagons (see Figure 3).

1.1.7 At about 1625, the TXO looked back and saw that the EWR wagons were moving slowly towards Koheroa Road level crossing. The TXO ran after them and attempted to apply the handbrakes on 2 of the wagons. When this was unsuccessful, the TXO resorted to placing pieces of ballast on the rail, which eventually stopped the wagons after they had travelled about 450 metres.

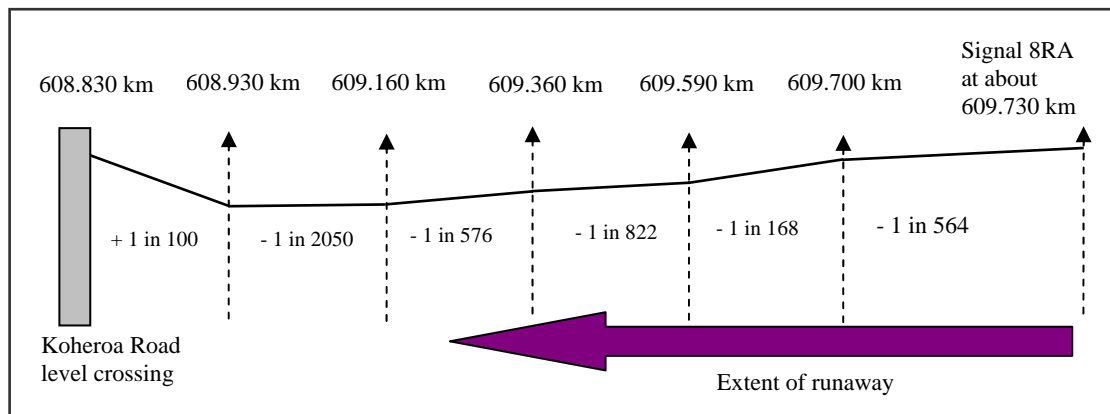
**Figure 4**  
**Gradients on Down main line at Mercer (not to scale)**

- 1.2.1 The North Island Main Trunk through Mercer was double track. Trains ran on the left-hand track in the direction of travel, with northbound trains on the Up main line and southbound trains on the Down main line.
- 1.2.2 A loop was provided at Mercer, but no safety points were installed at either end because shunting was not scheduled there.
- 1.2.3 The track gradient on the Down main line within station limits at Mercer changed several times over short distances. The gradient descended from about the 609.730 kilometre (km) at signal 8RA to about the 608.930 km where it climbed to Koheroa Road level crossing (see Figure 4).

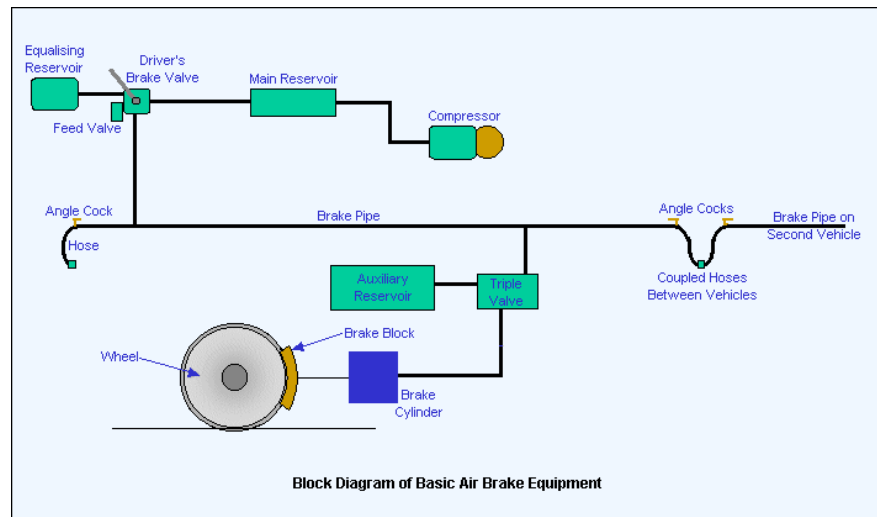
**Figure 6**  
**Diagram of a train's air brake system (not to scale)**

- 1.5.2 The compressed air was transmitted along the length of a vehicle through a brake pipe. Flexible hoses, connected to the brake pipe, were provided at the ends of each vehicle. When the flexible pipes were coupled together at the formation of a train consist and a locomotive was attached, the air pressure was transferred from one vehicle to another. A brake (angle) cock was located where the flexible hose joined the brake pipe (see Figure 6). The brake (angle) cock allowed shunting staff to retain or vent any captured air pressure when a rake of wagons was cut off from a locomotive during shunting activities.

- 1.5.3 Each time a locomotive engineer applied the brake, the reduction of air pressure was detected in a triple valve on each coupled vehicle. When the pressure on the brake pipe side of the triple valve fell, the auxiliary reservoir pressure on the other side pushed a slide valve over, opening a connection between the auxiliary reservoir and the brake cylinder. Auxiliary reservoir air was then fed to the brake cylinder, forcing its piston to move against spring pressure and cause the brake blocks to be applied to the wheels. Air would continue to pass from the auxiliary reservoir to the brake cylinder until the pressure in both was equal.
