05-123

empty passenger Train 4356, overrun of conditional stop board without authority, following an automatic air brake valve irregularity, Meadowbank

6 October 2005

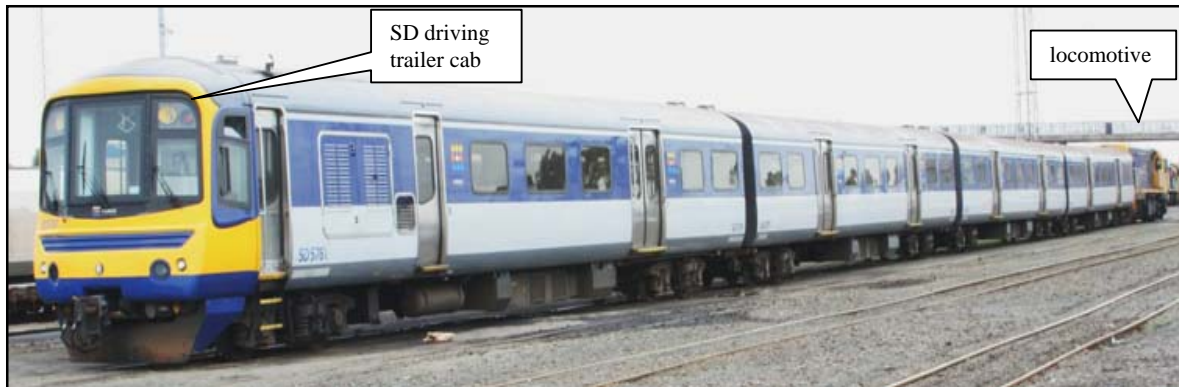
Figure 1
SA/SD consist

- 1.1.1 On Thursday 6 October 2005, Train 4356 was an empty passenger service being positioned from Otahuhu to Britomart to begin passenger operations for the afternoon.
- 1.1.2 The service was operated by Connex Auckland Limited (Connex) and was crewed by a Toll NZ Consolidated Limited (Toll Rail) locomotive engineer² and a Connex train manager.
- 1.1.3 Train 4356 consisted of SD5811 driving trailer equipped with a driving cab, 3 SA class passenger carriages and a DC class diesel-electric locomotive that provided motive power (see Figure 1).

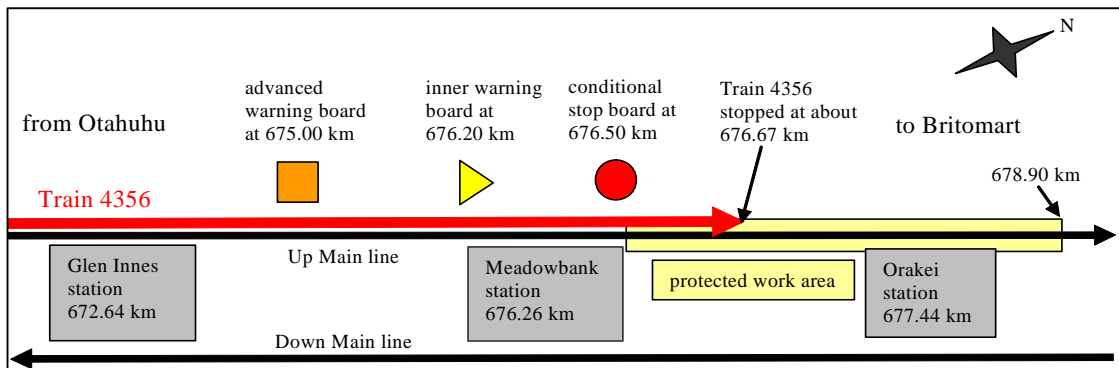
Figure 3
Plan of North Island Main Trunk between Otahuhu and Britomart (not to scale)

- 1.4.1 The North Island Main Trunk between Otahuhu and Britomart was double track. Trains ran on the left-hand track in the direction of travel, with northbound trains travelling to Britomart on the Up Main line and southbound trains travelling from Britomart on the Down Main line.
- 1.4.2 The authorised maximum speed for passenger trains travelling between Otahuhu and Britomart was 100 km/h.
- 1.4.3 Train 4356 stopped at about 676.67 kilometres (km) between Meadowbank and Orakei (see Figure 3).

- 1.4.10 On the day of the incident, the PIC positioned the EPP about 20 m from the conditional stop board. He also provided the EPP with a portable radio and cell phone in addition to the air horn because of the prescribed 500 m distance between the conditional stop board and the worksite. The PIC also provided a motor vehicle to shelter the EPP because of inclement weather in the area. From the front passenger's seat, the EPP could see the inner warning board, located about 300 m away (see Figure 3).

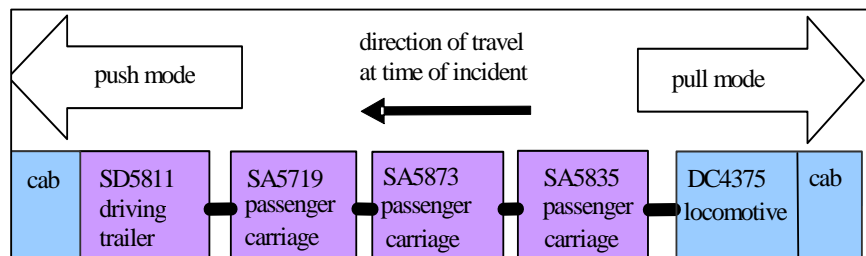
Figure 4
Plan of Train 4356 (not to scale)

- 1.5.2 ARTA owned the SA/SD consists, but leased the locomotives from Toll Rail.
- 1.5.3 Connex's asset list recorded the consist as set No.7 and it was made up of the requisite vehicles and remained coupled together (see Figure 4). DC4375 was not permanently allocated to the consist because locomotives were regularly exchanged for servicing and maintenance.

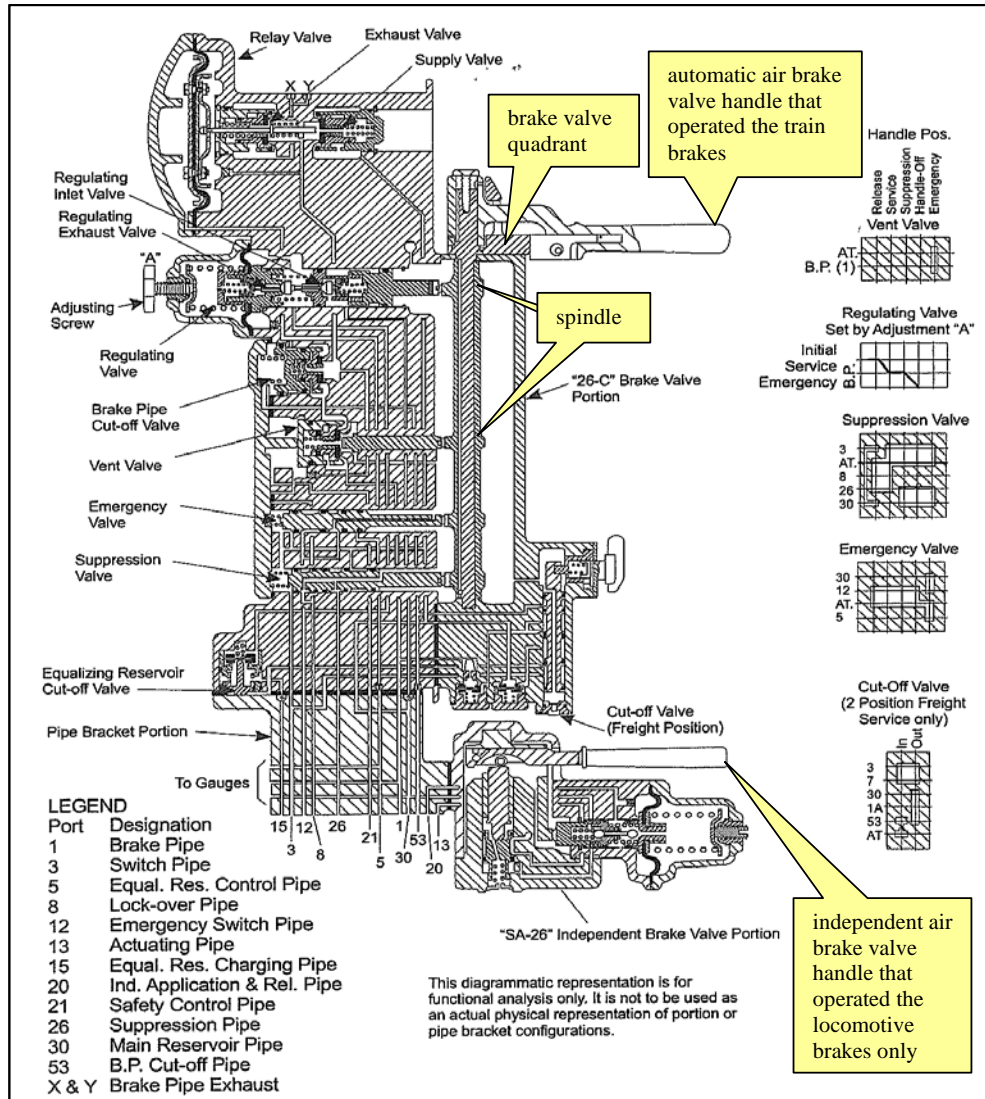
Figure 5
Detailed internal elevation of 26-C auto brake valve

- 1.6.1 The 26-C auto brake valve was the primary device in a train's air brake arrangement. It provided the manual means for initiating and releasing air brake applications. The valve had 2 operating portions and handles. One handle controlled the automatic brake operation and the other handle controlled the independent brake operation (see Figure 5).

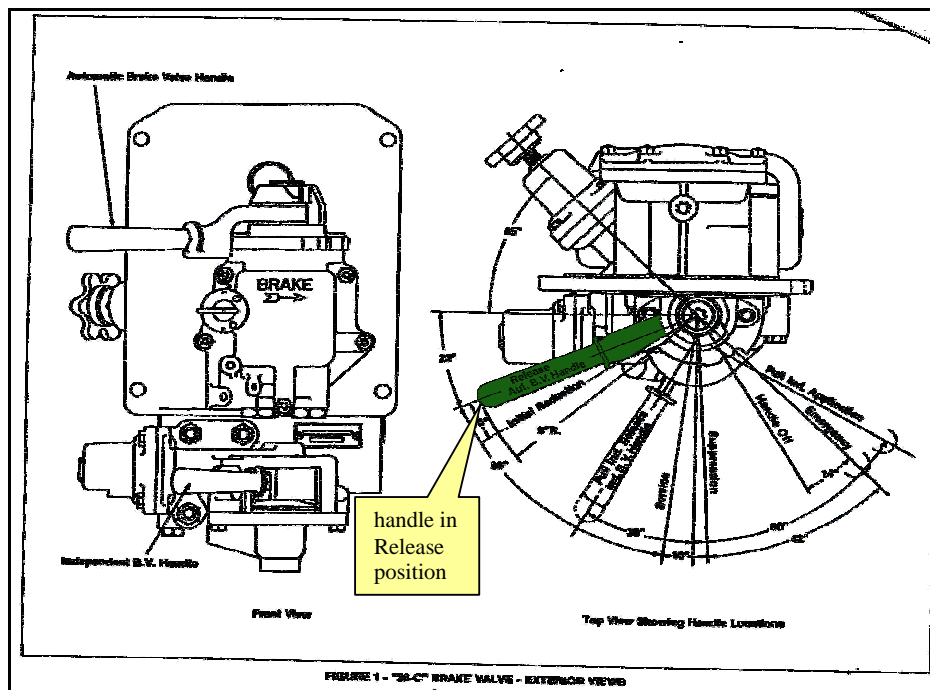
Figure 6
Exterior elevation and plan of 26-C auto brake valve

- 1.6.2 The auto brake valve handle rotated a spindle that directed air pressure to actuate a series of control valves, which in turn directed air flow through the brake pipe to the brake cylinders throughout all the coupled vehicles.
- 1.6.3 The train brake operation was activated by the locomotive engineer manually moving the auto brake valve handle into one of 6 externally detented quadrant positions: Release, Initial Reduction, Service, Suppression, Handle Off and Emergency (see Figure 6).

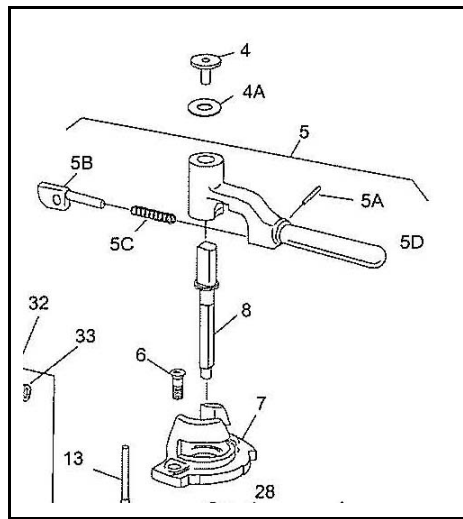
Figure 7
Exploded view of auto brake valve handle

- 1.6.16 Incorporated into brake handles was a detent plunger (part 5B in Figure 7) that was spring loaded to force it into detented impressions on the brake valve quadrant (part 7 in Figure 7). The detent impressions were located between each brake sector to signal to the locomotive engineer that he was moving into another type of brake application. The detent plunger on the handle fitted to SD5811 at the time of the incident was made from mild steel, similar to the material used on a Wabtec-manufactured handle.

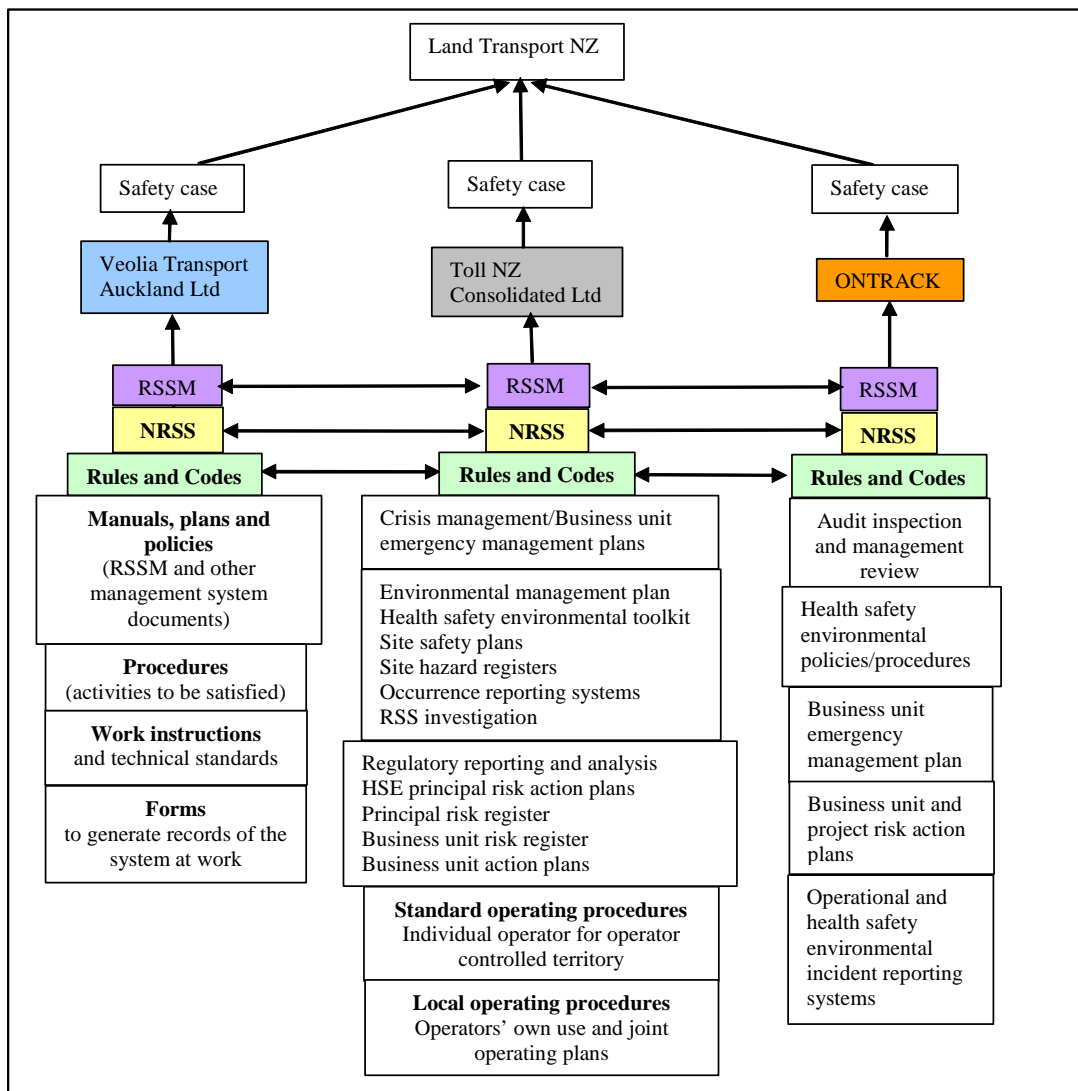
Figure 10
Current rail safety case/system structure

- 1.8.13 Toll Rail had implemented a multi-level approach to safety management. The separation into the strategic and operation levels together with the linkages between the various system elements are illustrated, together with Veolia's and Ontrack's safety management systems for comparison, in Figure 10.

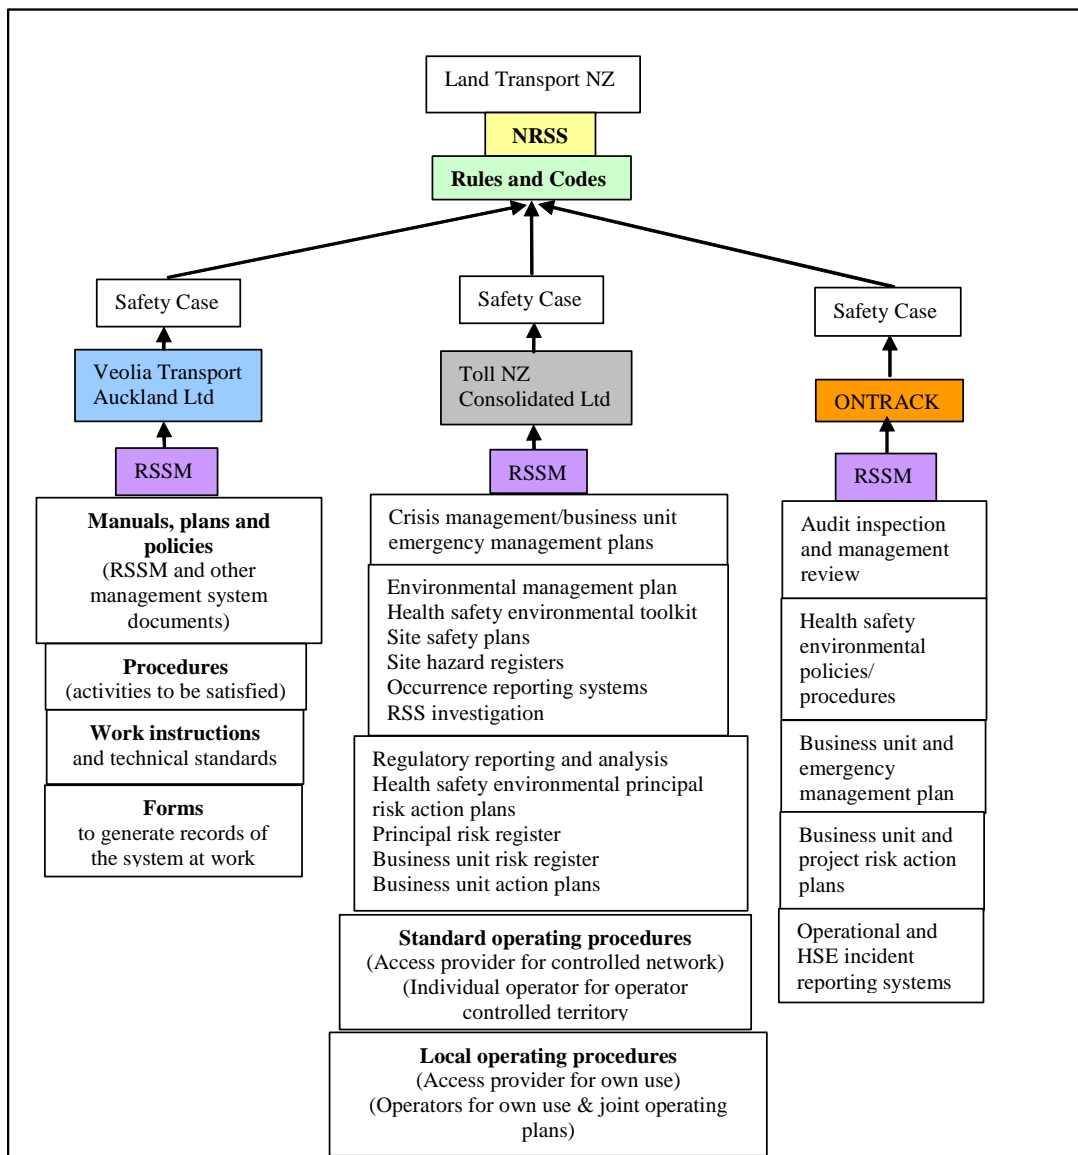
Figure 11
Example of generic rail safety system with appropriate regulatory oversight

- 2.28 Figure 11 shows an example of the generic principle where the regulator is actively involved in industry oversight where vested commercial interest is potentially in conflict with public vested interest in having a safe transport system. The maritime and aviation industries in New Zealand and the rail industry in Australia are examples of where that generic principle has been applied. The Commission supports a similar approach for the rail industry in New Zealand.

- 2.29 While the single failure of a brake mechanism as described in this report might not at first appear to be serious, the Commission's investigation into the building and commissioning process for the SD/SA sets revealed systemic issues with the level of regulatory oversight of the rail system. The recommendation made to the Director of Land Transport NZ, common to the Commission's published reports 06-101 and 06-102 (see section 1.9 of this report), indicates that there are other issues surrounding repair and maintenance that require the regulator to adopt a more strategic approach to risk management of the rail industry.
