RAILWAY OCCURRENCE REPORT

05-128

diesel multiple unit Train 3056, passenger injury, Papatoetoe

31 October 2005

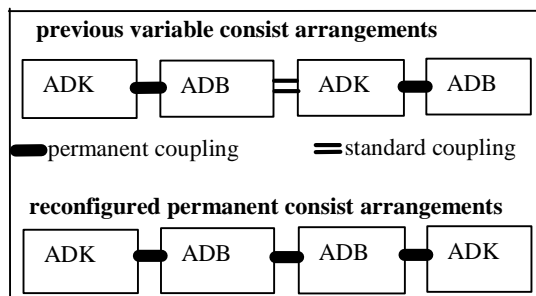
Figure 3
ADK/ADB consist configurations

- 1.4.4 In early 2005, the Auckland Regional Transport Authority and Toll NZ Consolidated Limited (Toll Rail) decided to operate the ADK/ADB fleet permanently as 4-car sets instead of the arrangement of mostly operating them as 2-car sets. To bring the ADB cars together, 4 of the 9 sets were turned to face the opposite direction and the ADB cars were then permanently coupled together (see Figure 3).
