## MARINE OCCURRENCE REPORT

05-205

restricted limit passenger vessel *Black Cat*, control cable failure and collision with rock wall Seal Bay, Akaroa Harbour

17 April 2005

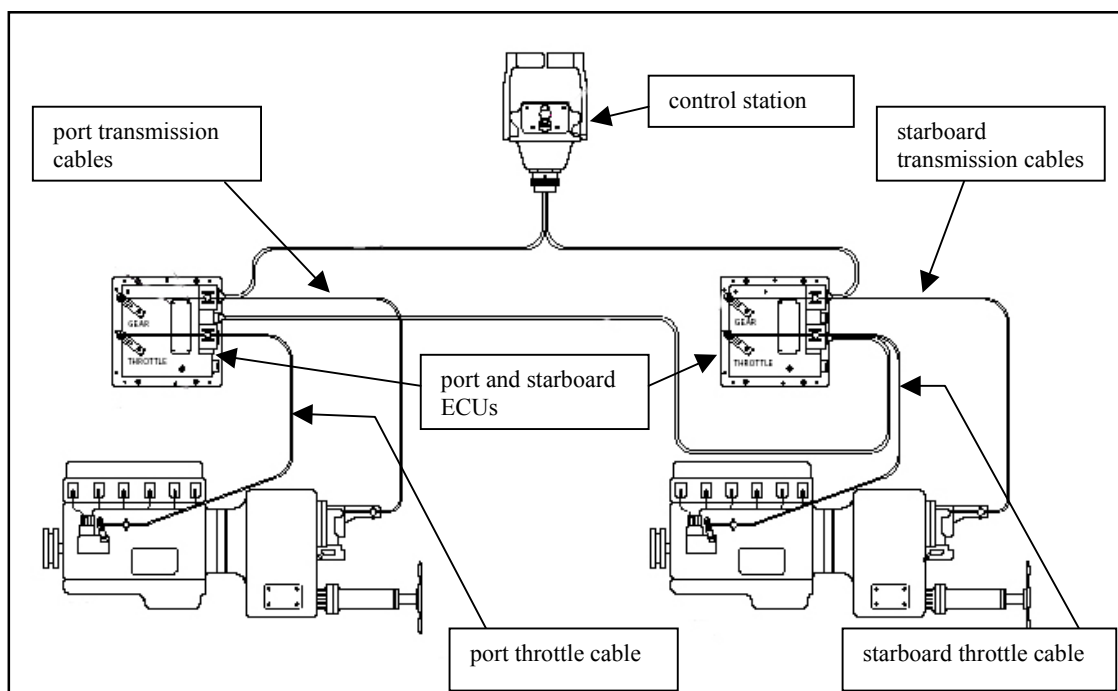
**Figure 2**  
**Diagram of the engine and transmission control system**

- 1.2.4 Each of the 2 propulsion engines was controlled by a single lever that selected forward or reverse gear and also varied the engine speed. The control system was a combination of electronic and cable control (see Figure 2). The bridge control stations were electrically linked to the 2 electronic control units (ECUs), which were linked by cables to each engine and transmission. The electrically linked control heads allowed any one of several individual control stations to be used. The *Black Cat* had 4 control stations: in the wheelhouse, on each bridge wing and one in the forecabin hatch. The last was used when the vessel was being secured to its mooring. Control was switched between each of the control stations by setting the lever on the active station to neutral then pressing the "station select" button on the head unit at the new control station. An indicator light on each head unit showed when that station was active (see Figure 3).

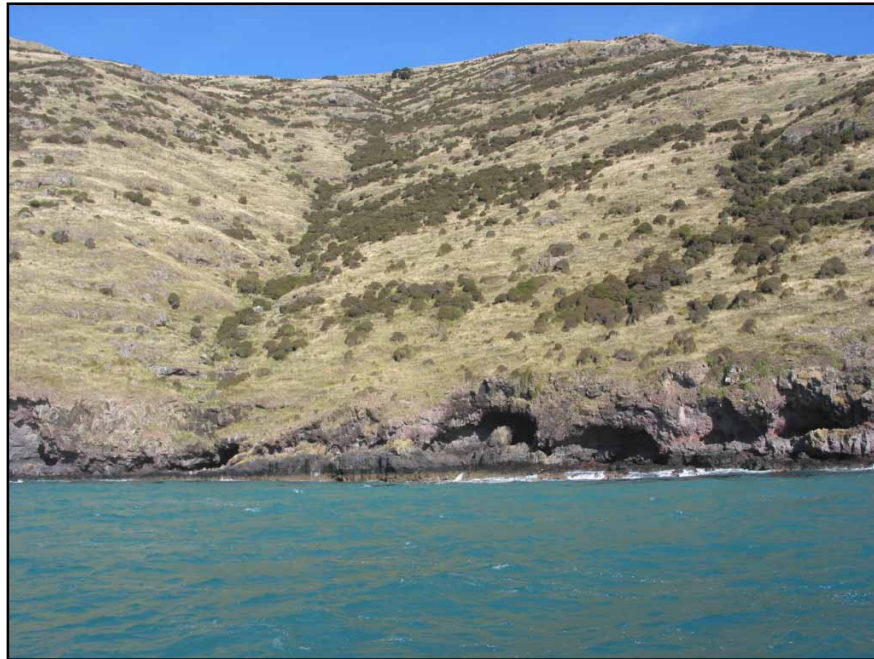
**Figure 10**  
**The coast around Seal Bay**

- 1.7.2 In Seal Bay a small rock shelf breaks the steep rise of the shoreline. New Zealand fur seals bask on this rock shelf. From the shelf the rocks fall away sharply, leaving a sheer rock face, and it was with this that the starboard side of the boat collided (see Figures 10 and 11).
