## MARINE OCCURRENCE REPORT

05-207

freight and passenger ferry *Santa Regina* and private launch  
*Timeless*, collision, off Picton Point, Queen Charlotte Sound

2 May 2005

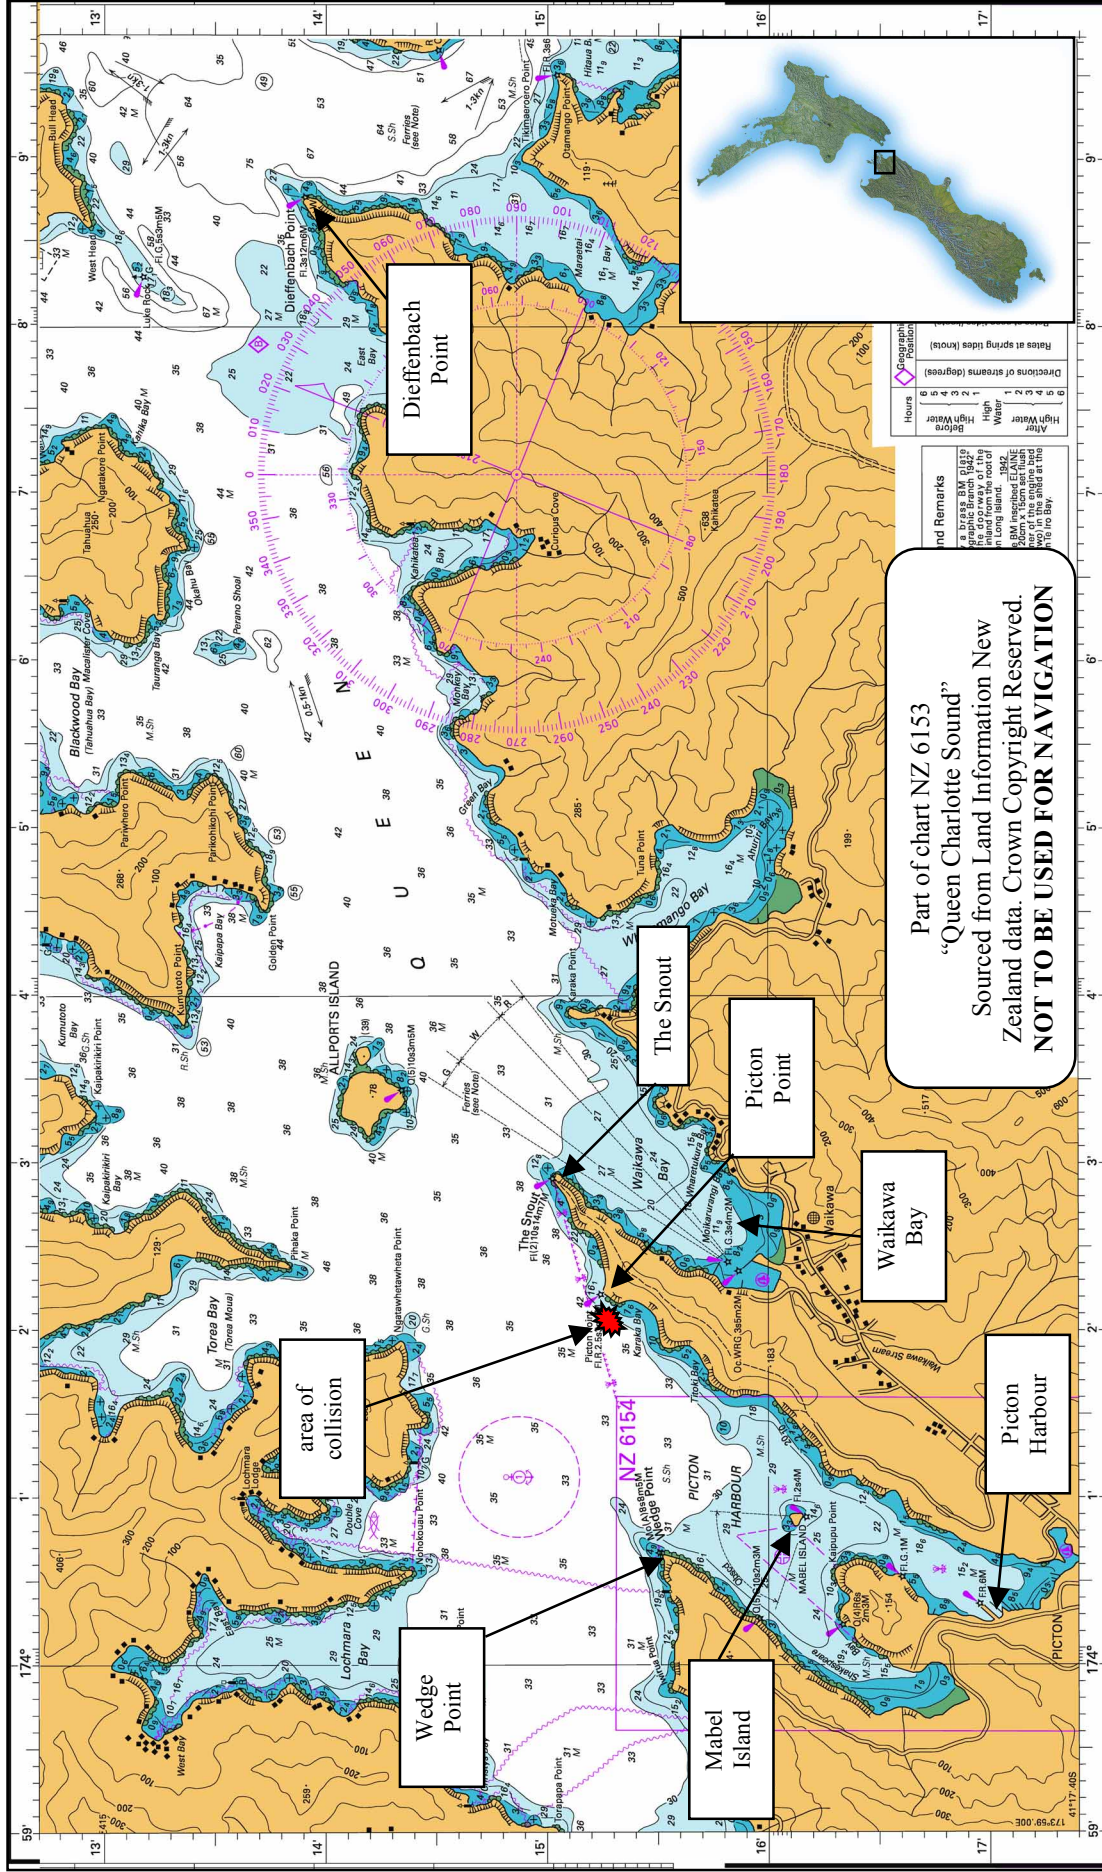
Figure 1  
 General chart of the area

- 1.1.1 Around lunchtime on Monday 2 May 2005, the owner of the private launch *Timeless* and his partner left Picton Marina to go fishing. They anchored near Dieffenbach Point (see Figure 1), where they remained for the whole afternoon. At about 1800, when the weather started to deteriorate, they decided to return to Picton. The owner was conning the boat by eye as they made their way along Queen Charlotte Sound at a cruising speed of about 7 knots.

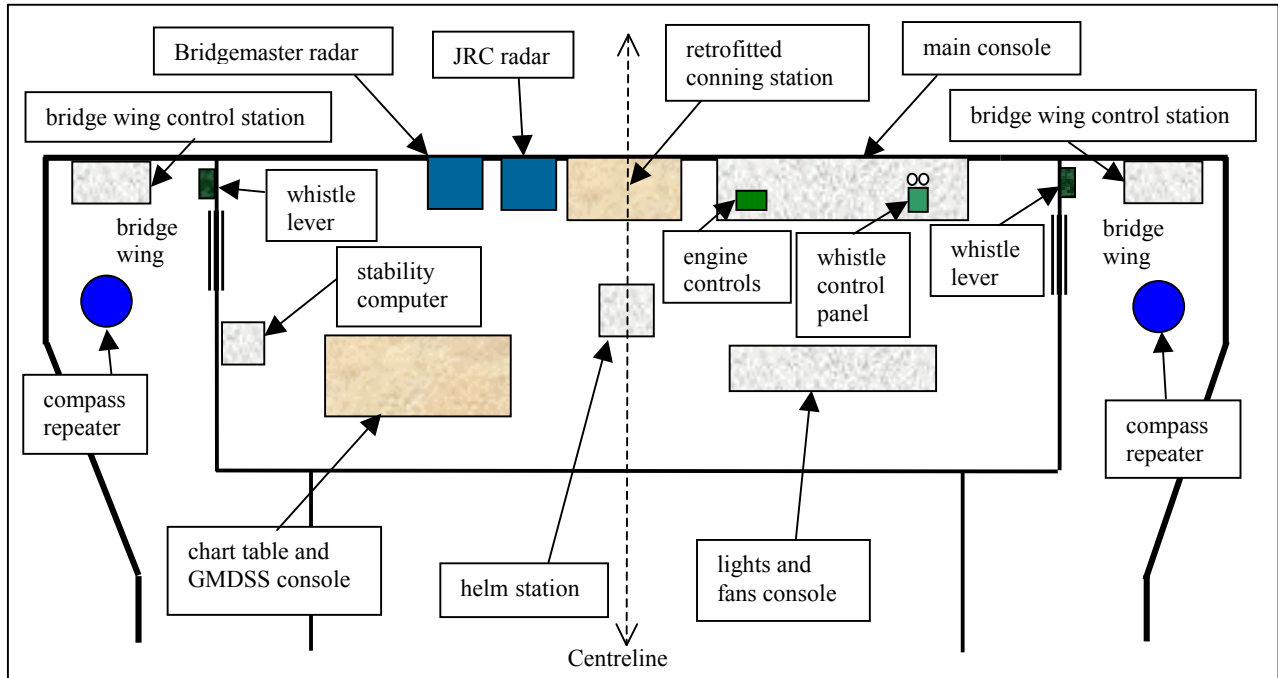
**Figure 3**  
**Bridge layout of the *Santa Regina* (not to scale)**

1.4.5 The design of the navigating bridge (see Figure 3) had the major controls for the CPPs, engines, bow thrusters etc. located on a console situated at the bridge front, to starboard of the centreline. The two radars were located at the front of the bridge, but to port of the centreline. The main helm station was on the centreline midway between the front and back of the bridge. Another console with switches and indicators for fans and lights was situated to starboard of the helm station. The chart table, which had the echo sounder and one of the GPS units, was to port of the helm station. The stability computer was next to the chart table.

- 1.4.7 The passenger lounge on the upper deck was situated about 70 m and 40 m abaft the forward and aft whistles respectively.
- 1.4.8 A conning station had retrospectively been fitted on the centreline at the bridge front forward of the main helm station. At this conning station were the ENC monitor, the C Plath autopilot, the AIS, and the Leica GPS receiver that was interfaced with the other 3 pieces of equipment.
