RAILWAY OCCURRENCE REPORT

06-101 Report 06-101, diesel multiple unit passenger Train 3163, fire in 15 March 2006
diesel auxiliary engine, Manurewa

**TRANSPORT ACCIDENT INVESTIGATION COMMISSION
NEW ZEALAND**

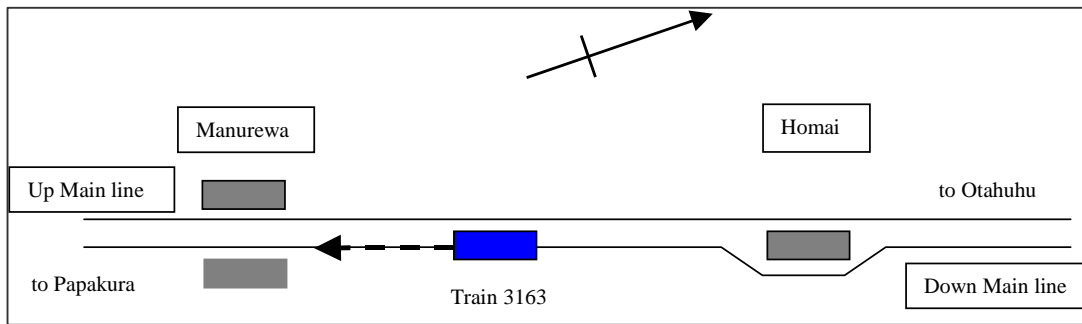
Figure 1
Route of Train 3163 (not to scale)

- 1.2.1 Manurewa station was 2 km south of Homai station between Papakura and Otahuhu on the North Island Main Trunk railway. It had platforms adjacent to the Up Main line and Down Main line (see Figure 1).

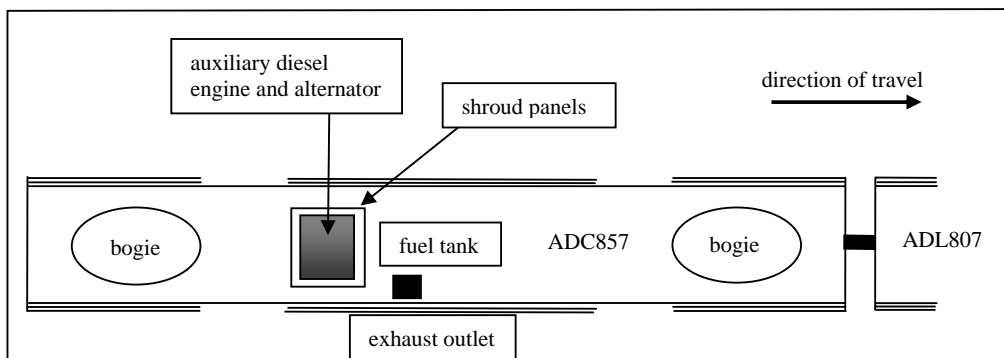
Figure 2
Under-floor plan of ADC857 showing location of auxiliary engine
(not to scale)

- 1.9.2 The auxiliary engine was manufactured by Detroit Diesel in the United States of America. It was a model 471T, 4-cylinder, in-line diesel engine and was fitted with a Garrett turbocharger⁶. The engines were supplied by Detroit Australia as standby generators and had been fitted to the ADC fleet during construction. The exhaust was expelled through a vent in the roof of the carriage (see Figure 2).
