## RAILWAY OCCURRENCE REPORT

06-102

SA/SD passenger Train 4306, braking irregularity, between Westfield and Otahuhu

31 March 2006

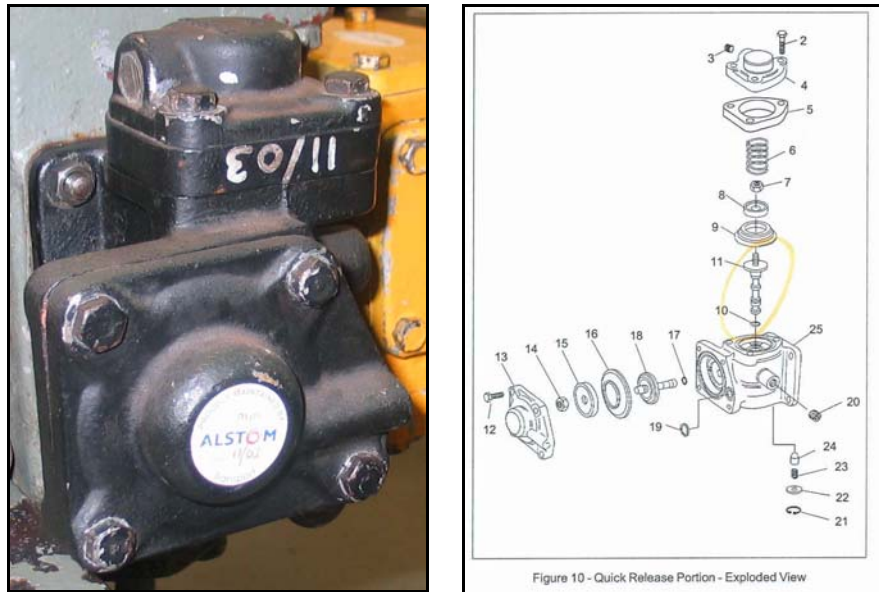
**Figure 8**  
**26-F valve, left, and exploded diagrammatic view of quick-release portion on right**

- 1.5.4 The 26-F valve consisted of a quick-release portion and a service portion mounted on a pipe bracket portion (see Figure 8).

- 1.5.5 The quick-release portion of the 26-F valve was designed to permit a fast, independent release of an automatic brake application. When the locomotive engineer operated the independent brake valve handle, air pressure developed at the control brake valve would flow into the 26-F valve to operate the small diaphragm and stem assembly in the quick-release portion (parts 2 to 11 inclusive in the right-hand view of Figure 8).

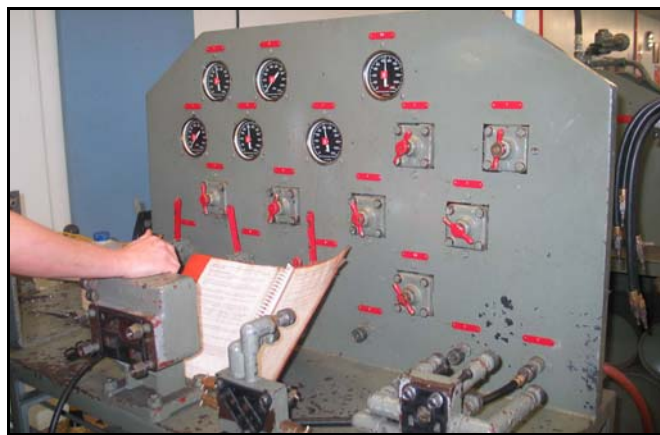
**Figure 10**  
**Air brake group's test rack**

- 1.9.7 Because of the different nature of Toll Rail's passenger vehicles, some of the air brake components originated from different manufacturers. There was a standard amount of time allocated to the refurbishment of the different components. The valves were stripped, cleaned, inspected, reassembled and tested against code on a test rack (see Figure 10). During the refurbishment, any item could be condemned if it did not meet the maintenance manual's standard.

- 1.9.8 After a component had been reassembled, it was painted and a quality sticker attached. Because the air brake group did not have its own maintenance instructions, the manufacturers' instructions were mostly used. Where procedural gaps occurred, staff had written up some instructions that were certified through internal channels.
