**Report 06-108, passenger Train 9328, derailed after running into  
landslide debris, 2.474 km Johnsonville Line, between Wellington and  
Wadestown, 26 August 2006**

**Report 06-108**  
**passenger Train 9328**  
**derailed after running into landslide debris**  
**2.474 km Johnsonville Line**  
**between Wellington and Wadestown**  
**26 August 2006**

**Abstract**

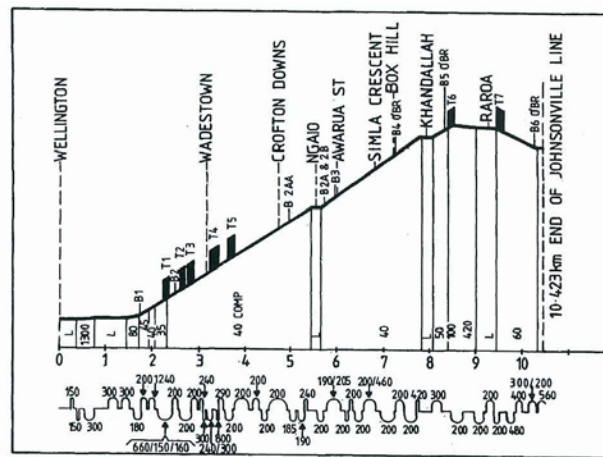
**Figure 3**  
**Gradient profile and track alignment detail of the Johnsonville Line (not to scale)**

- 1.3.2 The Johnsonville Line was 10.42 km long and was steeply graded throughout (see Figure 3). There were 7 tunnels, 4 rail bridges and many curves on the line. The track between Wellington and Crofton Downs followed steep hillside terrain. Between Crofton Downs and Johnsonville, the track followed less rugged terrain and was bounded on both sides by residential housing.

- 1.3.3 The gradient in the vicinity of the landslide was a rising 1 in 40 compensated<sup>5</sup> and the track was on a 160 m left-hand tight radius curve in a narrow cutting. Because of the terrain, parallel road access was not possible between Wellington and Crofton Downs.

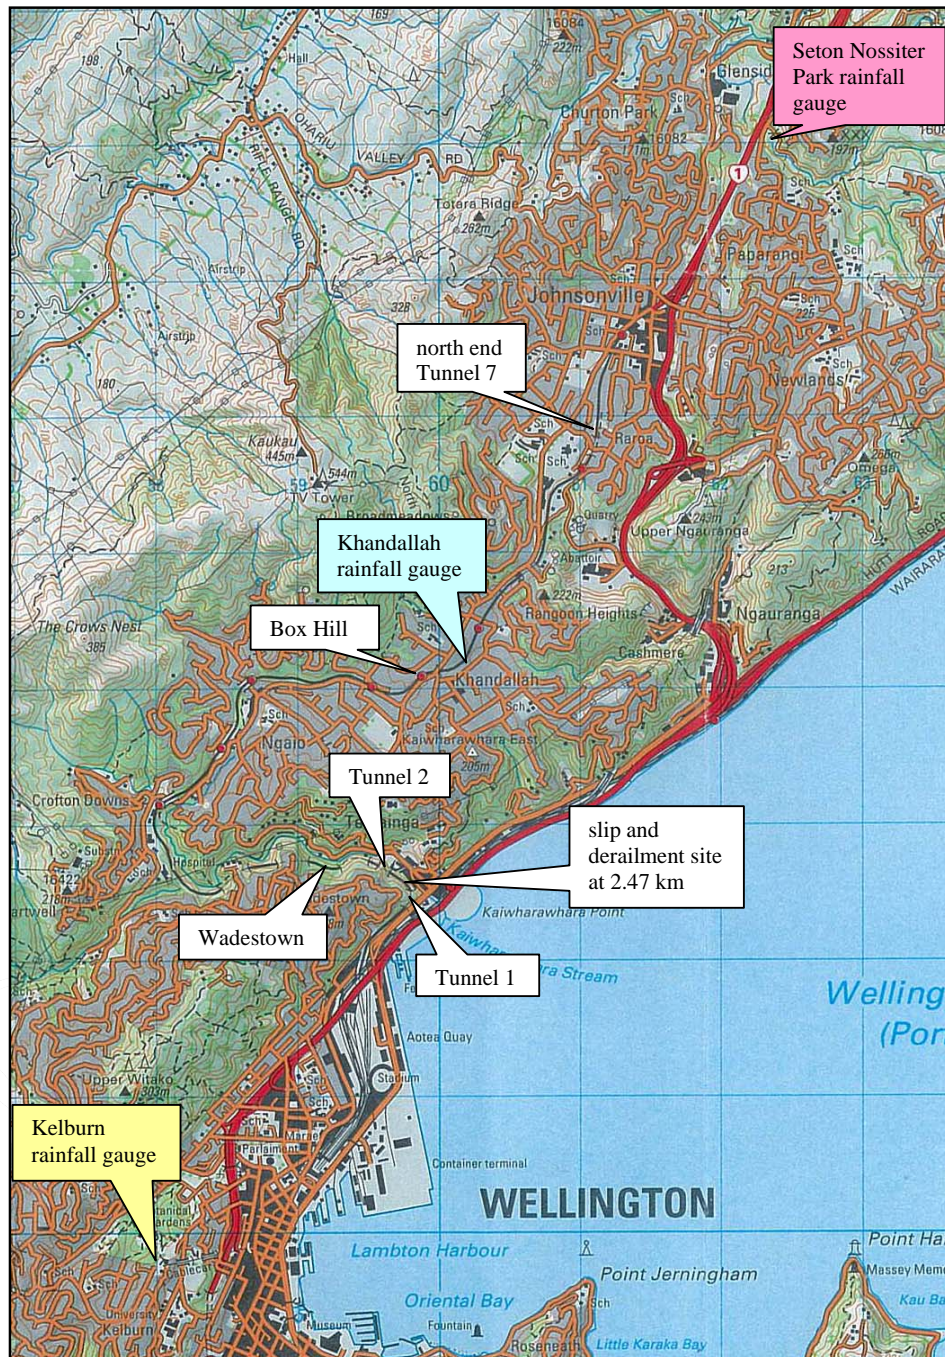
**Figure 5**  
**Map of Johnsonville Line**

1.8.1 The Commission approached 3 agencies that operated automated rainfall gauges at various sites near the Johnsonville Line as follows:

- the Greater Wellington Regional Council at Seton Nossiter Park, Glenside
- the Wellington City Council at Khandallah
- MetService at Kelburn.

- 2.2 The cutting's narrow profile meant that the debris from the slip had nowhere to go but across the track. Any EMU encountering a similar slip in this area was more likely to derail than to plough through it. If the derailment had occurred a short distance further on, the potential for a more serious outcome was possible because the terrain on the right-hand side of the train in the direction of travel dropped away to a deep parallel gorge through which the Kaiwharawhara stream flowed (refer left-hand picture in Figure 4 and topographical map in Figure 5).
