Report 07-010, Fletcher FU24-950, ZK-DZG, in-flight vertical fin failure, loss of control and ground impact, 5 kilometres west of Whangarei (Pukenui Forest), 22 November 2005

Report 07-010

Fletcher FU24-950

ZK-DZG

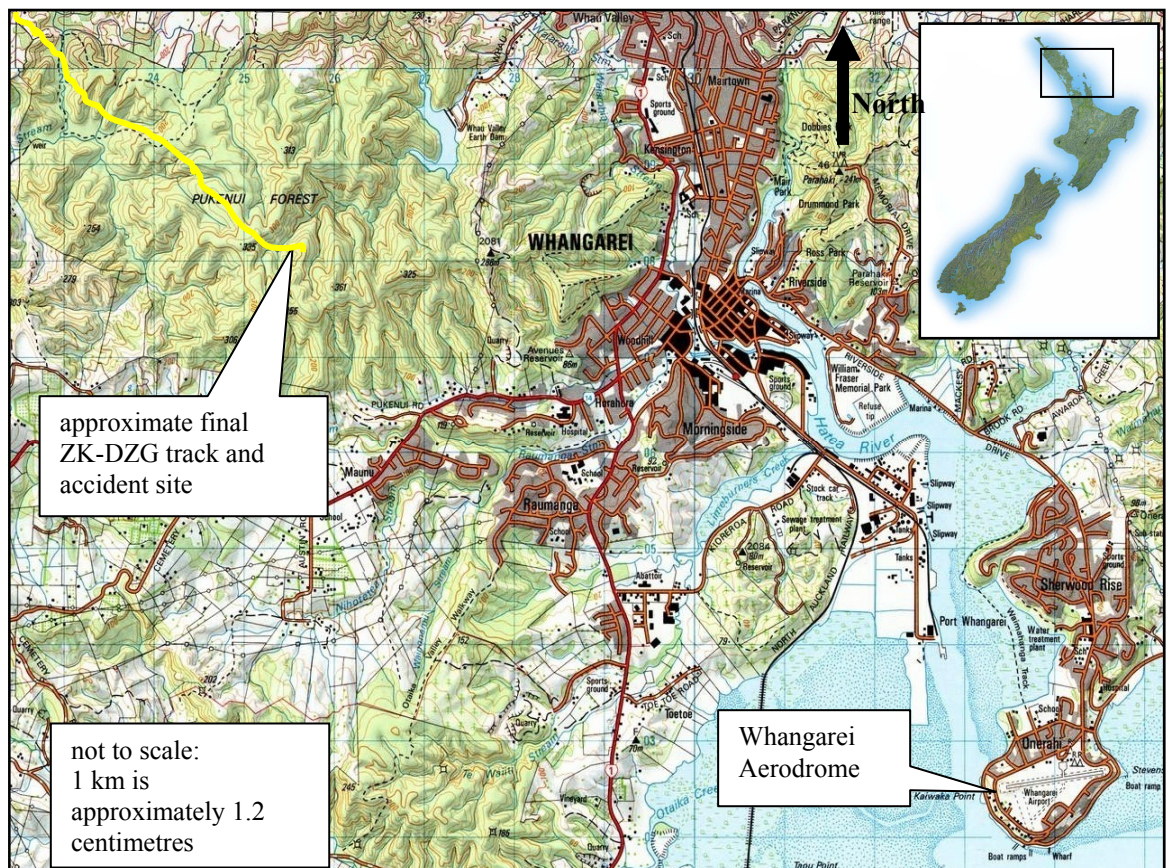
Figure 1
Location map

- 1.1.5 ZK-DZG was equipped with a global positioning system (GPS) and its navigation data was downloaded for analysis. From the data it was established that the aircraft departed from the airstrip at 1131 and flew for about 39 km on a track slightly right of the direct track to Whangarei Aerodrome, before altering heading direct to the aerodrome and Pukenui Forest located 5 km west of Whangarei city (see Figure 1).
