Report 07-207, bulk carrier, *Taharoa Express*, cargo shift and severe list, 42 nautical miles southwest of Cape Egmont, 22 June 2007

**bulk carrier
*Taharoa Express***

cargo shift and severe list

22 June 2007

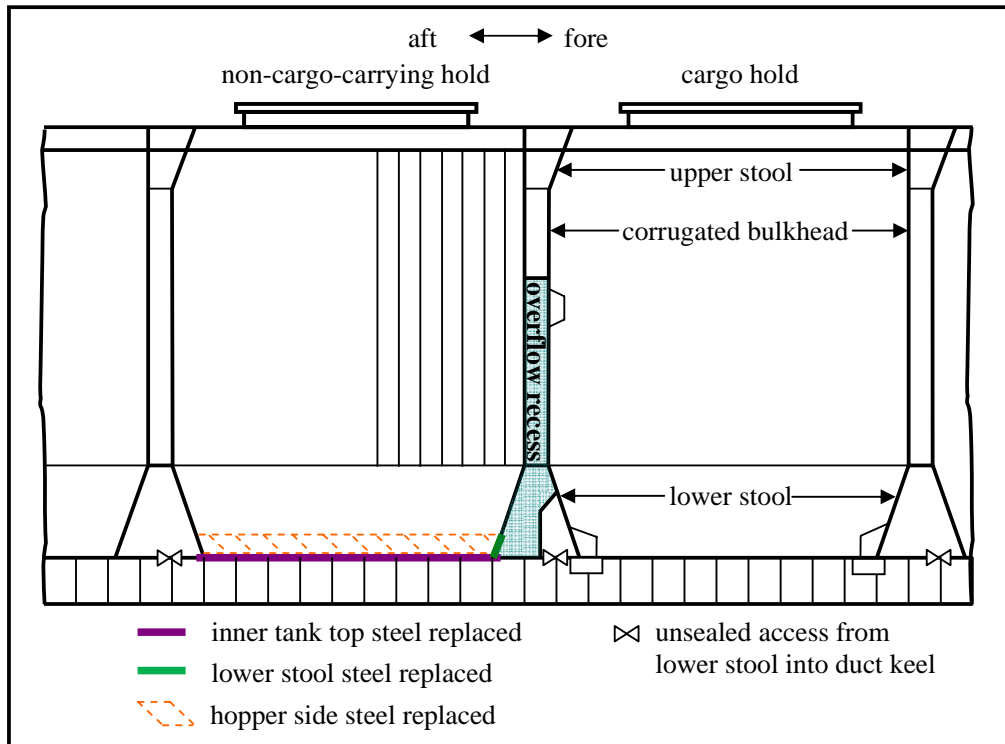
Figure 13
Schematic diagram of steel replaced in non-cargo-carrying hold

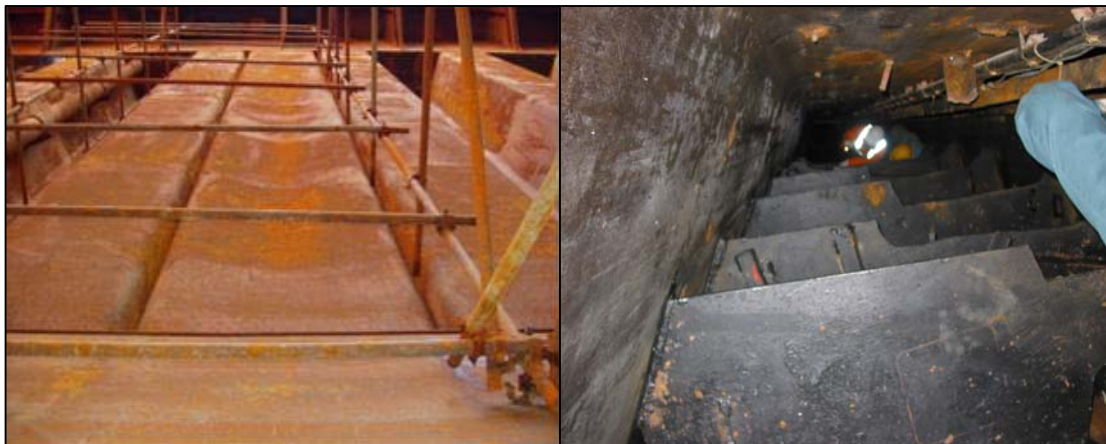
Figure 18
Bulge and temporary repairs to access trunk wall in number 6 hold

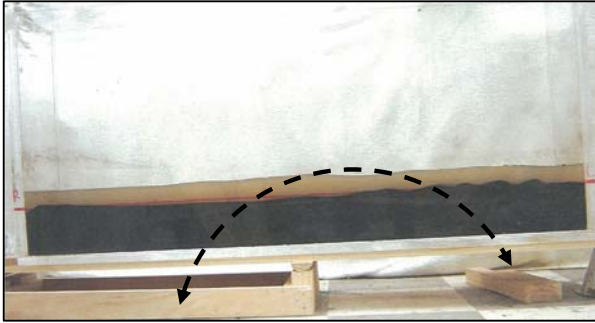
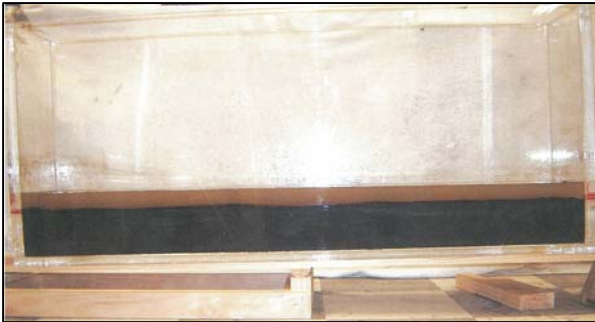
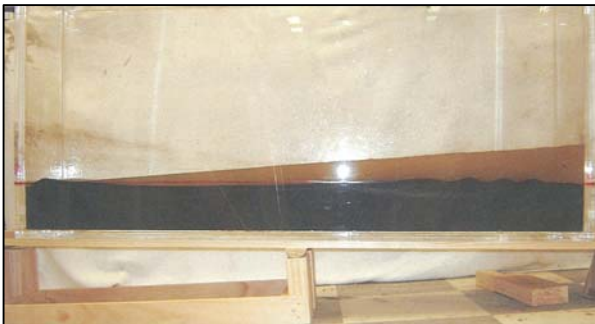
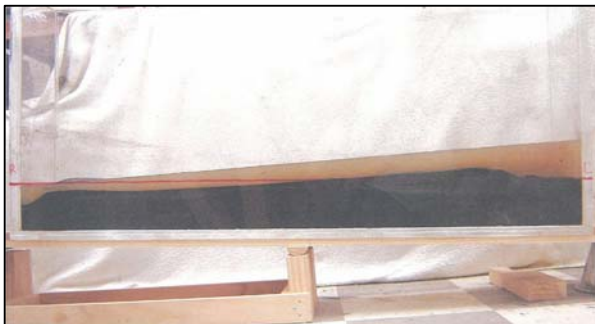
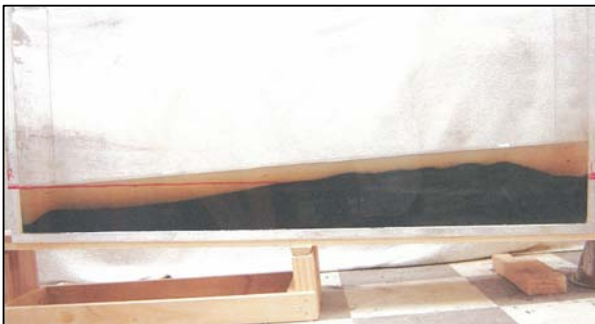
Figure 21
NZ Steel Mining study of cargo shift mechanism

Elapsed time: 0 mins
List of 4°
+/- 5° roll applied.

Elapsed time: 20 mins

Elapsed time: 40 mins
20 mins 4° list and
20 mins 8° list.

Elapsed time: 60 mins
20 mins 4° list and
40 mins 8° list.

Elapsed time: 80 mins
20 mins 4° list and
60 mins 8° list.

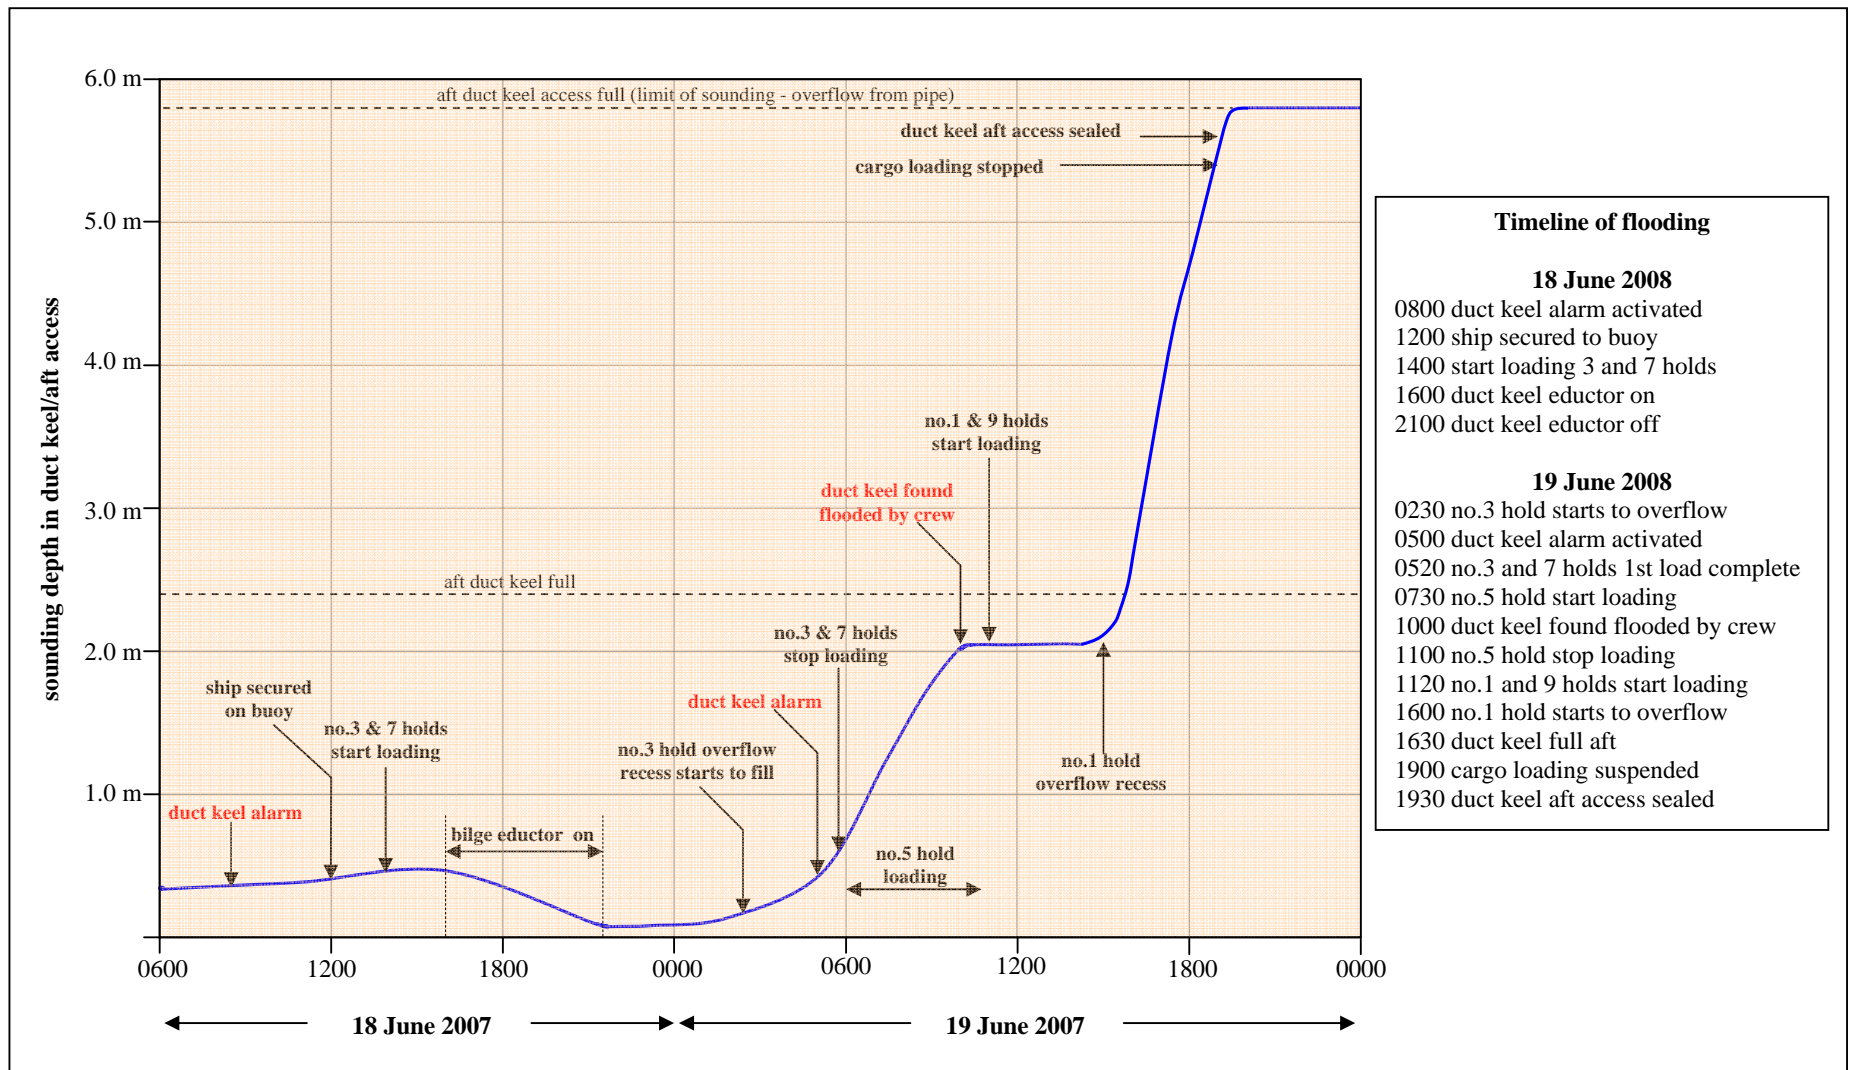
Figure 25
Timeline of duct keel flooding and key events

- 2.3.8 Figure 25 shows the timeline of the duct keel flooding to the suspension of cargo loading. It shows the cues that were missed by the crew on the ship and the consequences of continuing to load the ship without identifying the root cause of the problem.

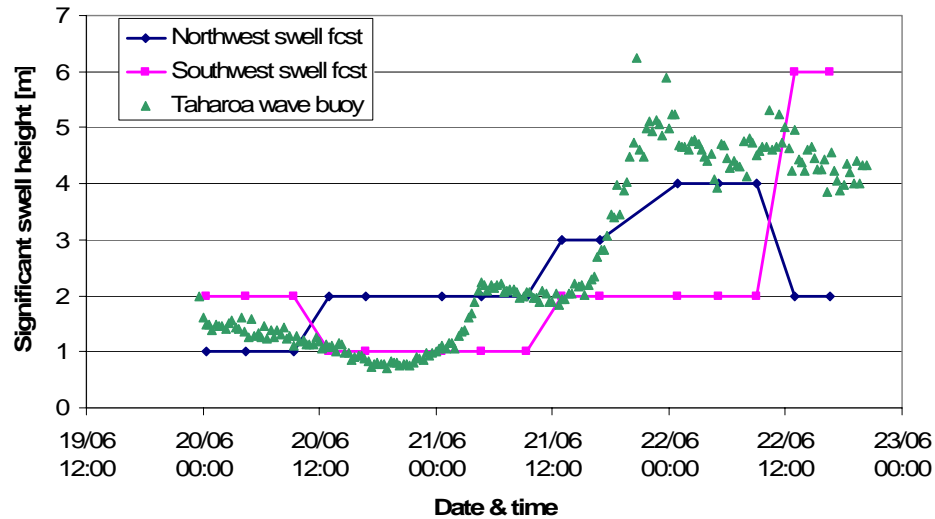
Figure 2: Forecast and Observed Swell Height along the Route of “Taharoa Express”

Weather forecasts for New Zealand coastal waters [1] and wave buoy measurements at Taharoa [2] were provided by TAIC. The forecast identified distinct northwest and southwest swell components, which correspond to beam and head seas, respectively for the passage down the coast of North Island. The measurements made at Taharoa show good correlation with the forecasts (see Figure 2) and are used to estimate periods of encounter and wave directions. The wave periods at departure are between 6 to 8 s, but increase to 10 to 14 s in the early hours of 22 June.

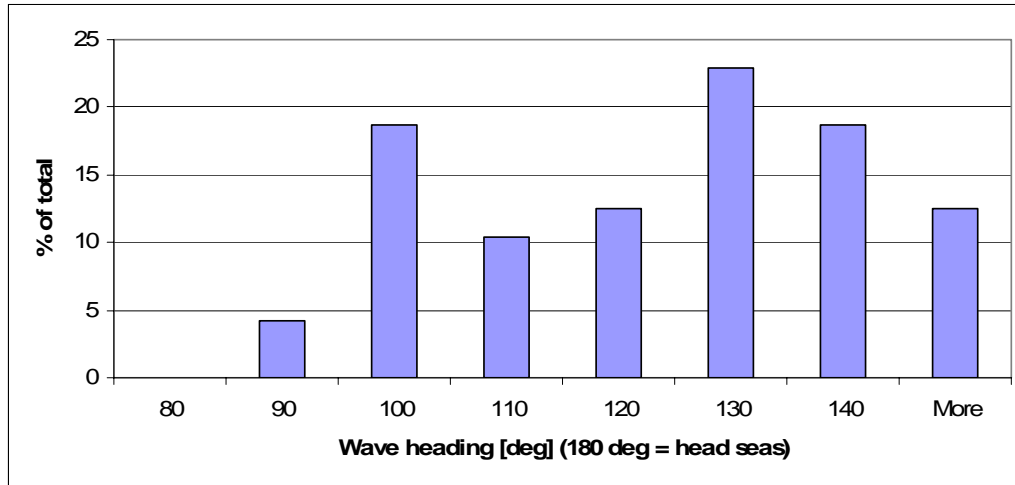
Figure 4: Wave Direction Following Emergency Departure from Taharoa Terminal

The distribution of swell direction relative to the heading of the “Taharoa Express” (Figure 3) is shown in Figure 4. The most significant components are between 90-100 deg (beam seas) and 130-140 deg (quartering seas). The distribution of encounter periods in Figure 5 peaks at 5 s and a further peak between 8 and 10 s.

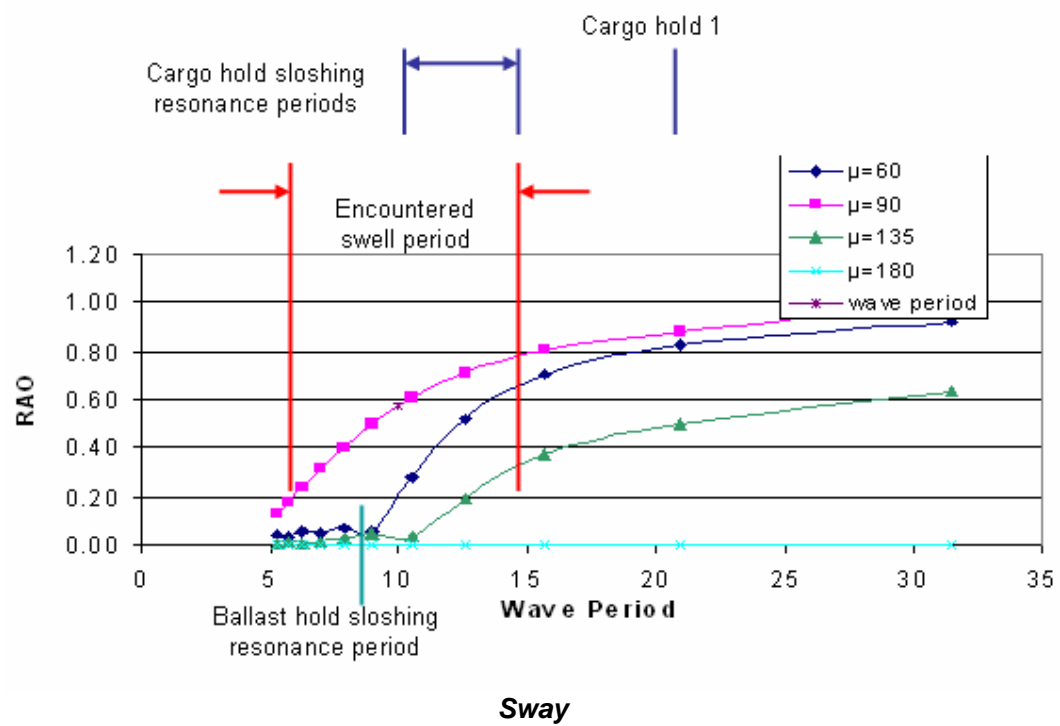
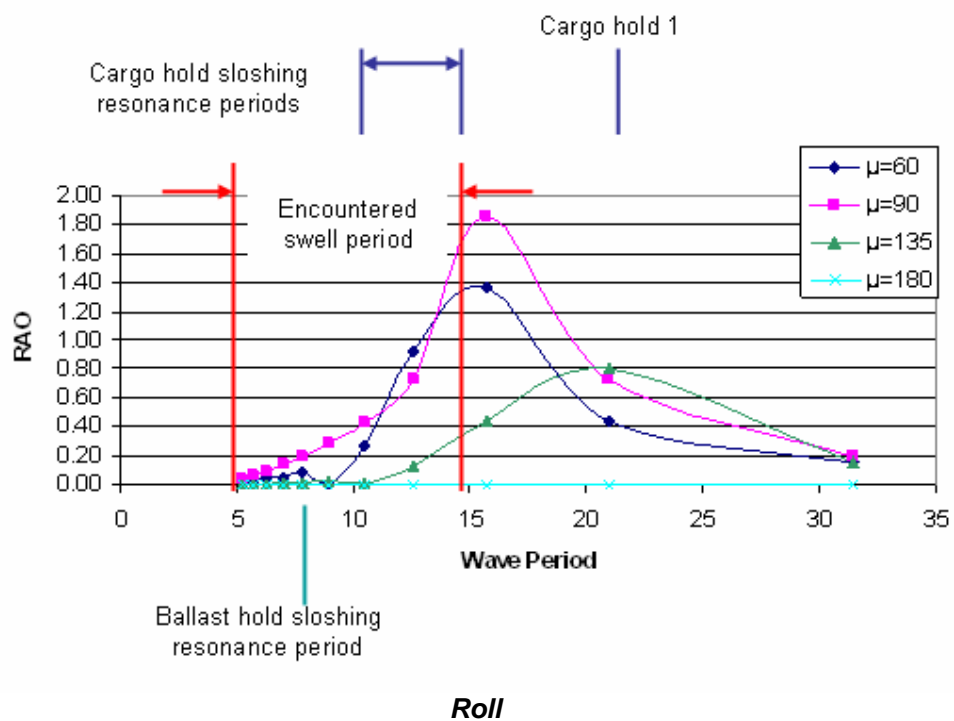
Figure 7: Response Amplitude Operators and Sloshing Resonance for Transverse Motions

The comparison of the sloshing resonant frequencies with the range of likely ship motions is a first pass to determine the probability of severe sloshing. The ship motions are characterised by the response amplitude operators (RAOs). Figure 7 shows the RAOs of the transverse motions of the “Taharoa Express” compared to encounter wave periods. The main wave direction μ is between 90 and 100 deg and between 130 to 140 deg (see Figure 4).

- For sway, the encountered waves result in vessel motion amplitudes large enough to cause sloshing at the first resonant period.
- The peak of the roll RAOs is near the resonant sloshing period of the cargo holds, with a peak roll amplitude of about 6 deg.
- Lateral accelerations are approximately 0.1g for a 5 m wave height (see Figure 8) and 0.08 g for a 3 m wave height. The maximum acceleration occurs near the resonant sloshing periods calculated previously.

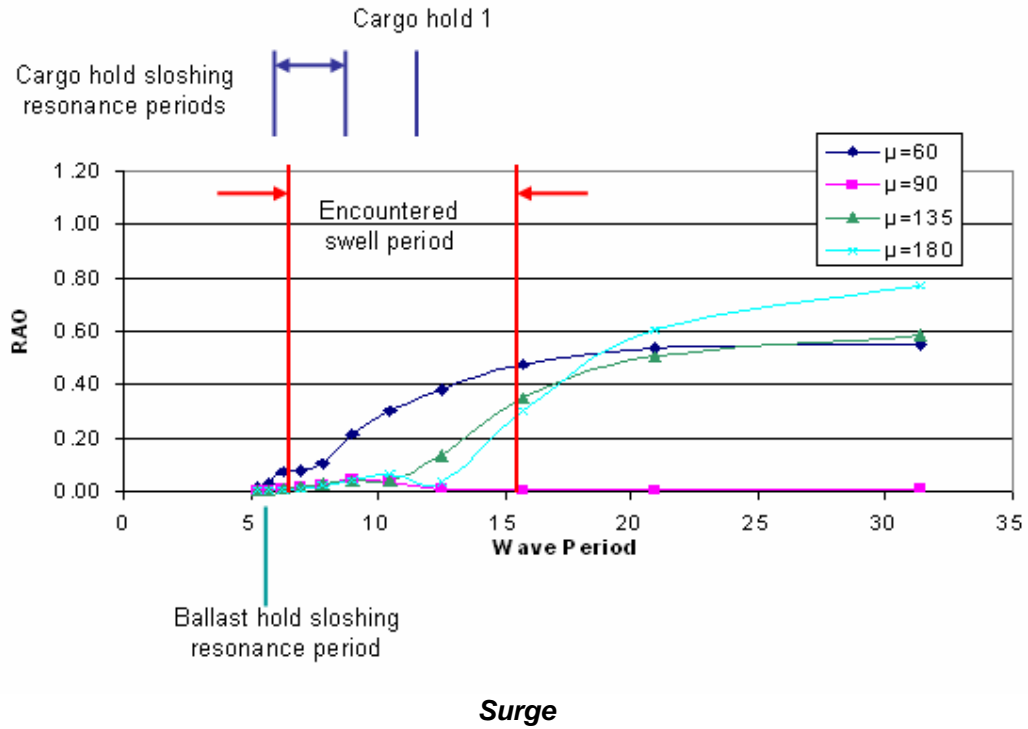
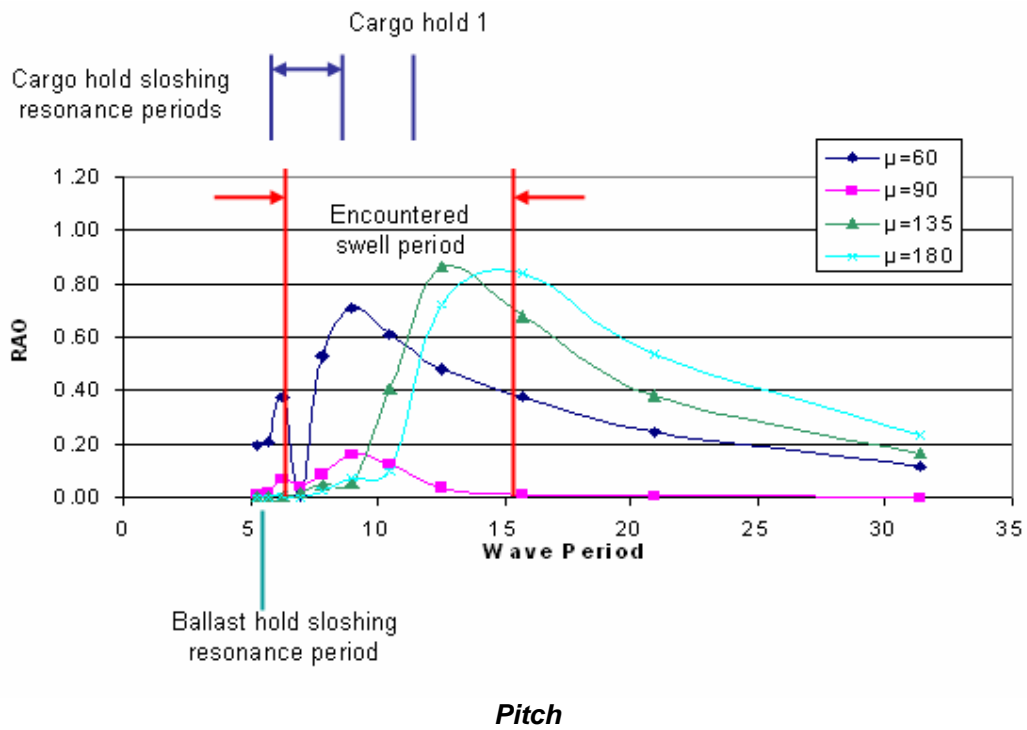
Figure 9: Response Amplitude Operators and Sloshing Resonance for Longitudinal Motions

- The surge RAO (Figure 9) near the sloshing resonance periods is several times smaller than the sway RAO.
- Pitch motions are significant, but their significance on the sloshing response is less than linear motions.

To identify the high risk cases warranting further analysis, the first consideration is the magnitude of the RAO at the sloshing resonant periods. This is found to be significant for both sway and roll. For surge and pitch, the RAO at the sloshing resonant periods was far smaller. Secondly, the sloshing resonant periods are well within the range of encountered wave periods for the transverse vessel motions. In the longitudinal case, there is considerably less overlap between the sloshing resonant periods and the encountered swell periods. The nature of the motion (linear or angular), the hold shape and filling level also affects the sloshing response. For the present hold conditions, the linear hold motions tend to result in the most severe sloshing. Therefore, the most severe sloshing response was caused by sway. The sloshing response due to roll was found to be less significant. Neither longitudinal motion resulted in the severe sloshing observed in the analysis of the transverse motions.

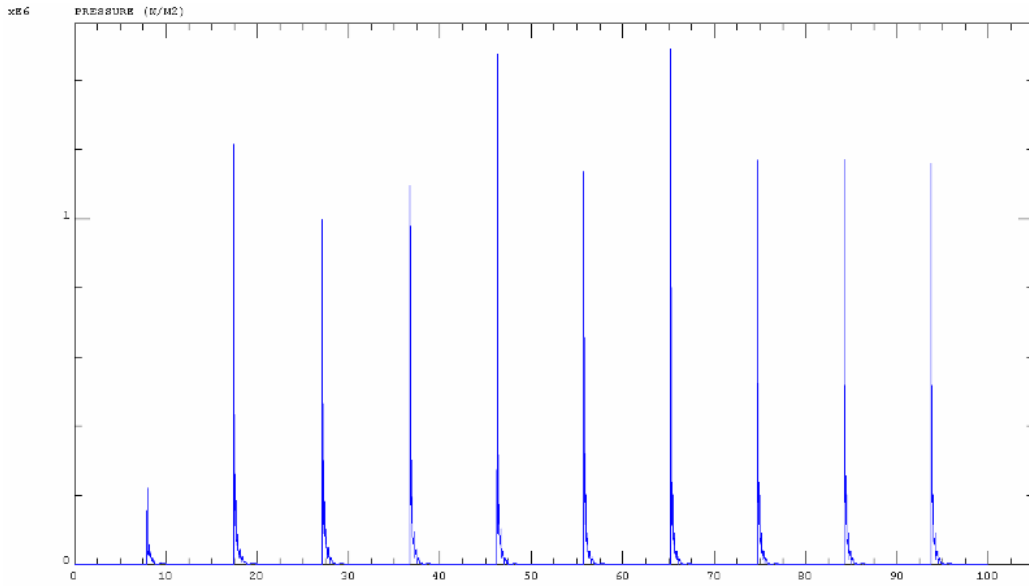
Figure 11: Pressure History at the Hopper (Point 1) During Transverse Sloshing at Resonance. Pressure in MN/m²

Cargo hold No.5 contains 5,889 tonnes of iron sand and 6,915 tonnes of free water. This corresponds to a cargo height of approximately 2 m and a free water height of 7.7m. This gives a filling ratio of 0.18, which is above the threshold in [6]. The worst case scenario analysed uses a significant wave height of 5 m, which corresponds to a sway amplitude of 2.8 m. The sloshing motion is excited at the first natural sloshing period of 10 s.

The impact pressures at the foot of the upper hopper tank in Figure 11 are about 15 times greater than the static pressure. The peak pressure magnitudes vary between 1,000 and 1,500 kN/m².

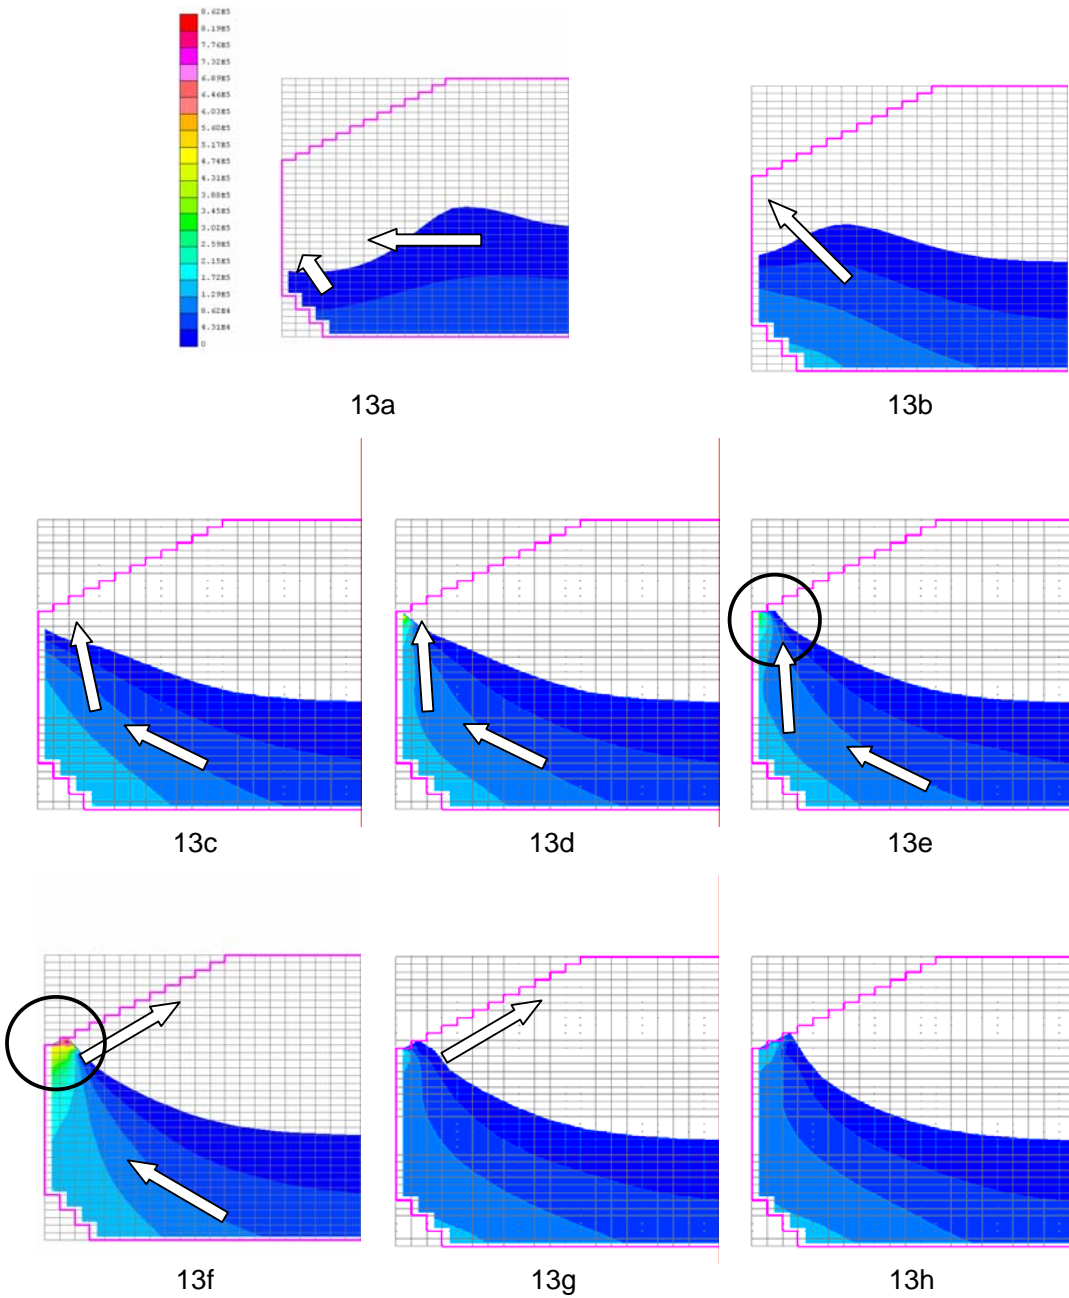
Figure 13: Impact Pressure Evolution in Cargo Hold No.5

The sequence of a typical sloshing impact is shown in Figure 13, where the white arrows indicate mean flow fields. The travelling wave moving towards the hold side wall is seen in Figure 13a. Water is directed upwards by the lower hopper. In Figure 13b, the travelling wave has reached the side wall. Subsequently the jet shown in Figure 13c forms travels directly toward the upper hopper with a velocity of approximately 20 m/s. The jet has reached the onset of the hopper tank and the initial impact is visible in Figure 13d and 13e, with the main impact occurring in Figure 13f. From the point of impact, a pressure pulse in excess of the static pressure propagates into the fluid and along the side shell. The maximum impact pressure in this sequence is 860 kN/m² and the duration of the impact between Figures 13d and 13f is approximately 0.15 s. Once the

jet is deflected, the pressure drops off (in Figure 13g) and the flow is moving along the hopper, as shown in Figure 13h.

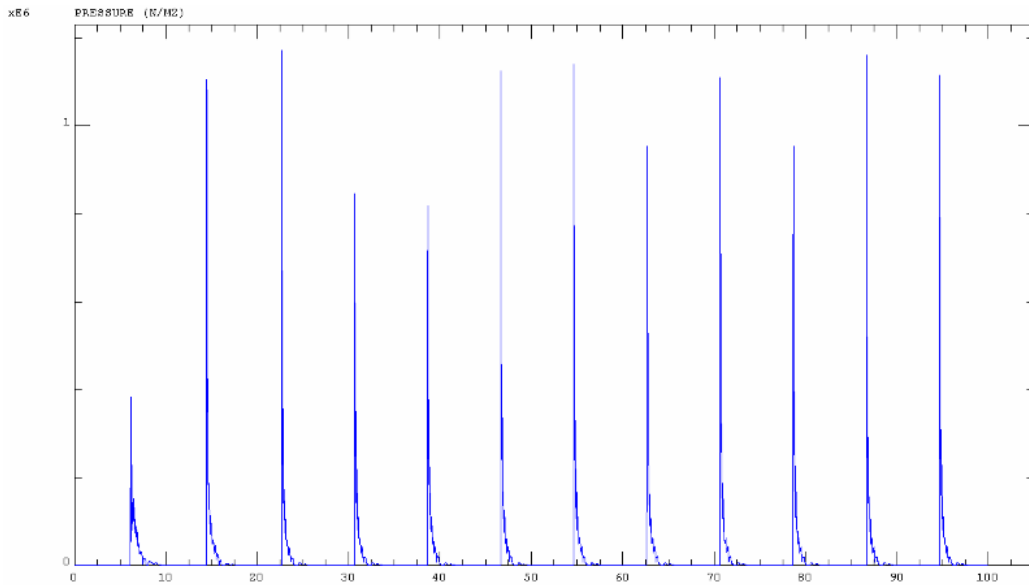
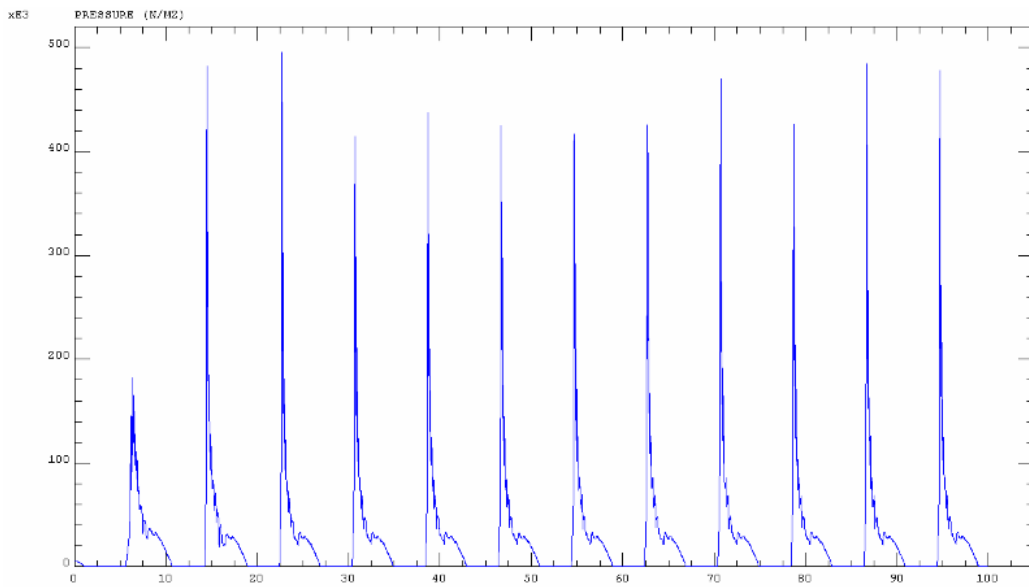
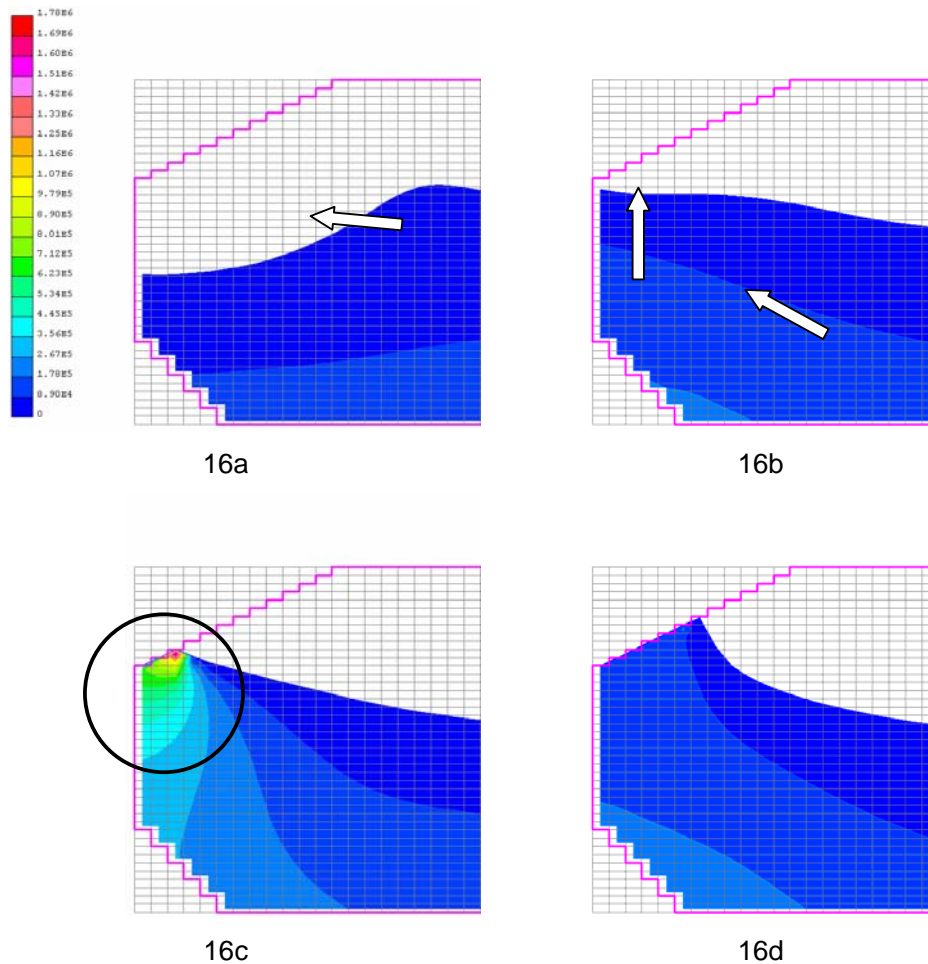
Ballast hold No.6 is filled up to 12.8 m of water, which corresponds to a filling ratio of 0.30. This tends to be in the critical region where violent sloshing is expected. Figures 14 and 15 show the pressure history for the first resonant sloshing period of 8.6 s at monitor points 1 and 2, respectively. The pressures follow a similar behaviour as in cargo hold No.5. The impact sequence in Figure 16 is also similar, although the travelling wave in Figure 16a is not as well defined as previously. The pre-impact jet velocity is slightly lower at 15 m/s, but the post-impact velocity is in excess of 30 m/s. The impact causes a pressure pulse to propagate into the fluid as shown in Figure 16c.

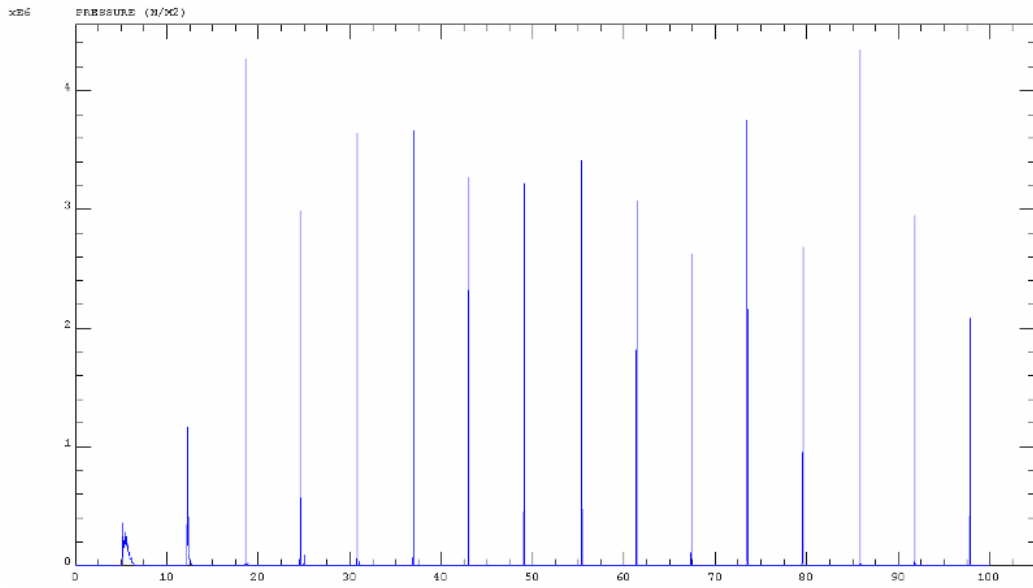
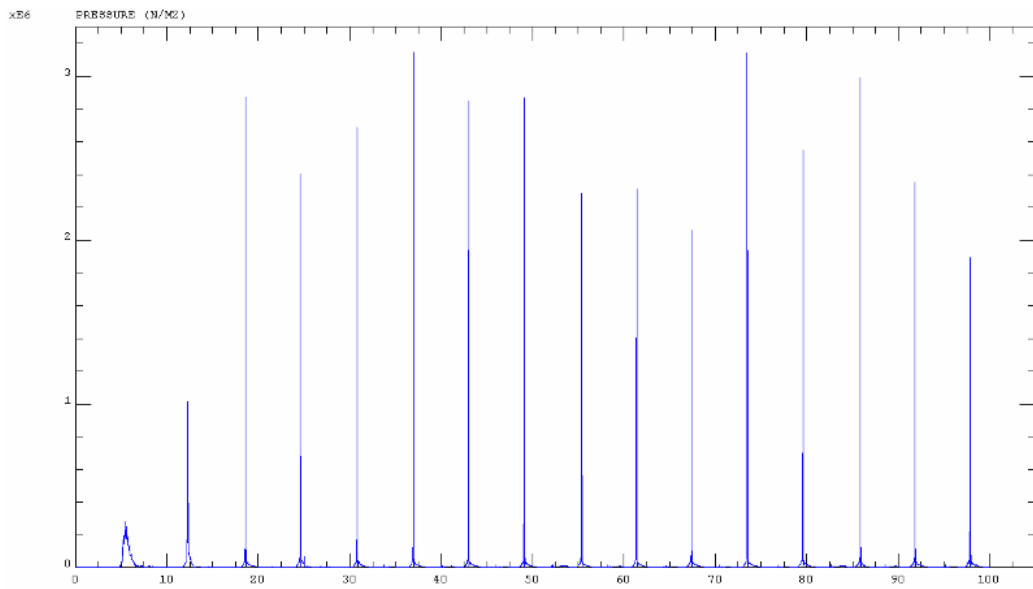
The excitation at the second resonant period of 6.1 s results in a considerably more severe sloshing response. Figures 17 and 18 show an increase of the impact pressure by up to an order of magnitude compared to the previous cases. However, when the swell was large (5 m), the swell period was usually closer to the first sloshing resonance. It is therefore highly unlikely that the second harmonic would be encountered, although the very short rise time and the possibility of quartering seas means that this condition cannot be completely discounted.

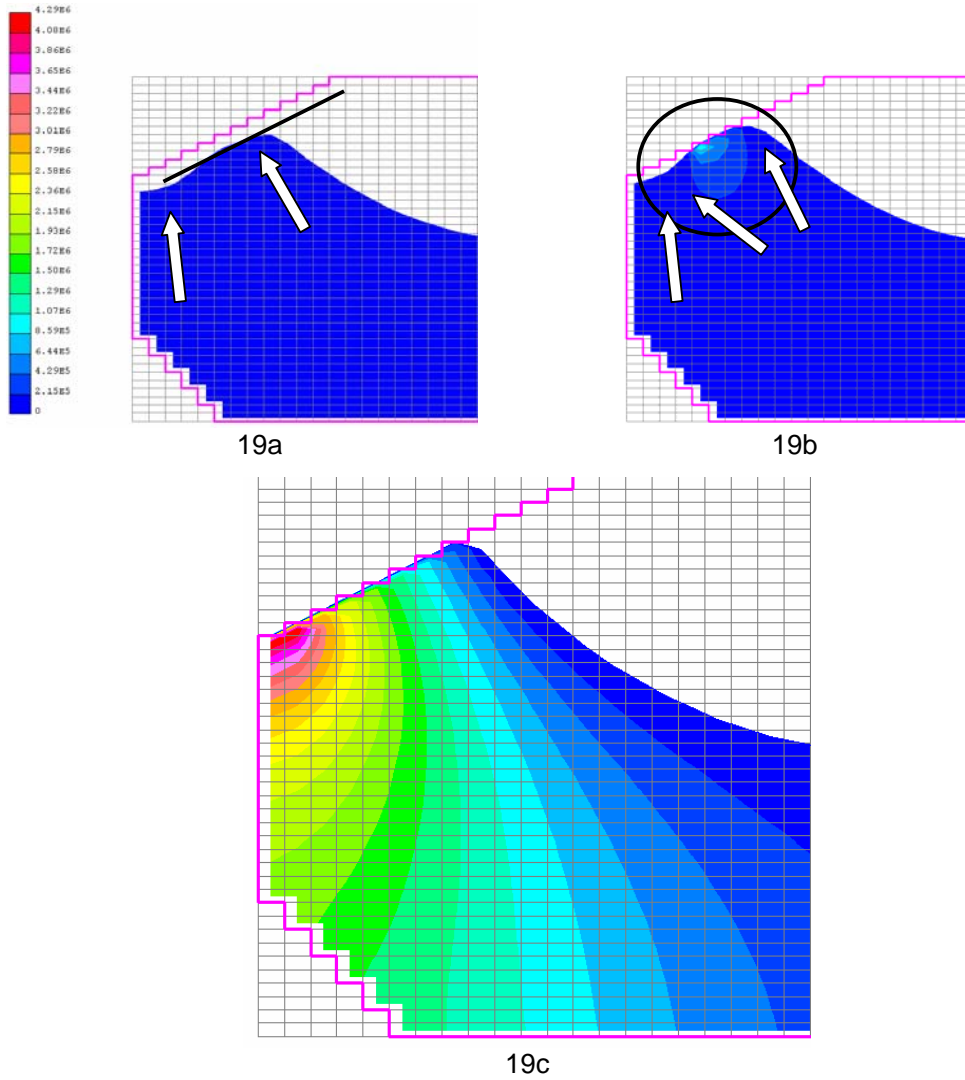
Figure 19: *Impact Pressure Evolution in Ballast Hold No.6. The Second Resonant Mode is Excited.*

The severity of the impact pressure in this condition is explained by the impact sequence. Rather than forming a jet at the side wall, the fluid is moving directly towards the hopper (Figure 19a), while a secondary jet is moving up along the side wall. The initial impact magnitude is approximately 1,000 kN/m², which corresponds to a lower speed (12 m/s) but a direct impact. The resulting pressure pulse then directs part of the flow back towards the tank (Figure 19b), while a component of the flow is directed towards the foot of the upper hopper. These two flows impact the hopper simultaneously. This leaves no path to divert the oncoming flow and a much higher impact pressure results (see Figure 19c). The duration of this impact of about 0.1 s is slightly shorter than in the previous cases, but the non-uniform nature of the impact can result in significant fluid-structure interaction effects.

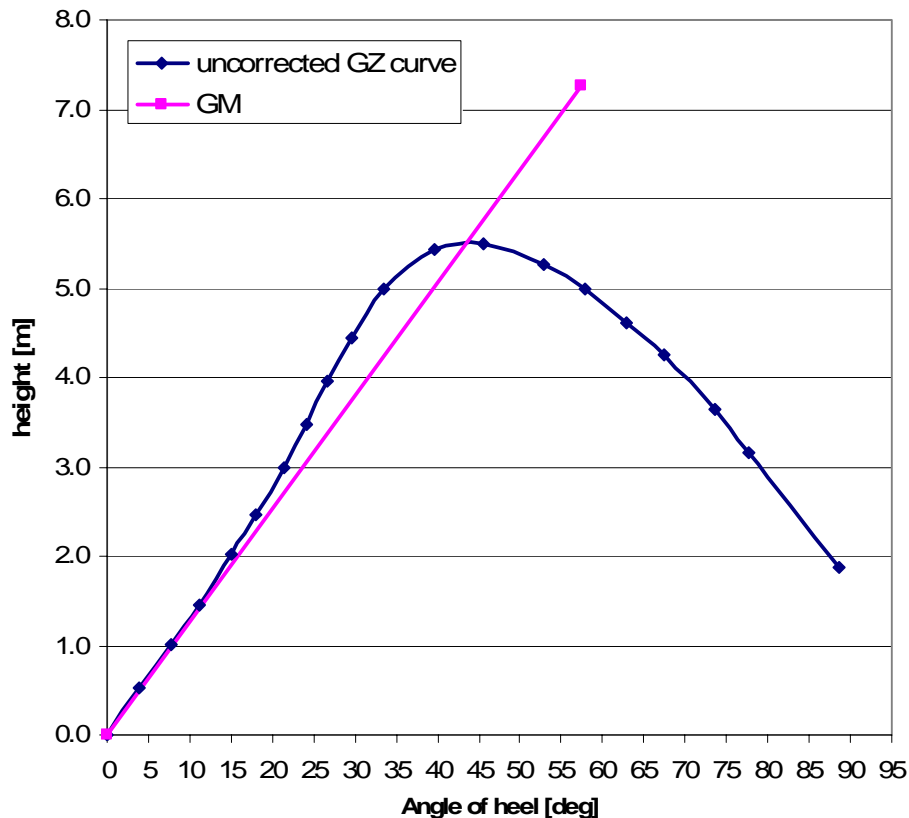
Figure 20: GZ Curve from Loading Computer
Not Corrected for Free Surface Effects (GM=7.27 m)

The GZ curve from the loading computer is reproduced in Figure 20. This GZ curve does not take account of the reduction in static stability caused by the free water in the cargo holds.

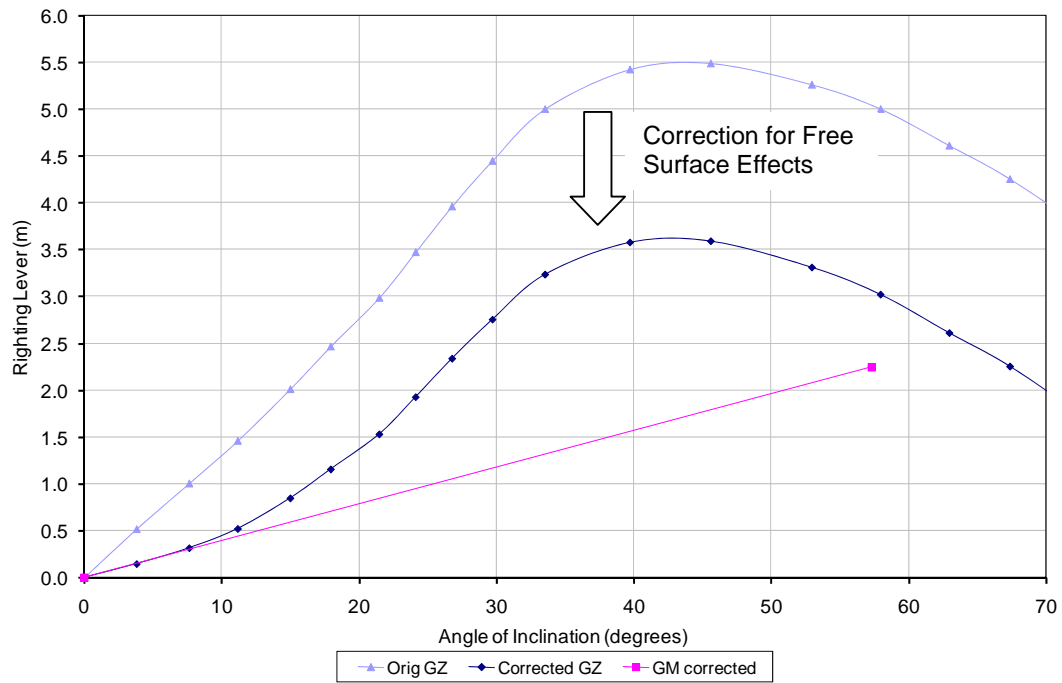
Figure 21: GZ Curve with Free Surface Correction

The corrected GM is reduced to 2.2 m due to the effects of the free surface in the cargo holds, with the approximate shape of the corrected GZ curve shown in Figure 21.

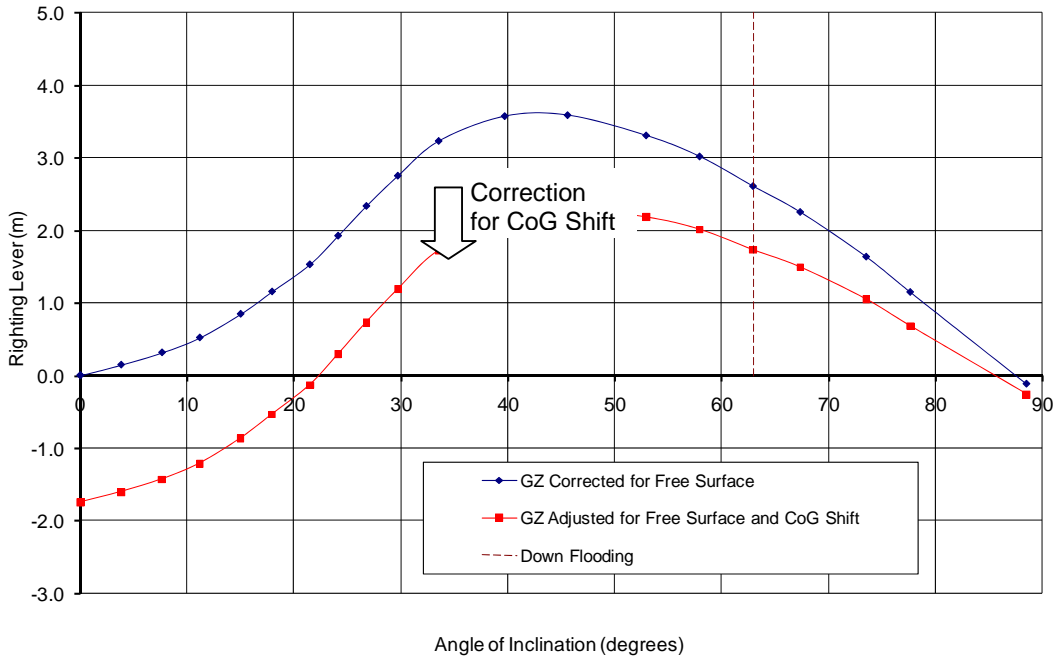
Figure 22: GZ Curve with Adjustment for Cargo Shift

Figure 22 shows two points of intersection of the GZ curve adjusted for free surface effects and cargo shift with the x-axis. The first point of intersection is the steady angle of heel the ship takes up due to the cargo shift. The second intersection occurs at the angle of vanishing stability – for angles of inclination less than this, the ship will return to its upright condition when the heeling moment is removed. Note that in this instance, down flooding would occur prior to this angle of inclination being achieved.

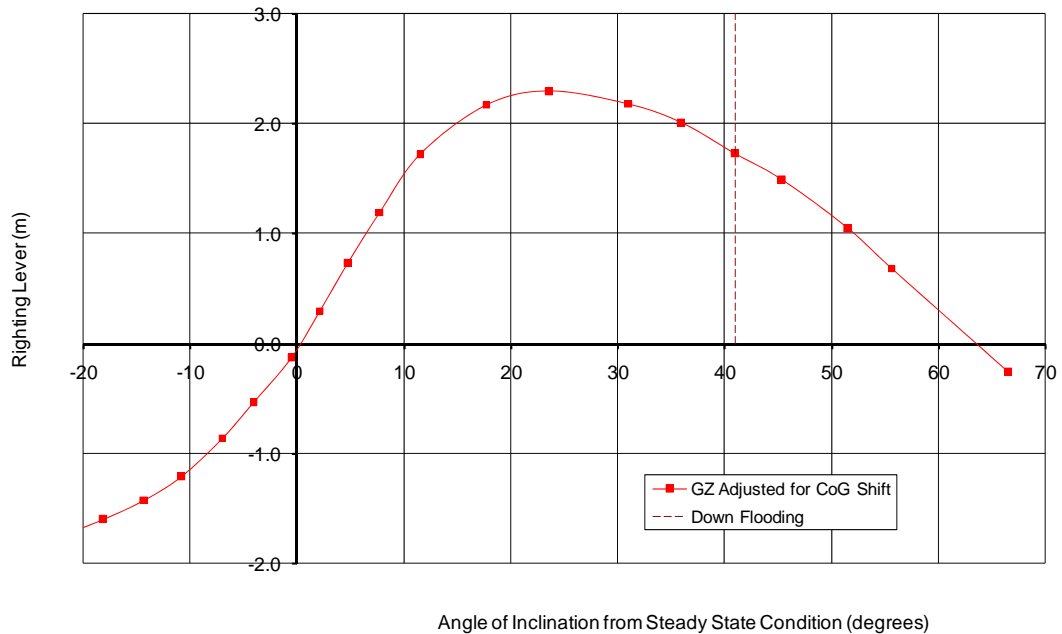
Figure 23: Adjusted GZ Curve about Steady State Heel Angle

The adjusted GZ curve is re-plotted in Figure 23, with the first point of intersection (i.e. the steady angle of heel) as the origin of the graph. The x-axis in this graph is the angle of inclination from the 22 degree steady angle of heel position.

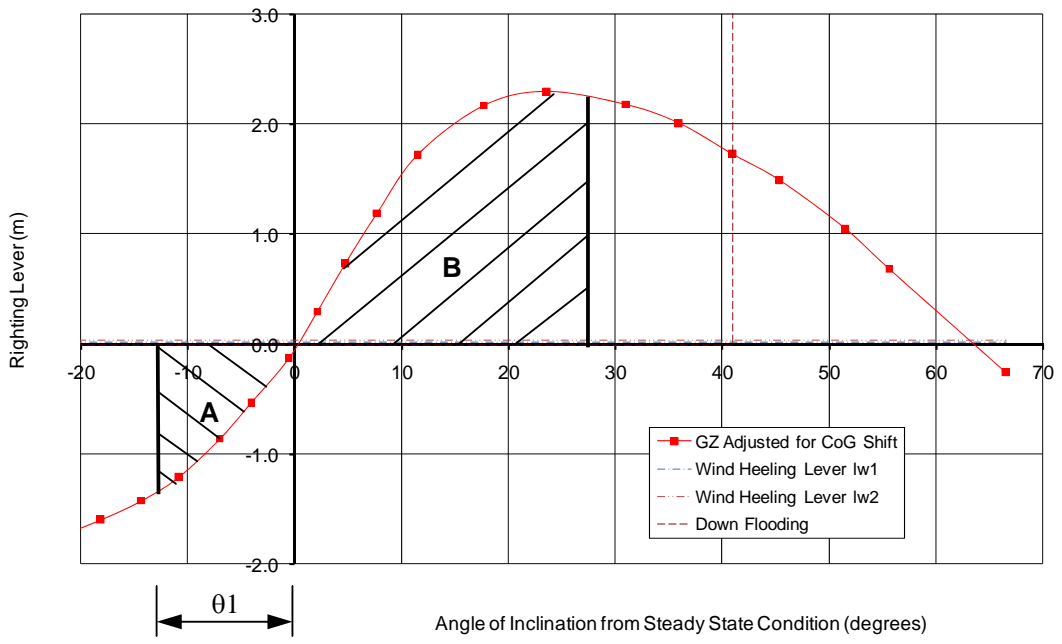
Figure 24: Adjusted GZ Curve about Steady State Heel Angle

The ability of the ship to withstand the combined effects of heeling due to beam winds and rolling has been investigated for an angle of inclination of 22 degrees. The approach used is detailed in the ship's loading manual [8] which references the Intact Stability Criteria of IMO resolution A.562(14). The adjusted GZ curve and the severe wind and rolling criterion are presented in Figure 24, with areas A and B determined as follows:

At the observed heel angle of 22 degrees the comparison of areas A and B shows a good reserve of stability. ($\text{Area B} / \text{Area A} = 4.5$). However, the rate of cargo shift is likely to increase as the heel angle increases, leading to further degradation in the vessel's stability over time. It is estimated that this criterion would be failed when the cargo shift resulted in a steady heel angle of approximately 32 degrees.

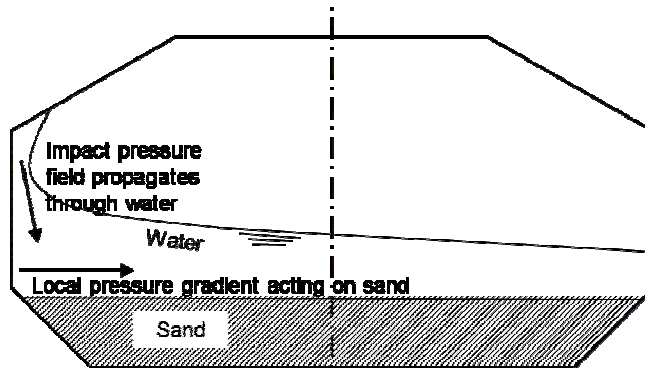
Figure 26: Global Pressure Gradient Acting on Sand

Both of these are investigated using fundamental multiphase theory. Ref [9] finds that if the ratio of the separation velocity w_p and the typical velocity w_T is much less than 1 (i.e. $w_p / w_T \ll 1$), particles are mixed in a fluid flow. In the current flow, this ratio is found to be approximately 0.02, compared to the threshold for mixing of 0.2 [10]. This indicates that iron sand will be entrained in the water due to the fluid motion. The second mechanism inducing sand motion is the pressure gradient. The comparison the Coulomb friction force (which resists motion) to the applied pressure gradient (which displaces the sand) shows that the global pressure gradient is not large enough to cause the movement of the iron sand (Figure 25). However, local pressure gradients due to sloshing impacts are far greater and may result in the displacement of the iron sand (Figure 26).

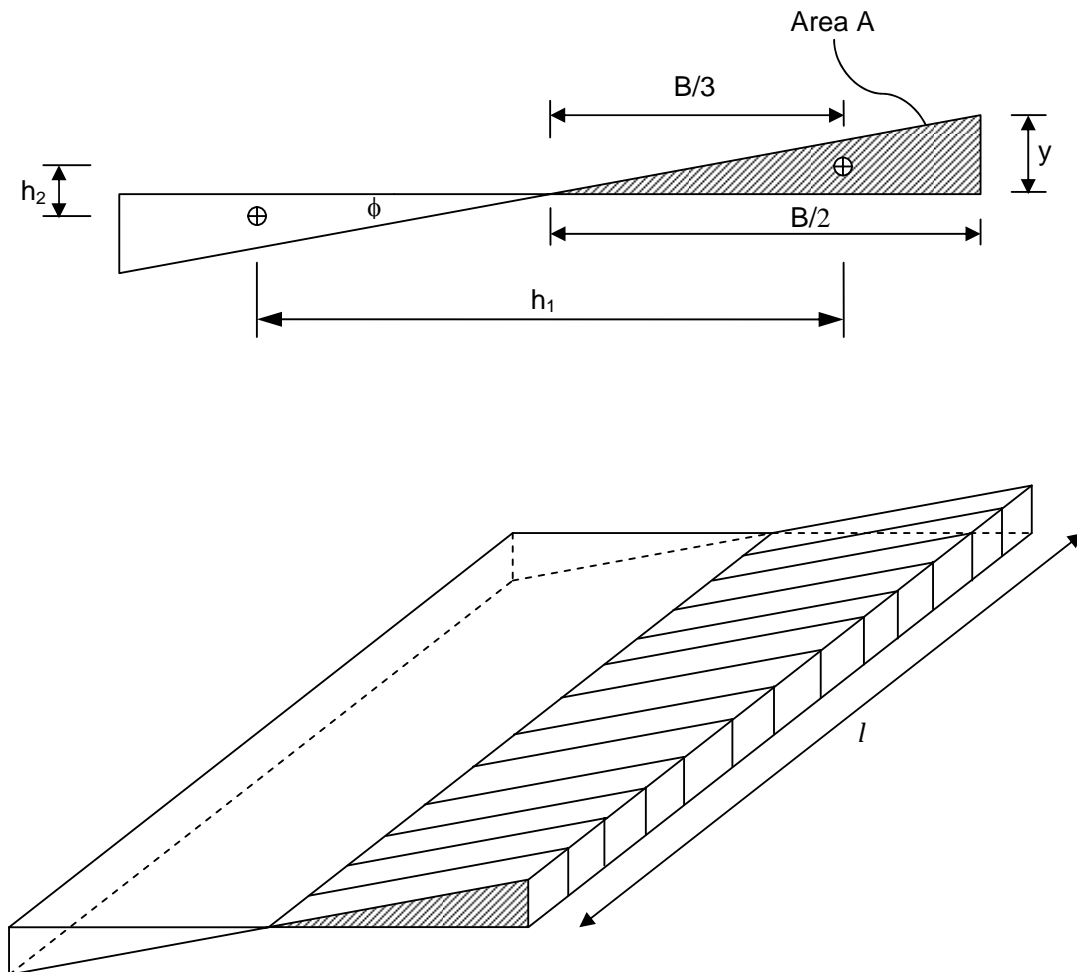
Figure B1: Cargo Shift

It is assumed that to incline the vessel to a steady angle of heel of 22 degrees, the surface profile of the cargo has shifted through an angle ϕ . This results in the shift of a wedge shaped portion of cargo from one side of the vessel to the other, as shown in Figure B1. The correction to the GZ curve comprises components due to the horizontal and vertical shift in the cargo mass moved.
