Report 08-101, express freight train 923, level crossing collision and  
resultant derailment, Orari, 14 March 2008

**Final report 08-101**  
**express freight Train 923**  
**level crossing collision and resultant derailment**  
**Orari**  
**14 March 2008**

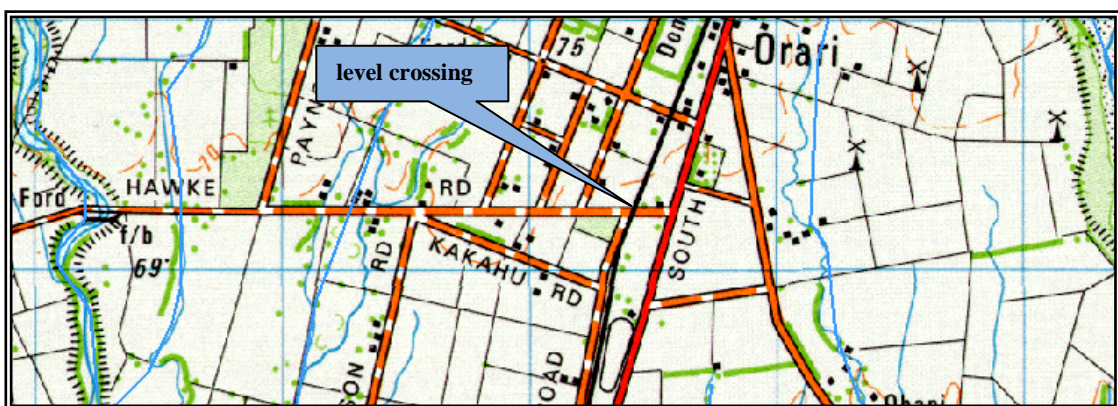
**Figure 2**  
Location of Hawke Road level crossing

- 1.2.1 Hawke Road level crossing was located at 141.77 km MSL, between Rangitata and Temuka. The level crossing was 162 m to the west of State Highway 1 (see Figure 2). Twelve trains and about 150 various road vehicles passed over the level crossing each day.

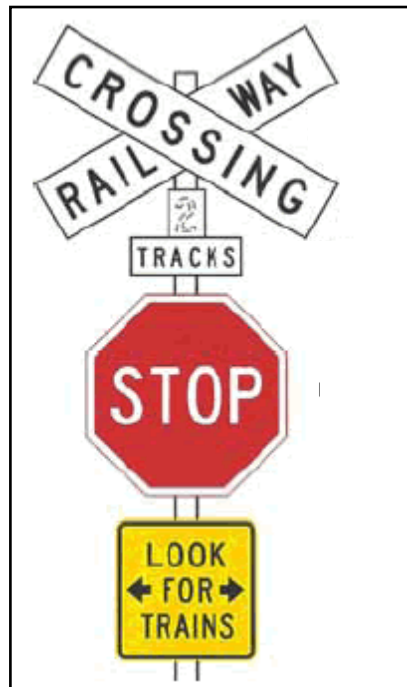
**Figure 6**  
**RG-32 railway level crossing “Stop” sign assembly**

Limit lines should be marked so that at passive control sites, no part of them is closer than 3 metres from the nearest rail. Limit lines for RG-32 assemblies should be in line with the sign (see Figure 6).
