**Report 08-103, passenger Train 6294, electrical fire and collapse of overhead traction line, Mana station, Wellington, 18 April 2008**

**Report 08-103**

**electrical fire and collapse of overhead traction line**

**Mana station, Wellington**

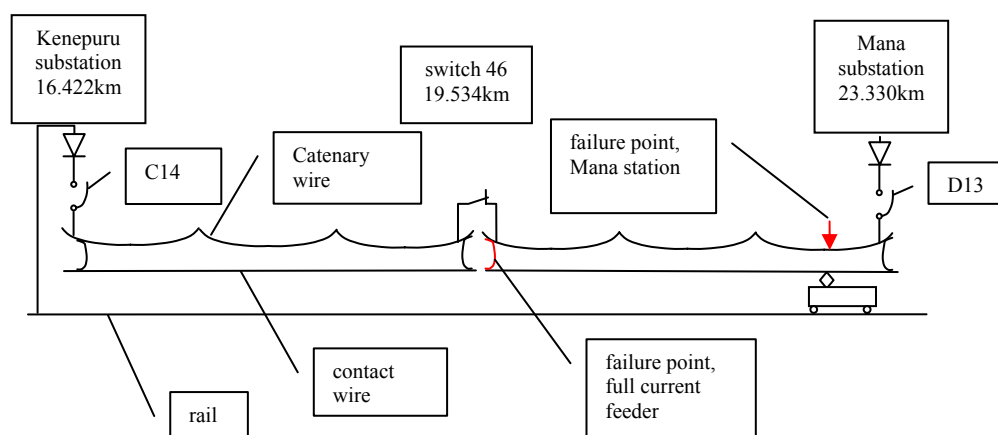
**Figure 2**  
**Power distribution network**

- 1.3.7 The overhead traction line consisted of 2 main copper conductors, the catenary wire and the contact wire (see Figure 2). The catenary wire supported the weight of the contact wire and was connected to the contact wire with conductive feeder cables and vertical, steel hanger tie wires. The contact wire was intended to be in sliding contact with the pantograph on the train, so was vertically aligned to be parallel with the track. The contact wire was tensioned to approximately 11 kilonewtons (kN). The catenary wire was also tensioned but followed a parabolic curve between the poles and above the contact wire to provide the means to hang the contact wire parallel with the track using the suspended hanger tie wires.

- 1.3.8 A normally closed, manually operated isolator switch No.46 was located near the middle of the overhead line section between the Kenepuru and Mana substations. When the switch was opened, the Kenepuru and Mana substations could only supply traction power to the half of the overhead line their side of Switch 46. The normal state of this switch was closed.

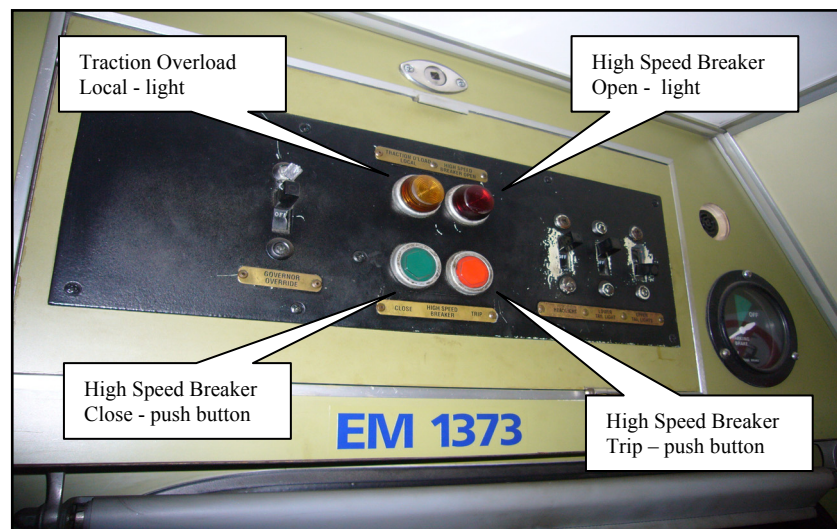
**Figure 3**  
**High speed breaker control and indication**  
© Transport Accident Investigation Commission

- 1.4.5 The circuit breaker was manually controlled by the 'Trip' and 'Close' push buttons mounted above the driver's window. An associated local red alarm light indicated when the circuit breaker was open (see Figure 3). The Trip and Close pushbuttons were train-lined<sup>9</sup> so could be operated from any driving cab along the train, but the indication lights were only displayed in the local EM/ET cabs. The circuit breaker was normally closed while the EM was in service but would trip automatically whenever a local traction motor overload occurred.

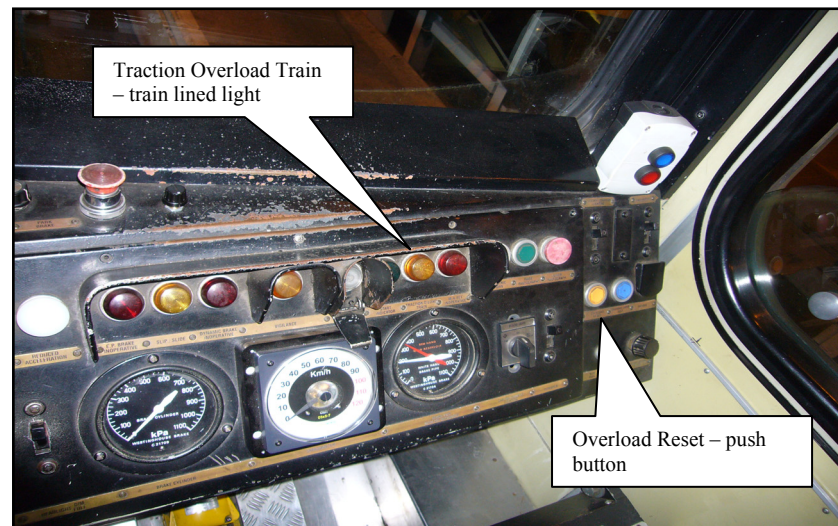
**Figure 5**  
**Traction motor overload and reset**  
© Transport Accident Investigation Commission

- 1.6.2 A traction motor overload would be indicated by 2 separate alarm lights at the same time. A local alarm light would illuminate in the driver's cabs for that EM/ET car and a train line alarm light would illuminate in all drivers' cabs making up the train. The local alarm light was above the cab front window and labelled 'Traction Overload Local' (see Figure 3) and the train-line alarm light labelled 'Traction Overload Train' was located to the right of the centre dashboard console, just below the front window of the cab (See Figure 5). These alarm lights would indicate that a motor set on the train had tripped out owing to an overload. There was no indication which bogie motor set had tripped out but a driver could find the EM car with the fault by physically inspecting a driver's cab from each EM/ET set to see if the local traction motor overload and circuit breaker open lights were on. The driver could also reset the traction motor overload and circuit breaker from any driving cab and carry on with the journey.

- 1.6.3 The control system electrical interlocks<sup>17</sup> and standard operating procedures<sup>18</sup> required the driver to set the power brake controller to the 'coast' position, close the high-speed circuit breaker then press the 'overload reset' button on the right hand side of the dash board control console to reset the traction motor overload circuit trip.

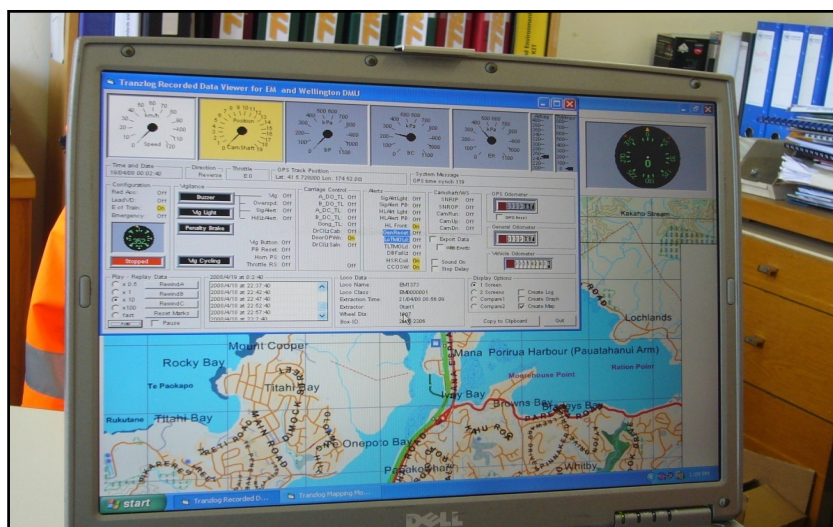
Figure 12

- 1.11.4 The Tranzlog data records were examined for the 4 days leading up to the incident at Mana. On 14 April 2008 there were no actual traction motor overload events during the 7 return trips made during the day. On the 15th there were 2 consecutive traction motor overload trips returning to Wellington on the Paraparaumu line while the train did 8 return trips during the day. On the 16th there were no actual traction motor overload events during 7 return trips made for the day. On the 17th there were 5 genuine overloads during the 6 return trips made that day. On the 18th there was one genuine overload during the day before the ones that immediately preceded the Mana incident.

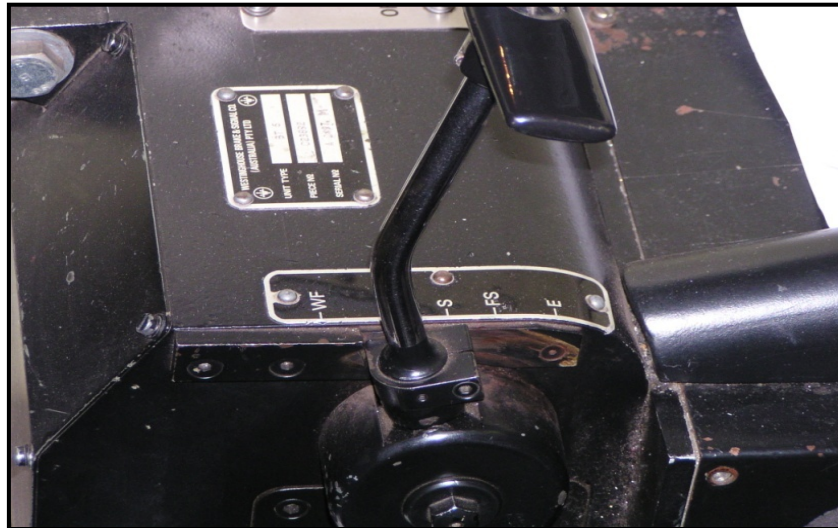
**Figure 13**  
**Power brake controller in 'coast' position**

- 1 The train moved forward when the driver had selected the desired terminal speed by moving a power brake control lever to the 'field series', 'shunt' (also termed parallel) or 'weak field' positions (See Figure 13). The automatic control system then accelerated the train to the maximum speed possible with that selected position. The driver could select the top speed selection ('weak field') from a stationary position if desired, and the automatic control system would step the traction motor configuration through each stage to achieve the maximum acceleration rate to the maximum speed. If the train reached the desired speed earlier than expected or the driver wanted to slow down, the 'coast' position would be selected for a period. Braking could also be applied if required.
