Report 08-110, train control operating irregularity, leading to potential low-speed, head-on collision, Amokura, 23 September 2008

Report 08-110

train control operating irregularity

leading to potential low-speed, head-on collision

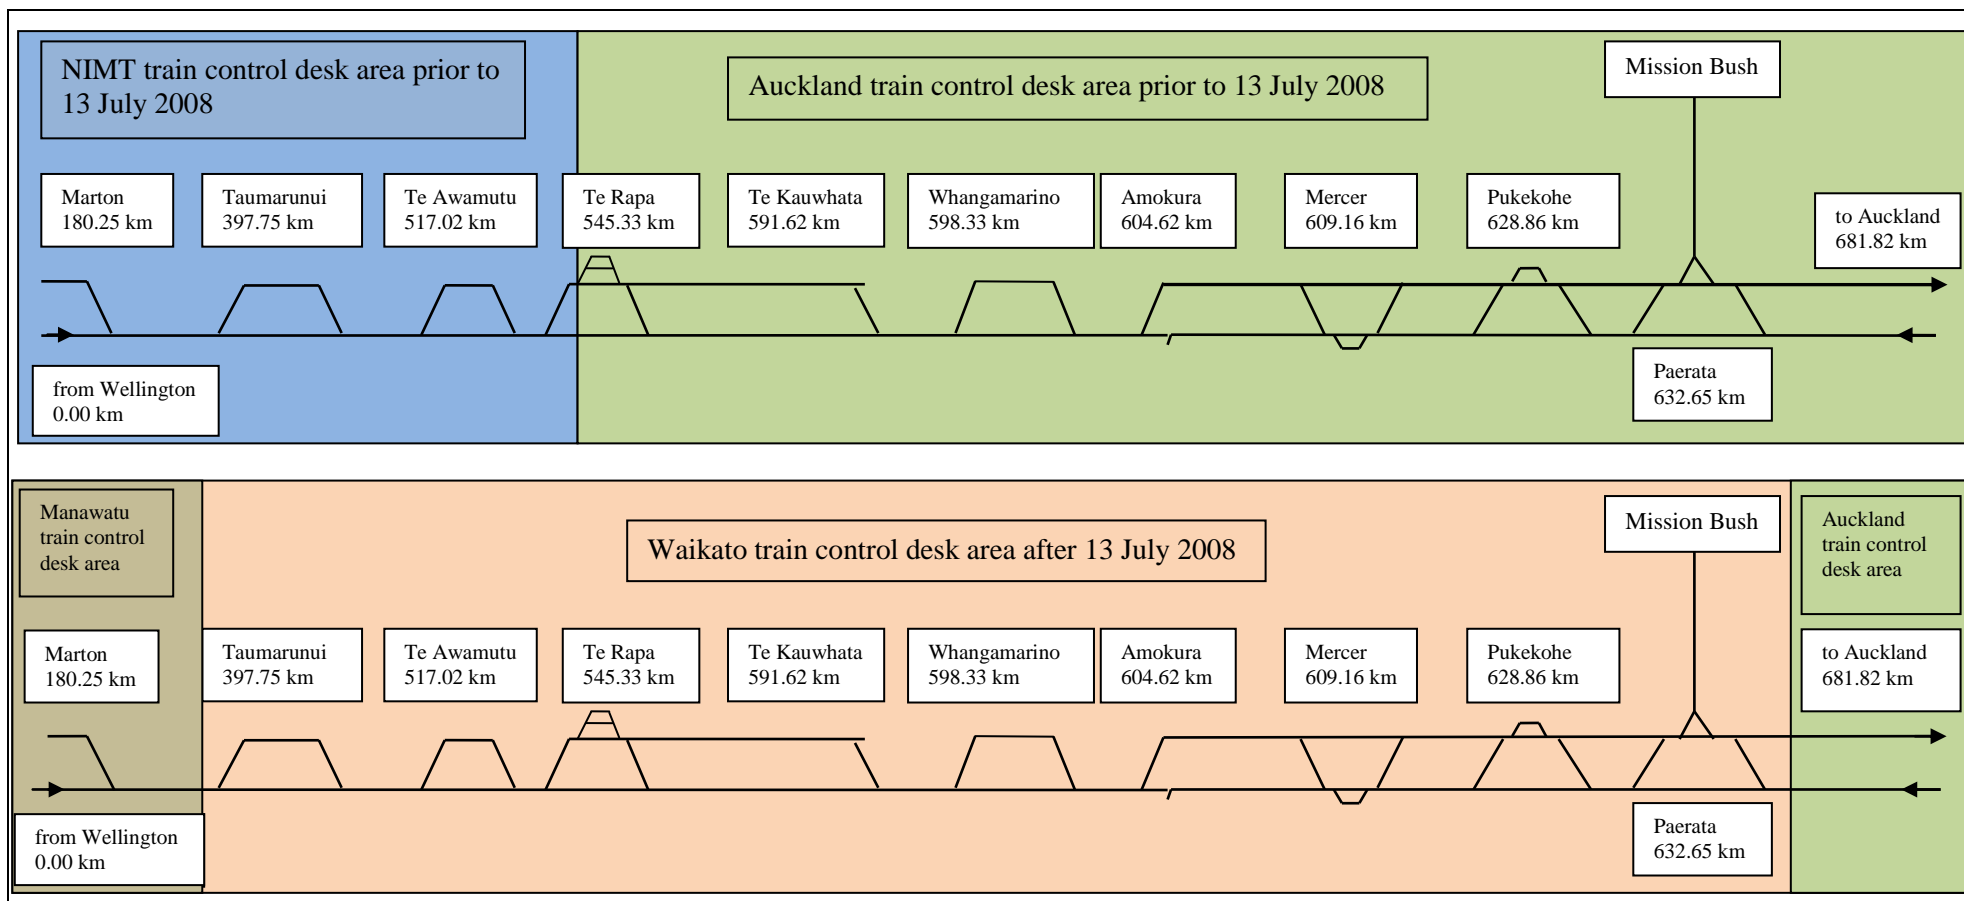
Figure 7
Train control boundaries and track layout on the NIMT between Auckland and Marton including Amokura (not to scale)

- 1.7.7 A timetable change that introduced an expanded Auckland suburban rail operation on 13 July 2008 necessitated alterations to geographic boundaries in 3 desks in the NTCC in order to spread work load balances (see Figure 7). On that date, the following changes occurred:
