Report 08-111: Express freight Train 524, derailment, near Puketutu,
North Island Main Trunk, 3 October 2008

Final Report

Rail inquiry 08-111

Express freight Train 524, Derailment
near Puketutu, North Island Main Trunk, 3 October 2008

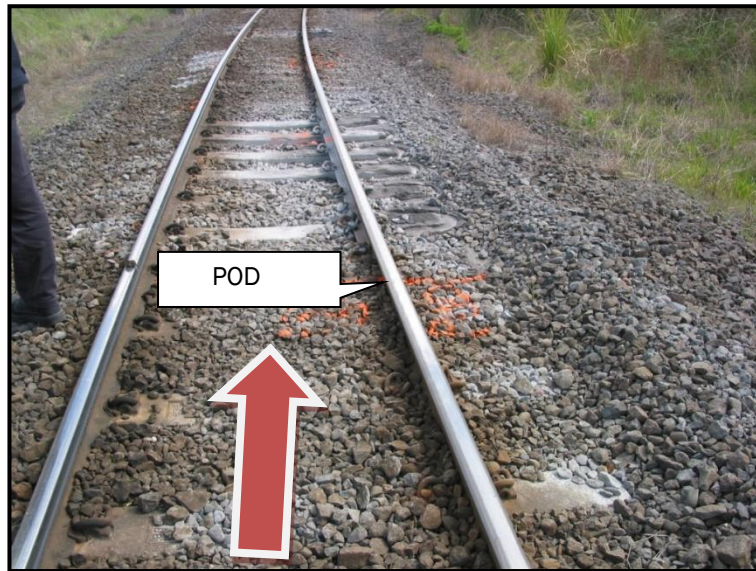
Figure 2
Location of the derailment

- 3.2.3. The POD was confirmed as 468.580 km. Wagon UK9007 derailed to the right-hand side (low-leg) in the body of a 260 m radius right-hand curve, 25 m past the start of the circular curve (see Figure 2).

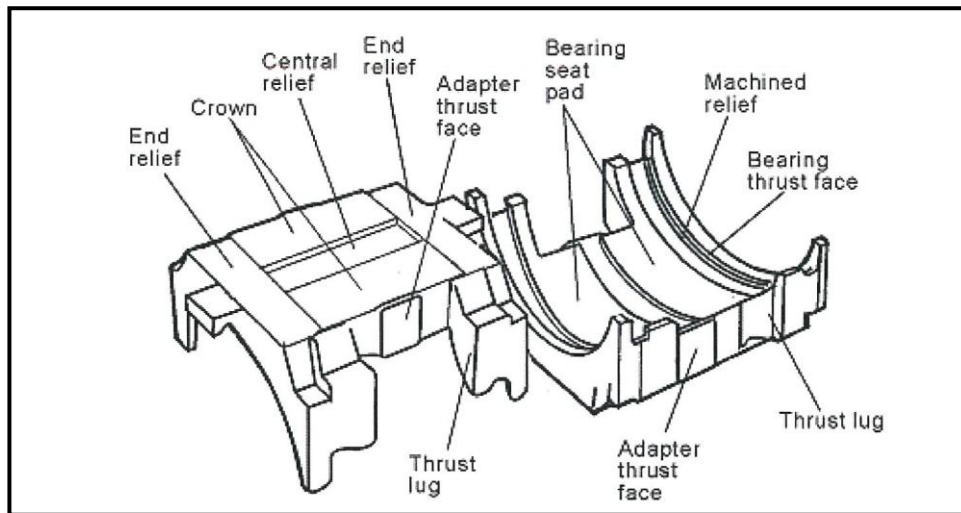
Figure 4
Nomenclature for narrow bearing adapter

- 3.4.4. Narrow bearing adapters as shown in Figure 4 were fitted to the Type 14 bogies associated with the UK class wagon fleet. The bearing adapters are machined components necessary for the correct fitting of a package bearing to a bogie and the distribution of the load. The adaptors can be inspected for wear in service but must be inspected whenever a wheel-set is removed from a bogie, and during each B-check and scheduled C-check.

- 3.4.5. A bearing that has been operating satisfactorily in a narrow adaptor will "creep" in service, causing 2 wear bands to appear on the outer race of the bearings and the bearing seat pads. These 2 wear bands should have no visible depth, be consistent and extend completely around the bearing.

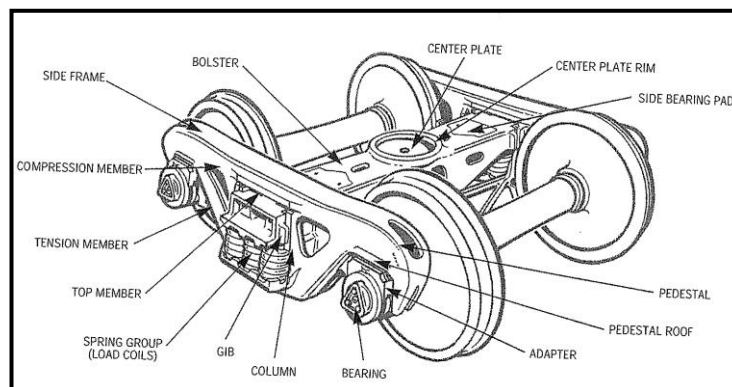
Figure 5
Bogie component nomenclature

3.5.2. The UK wagons were fitted with standard 3-piece bogies commonly used on freight wagons throughout the world. The 3 main pieces were one bolster and 2 side frames (see Figure 5).

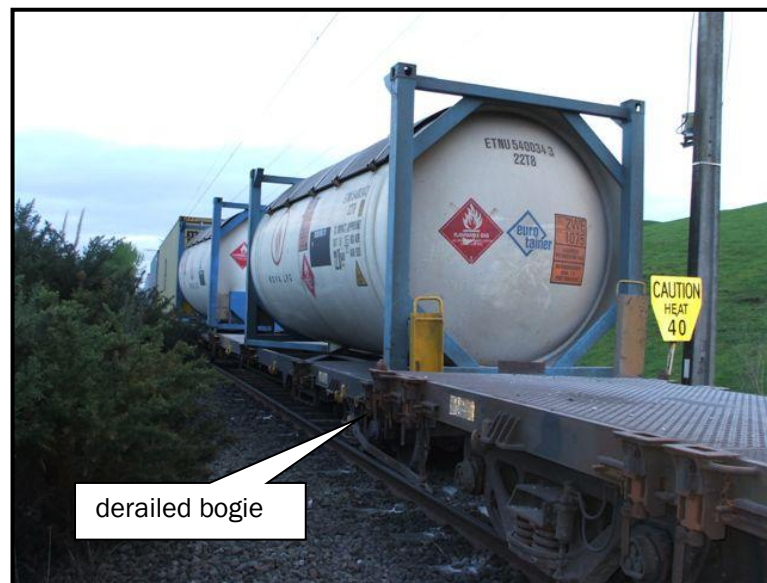
Figure 6
Wagon UK9007 with LPG tanks

- 3.5.3. Wagon UK9007, conveying 2 LPG tanks, was travelling with its handbrake trailing. The declared weight was 41.2 t (see Figure 6).
