**Report 08-202, coastal bulk carrier *Anatoki* and bulk carrier *Lodestar Forest*,  
collision, Tauranga Harbour roads, 28 April 2008**

**Report 08-202**

**coastal bulk carrier *Anatoki* and bulk carrier *Lodestar Forest*  
collision**

**28 April 2008**

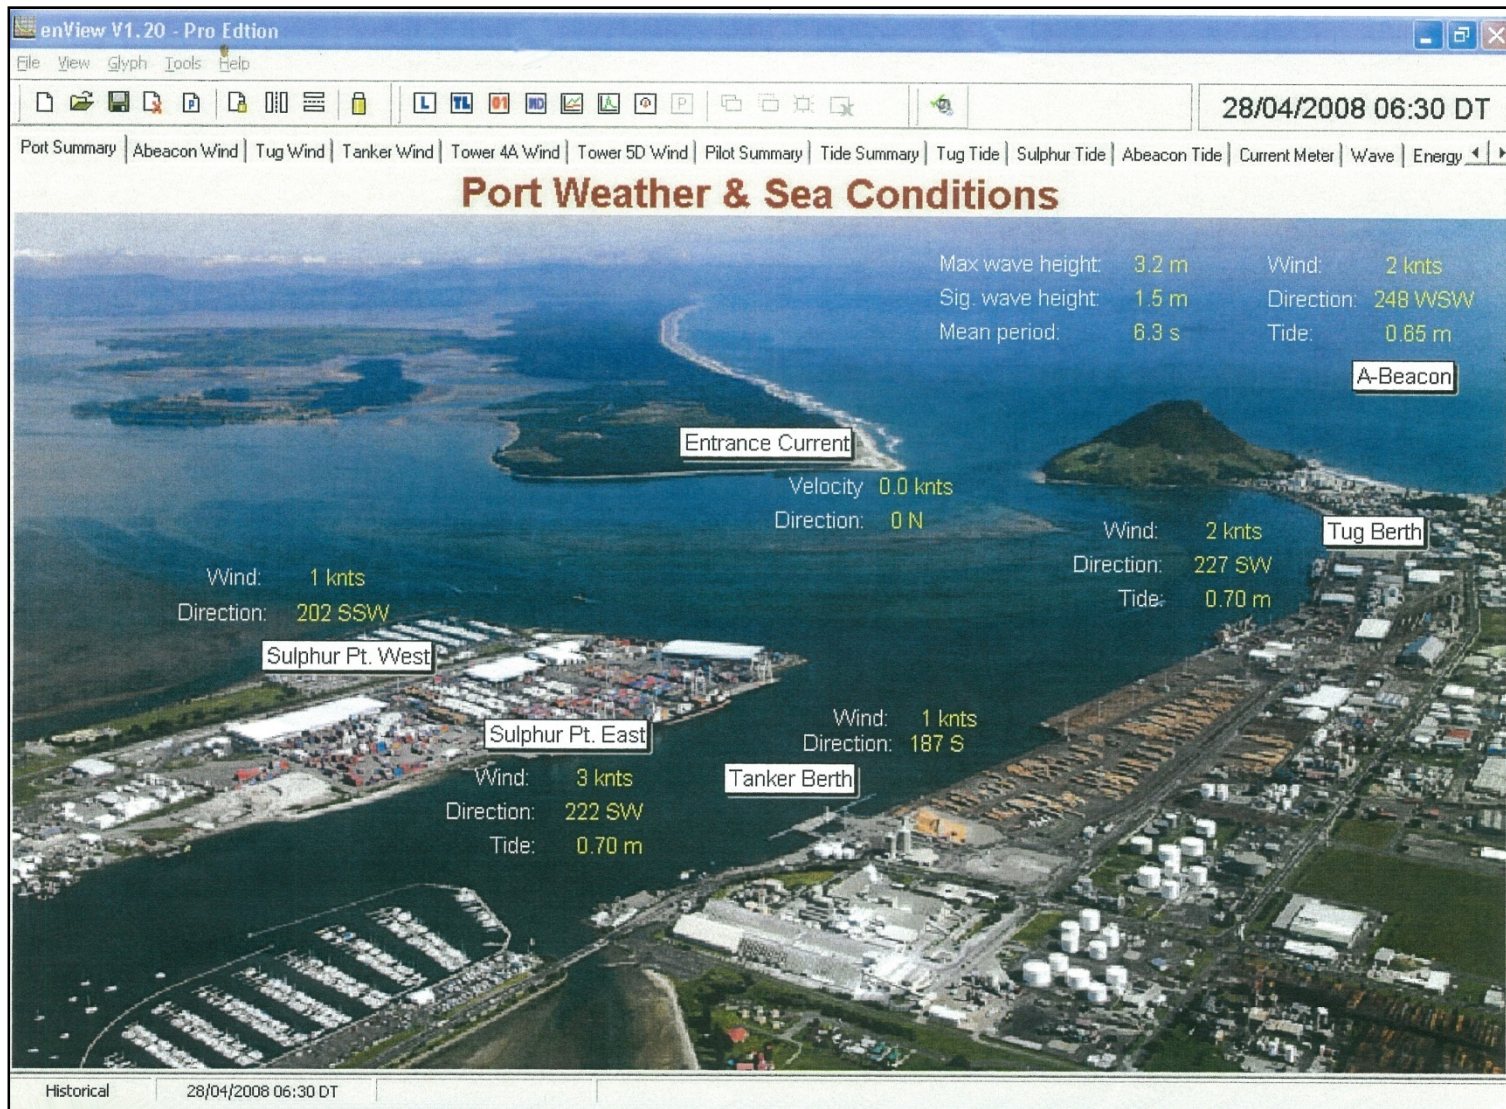
**Figure 4**  
**Pictorial summary of climatic and sea conditions in Tauranga Harbour at about the time of the collision**

- 1.5.6 Port of Tauranga Limited had numerous meteorological sensors around the port, which were used to produce a picture of the conditions within the port and out to “A” beacon (see Figure 4). The prevailing conditions at the time of the accident are shown, which for “A” beacon are light airs from a west-south-westerly direction, a significant wave height of 1.5 m and a tide of 0.65 m.
