**Report 08-203**

**Passenger Ferry  
*Monte Stello***

**Loss of Power**

**2 May 2008**

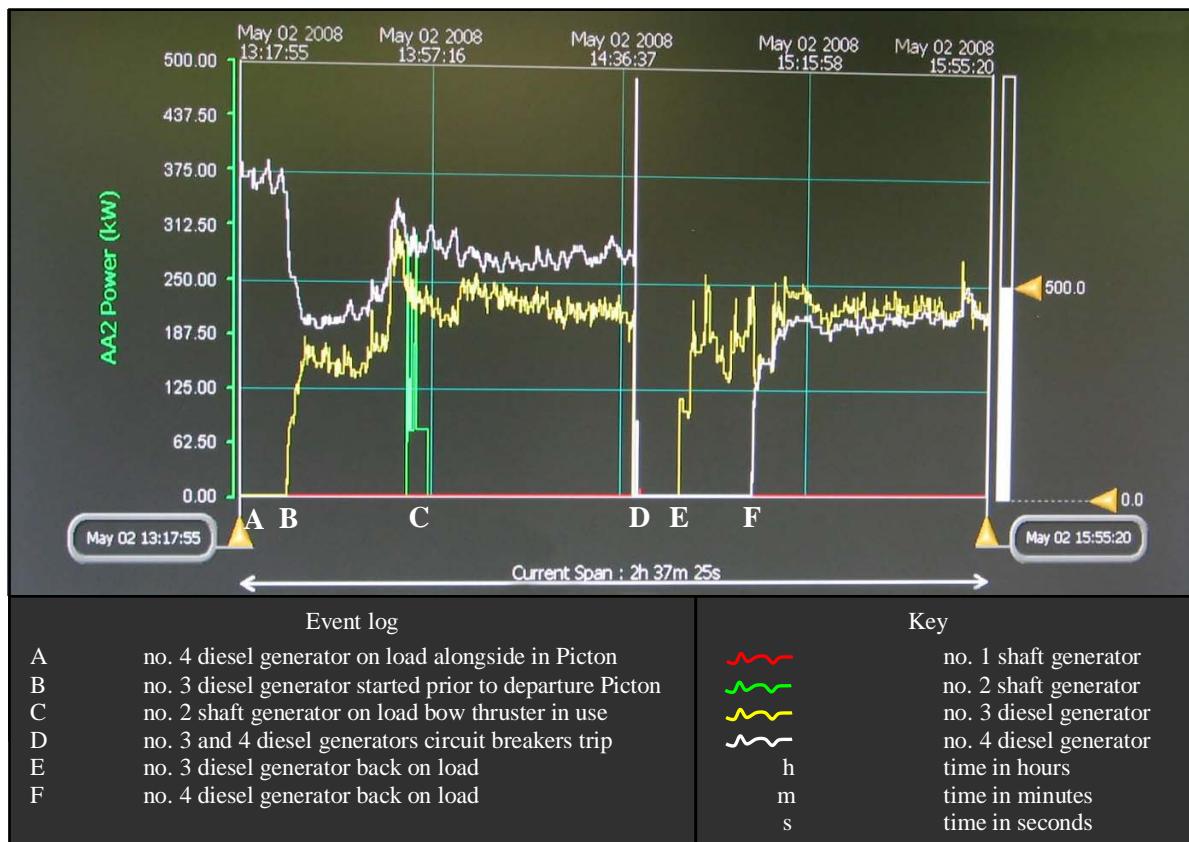
**Figure 12**  
**Load trend graph**

- 2.13 Figure 12 shows the load variations on diesel generators shortly before and after the loss of power. The graph covers a time span of 2 hours 37 minutes and key events are highlighted.

- 2.14 Figure 13 shows the order in which number 3 and number 4 generator circuit breakers opened (“D” in Figure 12) over a smaller time span of 1 minute 32 seconds.

- 2.15 Figure 13 shows that prior to the power interruption number 3 and number 4 diesel generators were supplying a combined load of about 488 kW. At 14:39:28, number 3 diesel generator instantaneously shed its load. At the same time the load shed by number 3 generator was taken up by number 4 diesel generator. The resultant total load on number 4 generator was less than its design rating, meaning that it should not have been overloaded.

- 2.16 After several seconds the load on number 4 diesel generator stabilised for about 16 seconds before its circuit breaker opened also. There was then no power supply to either number 1 or 2 bus-bars, after which the main engines protection devices operated shutting the main engines down.
