**Report 08-205: fishing vessel, San Cuvier, dragged anchor and grounded,  
Tarakeha Point, Bay of Plenty, 27 July 2008**

**Report 08-205**

**fishing vessel  
*San Cuvier***

**dragged anchor and grounded**

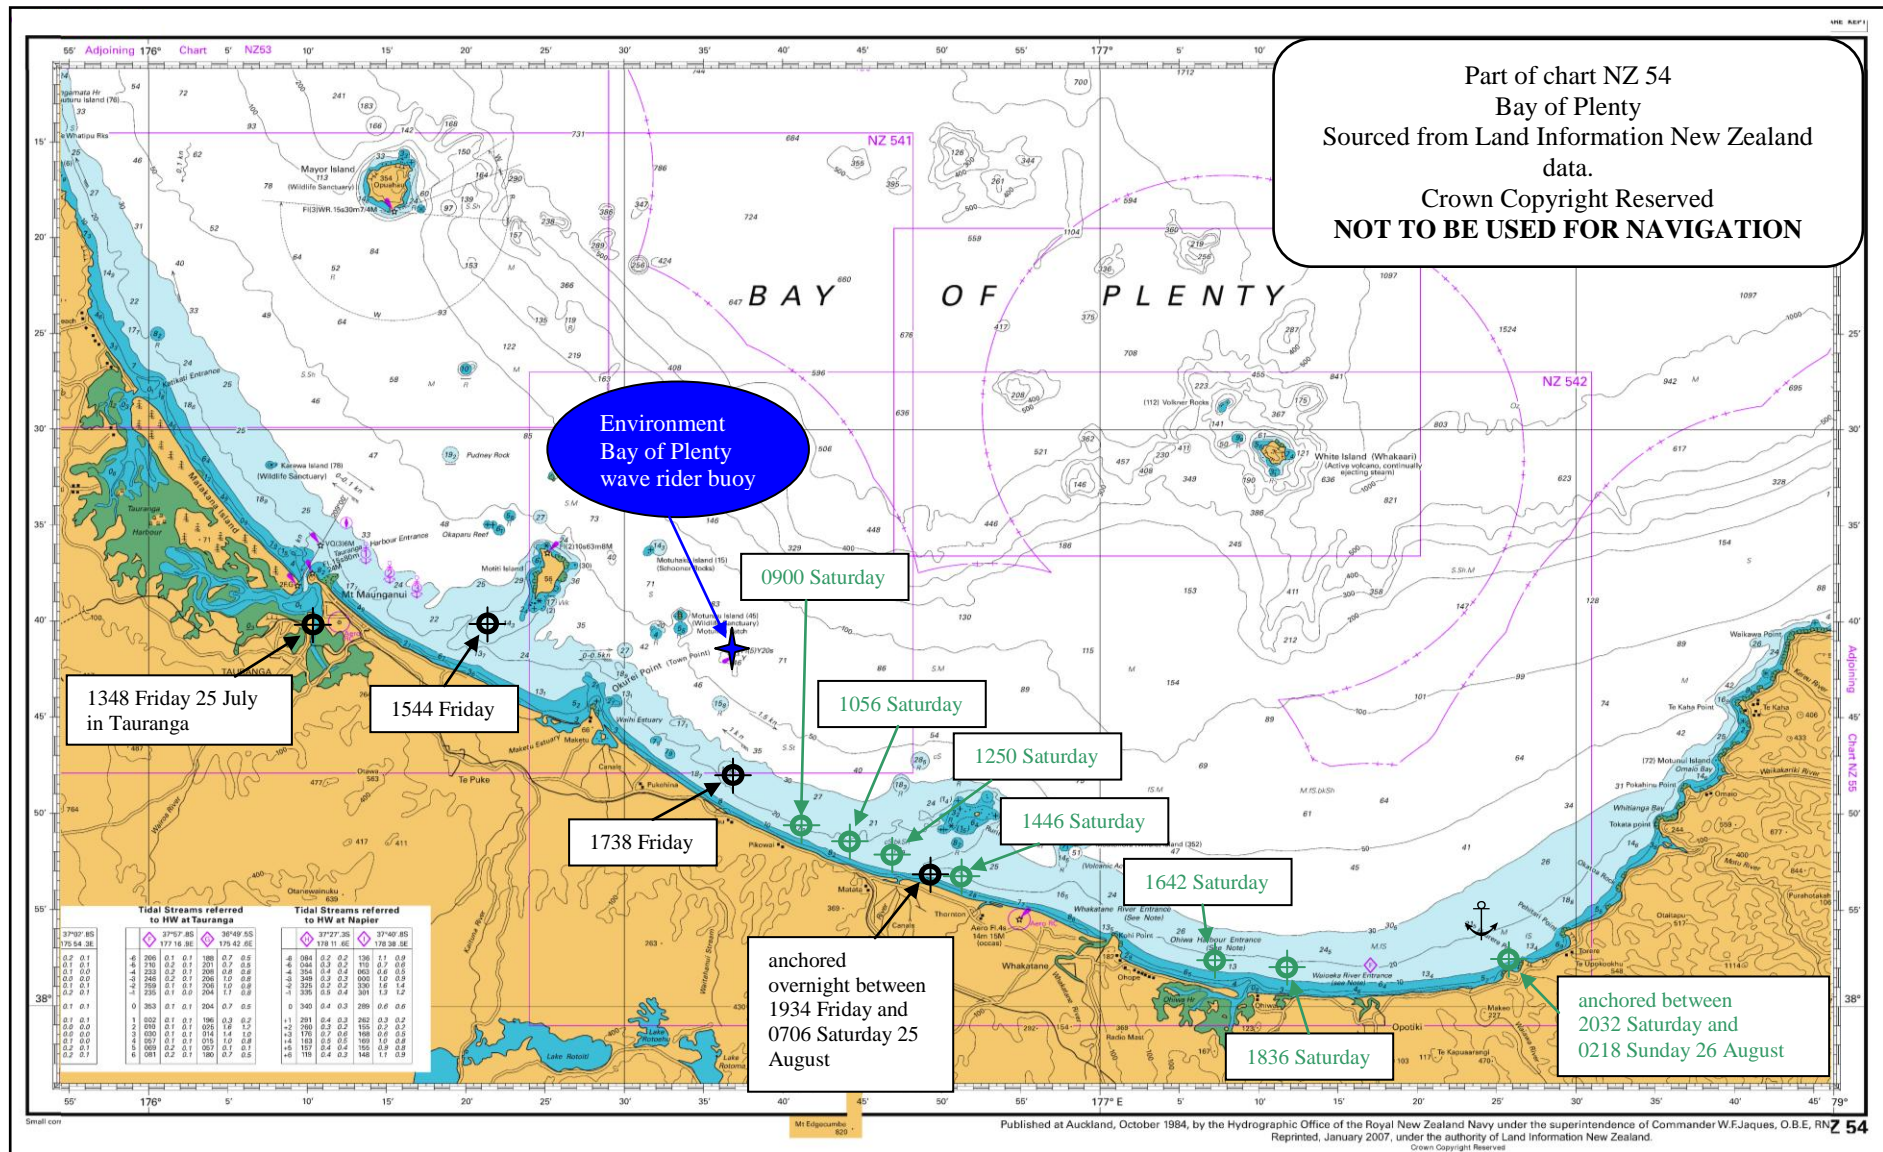
Figure 2  
 Route of the *San Cuvier* (positions and times from the Sanford tracking system)

- 1.1.2 At about 1800, that evening the crew started to set the bottom longline. Figure 2 shows the general area and vessel positions extracted from Sanford vessel tracking data. By about 1936 they had finished setting the longline and the vessel had been anchored to allow the crew to rest.

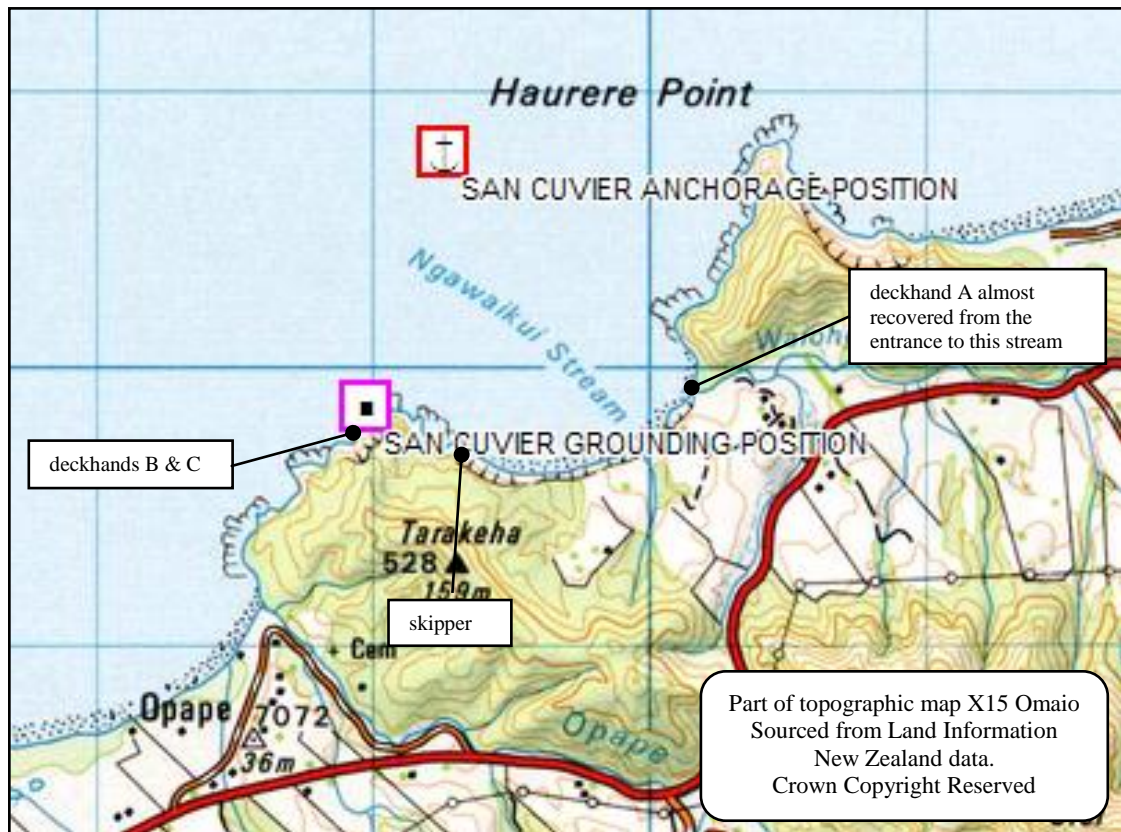
**Figure 3**  
**Topographic map showing positions of vessel and people**

- 1.1.4 At about 1800, just to the north of Opotiki, the crew started to set the longline. The crew completed setting the line and by about 2100 the vessel was anchored in position 37° 57'.564 S 177° 25'.764 E, as recorded by the vessel tracking system of the operator. This position was a little over half a nautical mile (nm) off the shore in what is locally known as Awaawakino or Morrison's Bay (see Figure 3).

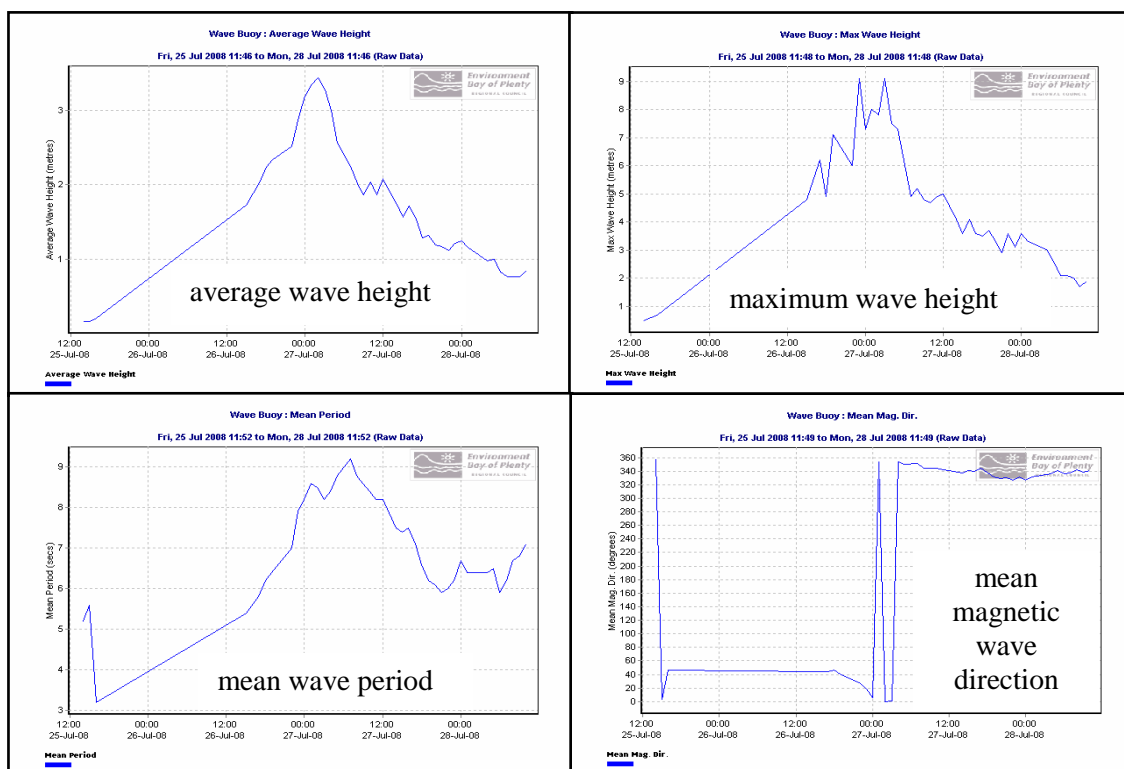
**Figure 4**  
**Environment Bay of Plenty wave rider buoy data**

- 1.4.3 The above information used the raw data from the Environment Bay of Plenty wave buoy (see Figure 4) that was located about 13 kilometres off Pukehina Beach, about halfway between Tauranga and Whakatane, which was about 42 nm from the accident location (see Figure 2). Of note, the average wave height rose steadily from 1800 on 26 July to peak at 3.43 m at 0200 on 27 July 2008. The maximum wave height rose more erratically and peaked at 9.1 m at 2300 and again at 0300, but only fell to just under 8 m between the 2 peaks. The mean wave period increased from about 6 seconds at 1800 to just over 8 seconds at midnight and did not reach its peak of 9.2 seconds until 0700 on 27 July. The direction of the waves was predominantly from the northeast, but at about midnight they turned through north to north-northwest.

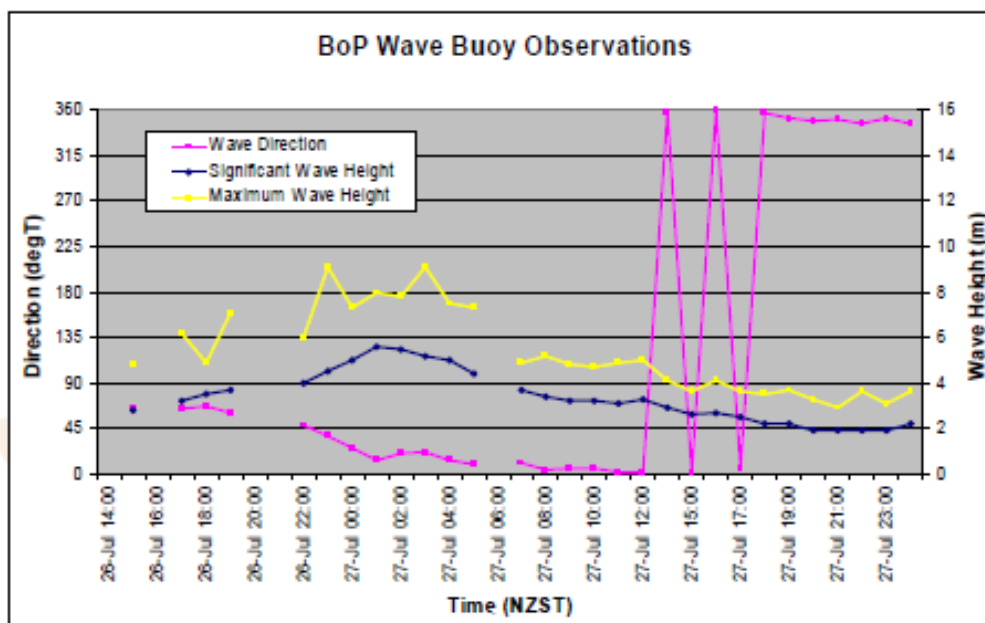
The wave buoy is located about 13 kilometres off Pukehina Beach about half way between Tauranga and Whakatane. Data transmission problems have resulted in some missing data but sufficient data was captured to allow a commentary to be made of the wave behaviour at the wave buoy. The wave buoy data is plotted in Figure 1, and listed in a table in the Appendix (Table 1).

Figure 1: Graph of significant wave direction (the direction that waves are moving from), significant wave height and maximum wave height as measured by the Environment Bay of Plenty wave buoy between 2 p.m. 26 July and midnight 27/28 July 2008.

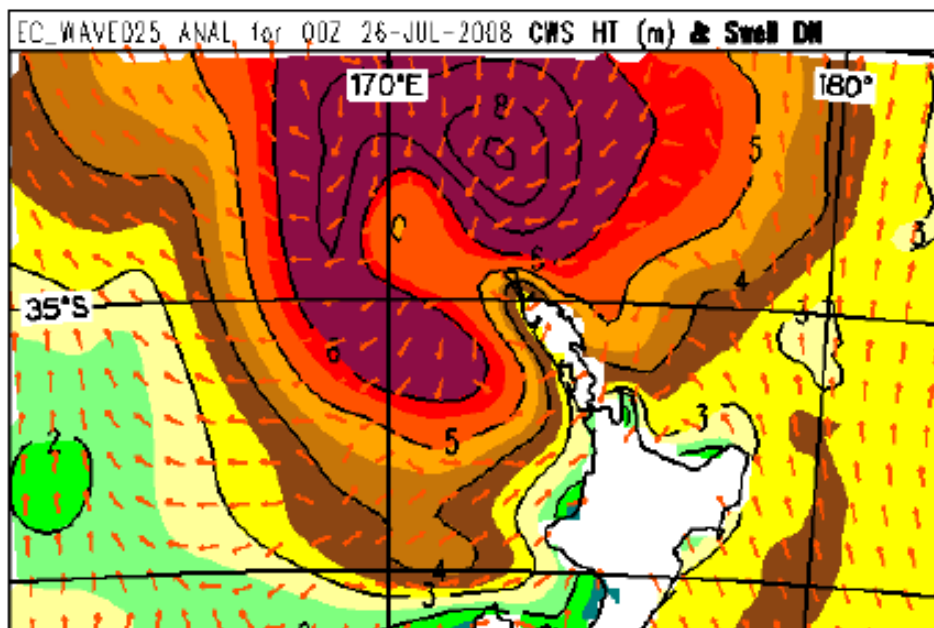
Figure 2: Combined wind wave and swell (CWS) computed analysis for midday 26 July 2008 (0000 UTC 26 July). Significant wave height is contoured in metres and the direction is indicated by the orange arrows.

The computed wave analysis at midday (Figure 2) is consistent with an extrapolation back to midday from the available wave buoy observations.

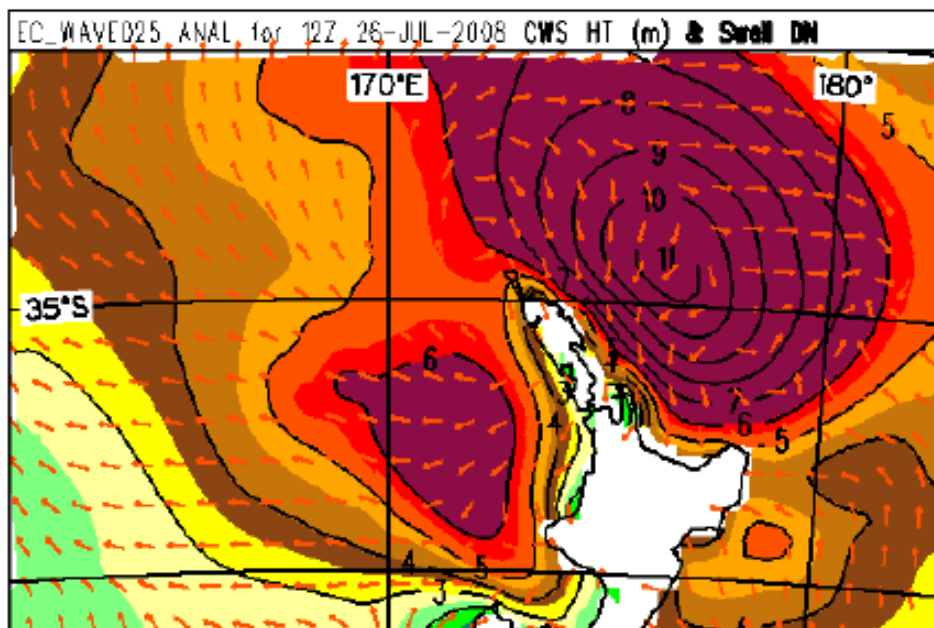
Figure 3: Combined wind wave and swell (CWS) computed analysis for midnight 26/27 July 2008 (1200 UTC 26 July).

The computed wave analysis at the end of this period indicates the significant change in wave characteristics resulting from the movement of the depression along the east Northland coast, and the consequent change in wind distribution and wave generation areas.

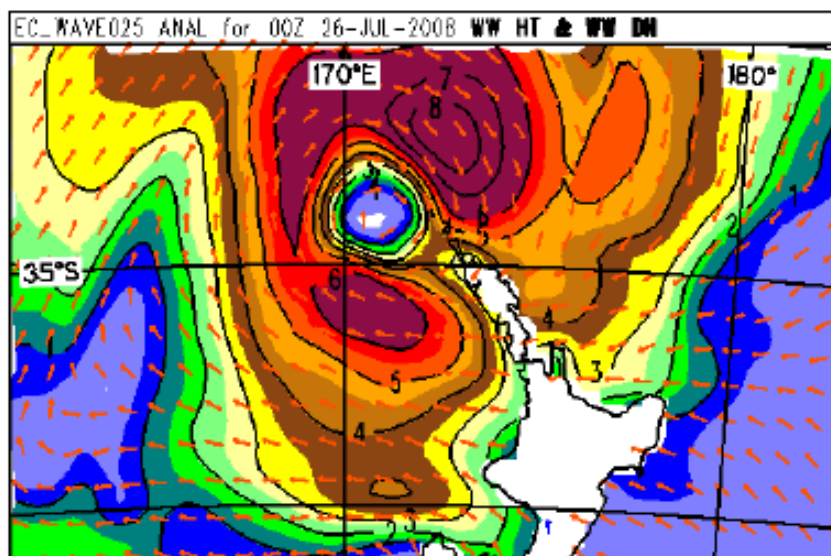
Figure 4 shows a large area of high wind generated waves north of Northland at midday on 26 July when the depression was centred to the northwest of Cape Reinga. During the following 12 hours those waves propagated southeastwards into the Bay of Plenty (ocean area). A large portion of these waves were absorbed by the coasts of Northland, Hauraki Gulf, Coromandel and Bay of Plenty (region). The extent of the remainder is illustrated in Figure 5 as a northerly swell were it affects the coast between Whakatane and Te Kaha.

Figure 4: Wind wave (WW) computed analysis for midday 26 July 2008 (0000 UTC 26 July).

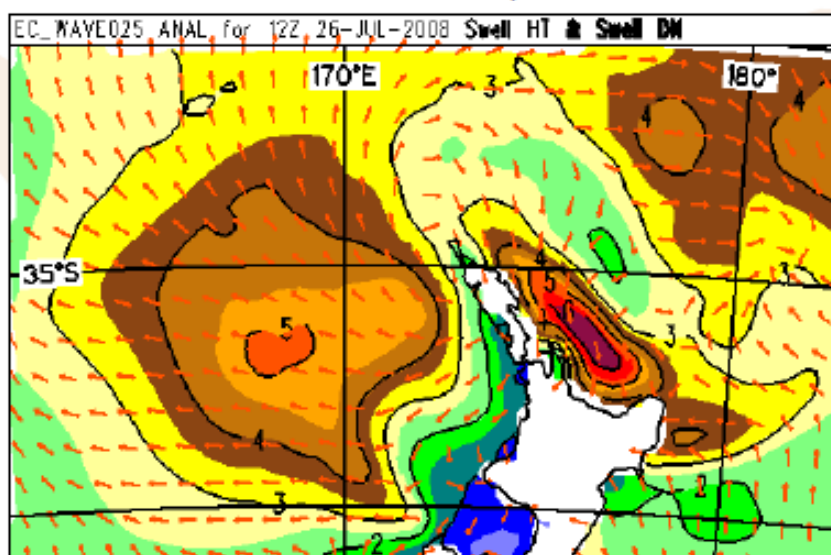
Figure 5: Swell wave (Swell) computed analysis for midnight 26/27 July 2008 (1200 UTC 26 July).

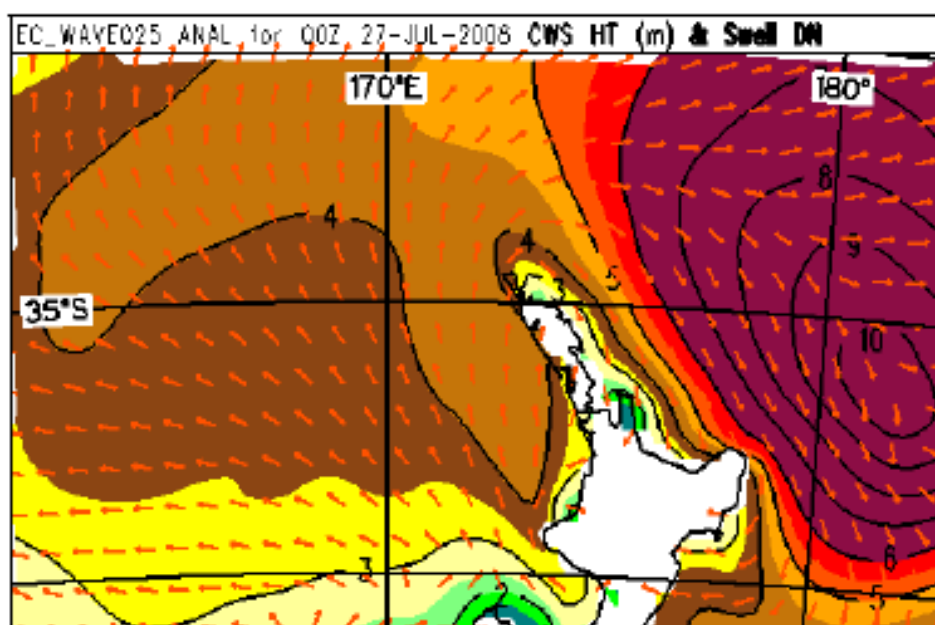
Figure 6: Combined wind wave and swell (CWS) computed analysis for midday 27 July 2008 (0000 UTC 27 July).

The computed wave analysis at midday, 6 hours after the end of this period indicates lowering combined significant wave heights in the near-coast Bay of Plenty except in the outer and eastern parts. The wave direction is indicated as north to northwest.
