Transport Accident  
Investigation  
Commission

# **Final report**

***Maritime inquiry MO-2022-201***  
***Charter fishing vessel Enchanter***  
***Capsize***  
***North Cape, New Zealand***  
***20 March 2022***

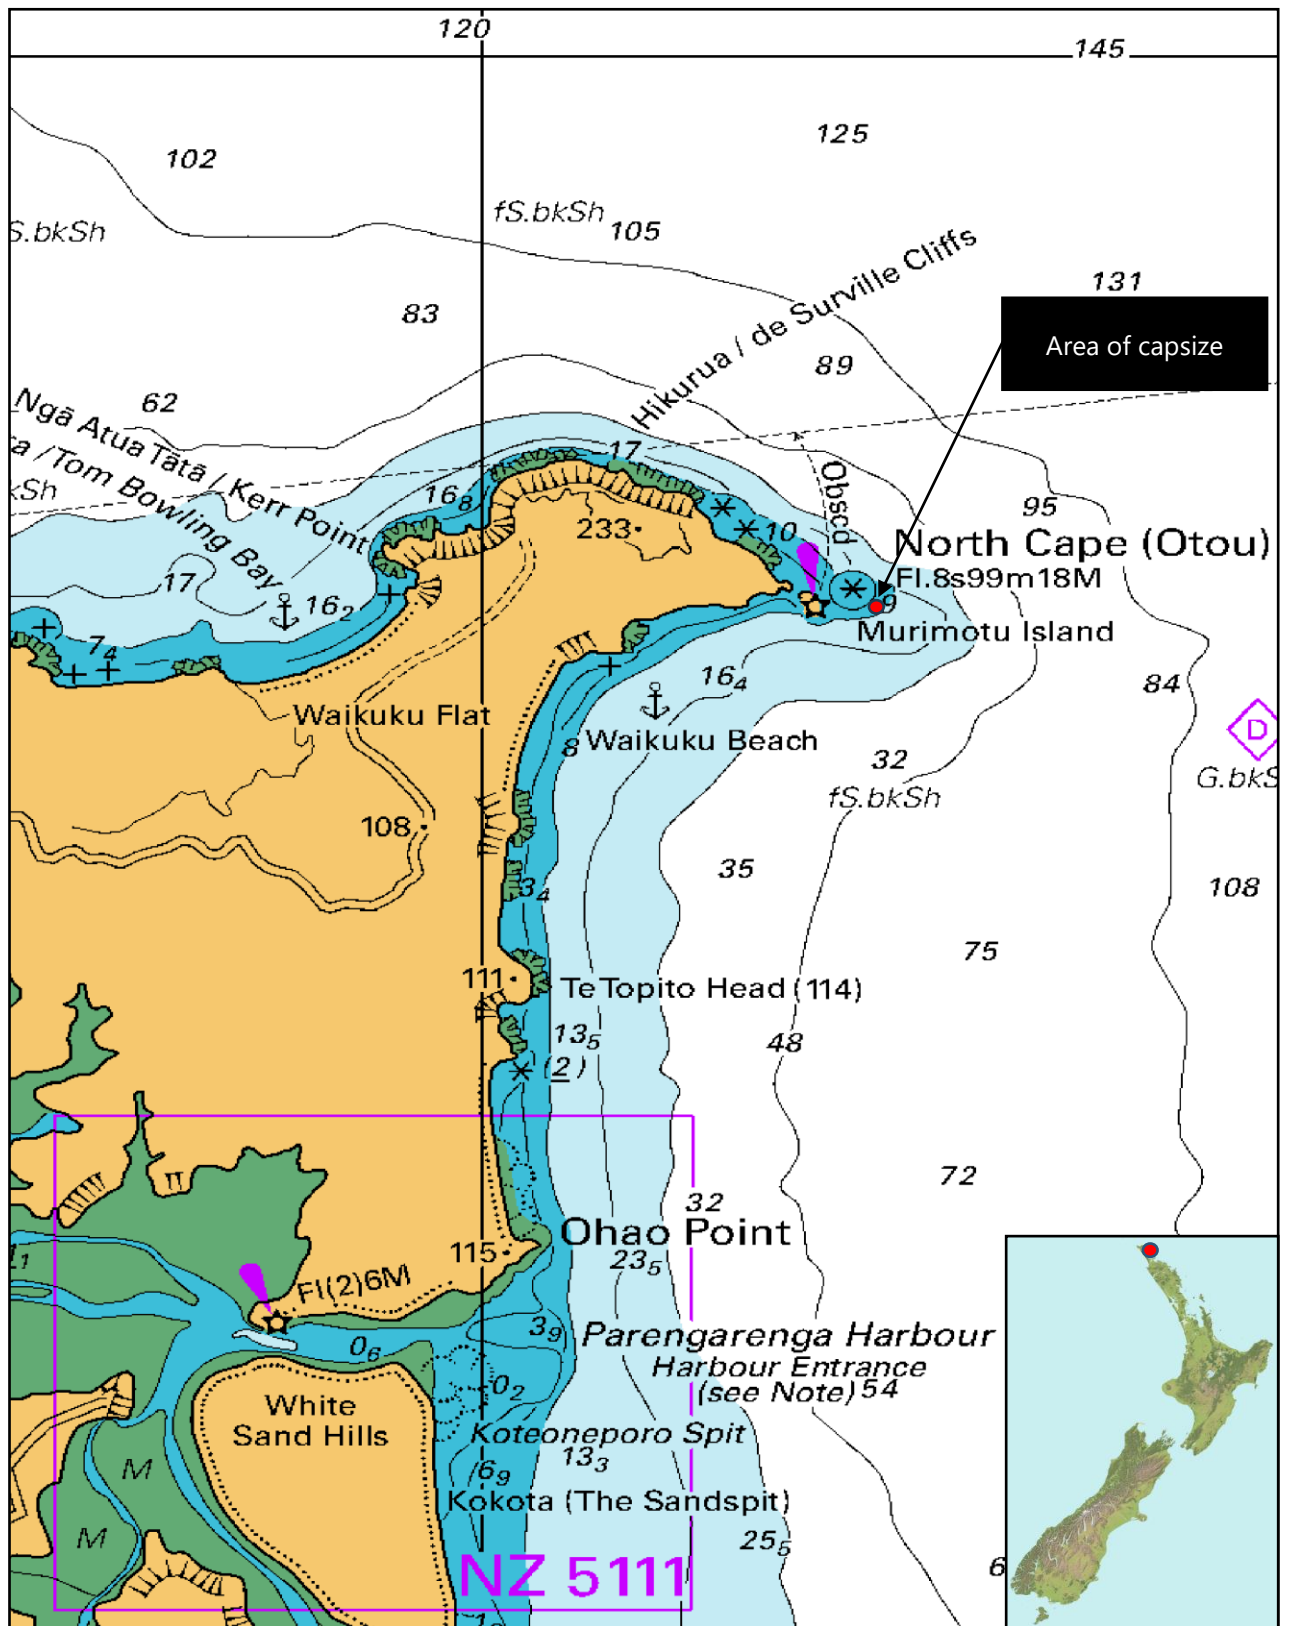
**Figure 2: Area of capsizes as calculated by the Commission**

- 3.26 When considering all the factors that could affect the drift of the flybridge, the Commission concluded it was **about as likely as not** that its rate and direction of drift after the EPIRB had been activated was similar to the 30 minutes prior to the EPIRB being activated (noting the EPIRB was attached to the flybridge). Therefore, it is **about as likely as not** that the location of the capsized vessel would have been within an area about 0.07 nautical miles (about 130 metres) south of the first encoded position, as shown in Figure 12.

- 3.27 Both the first GNSS position transmitted by the EPIRB and this calculated area of capsized vessel were within the 10 metre depth contour as shown in Figure 13.

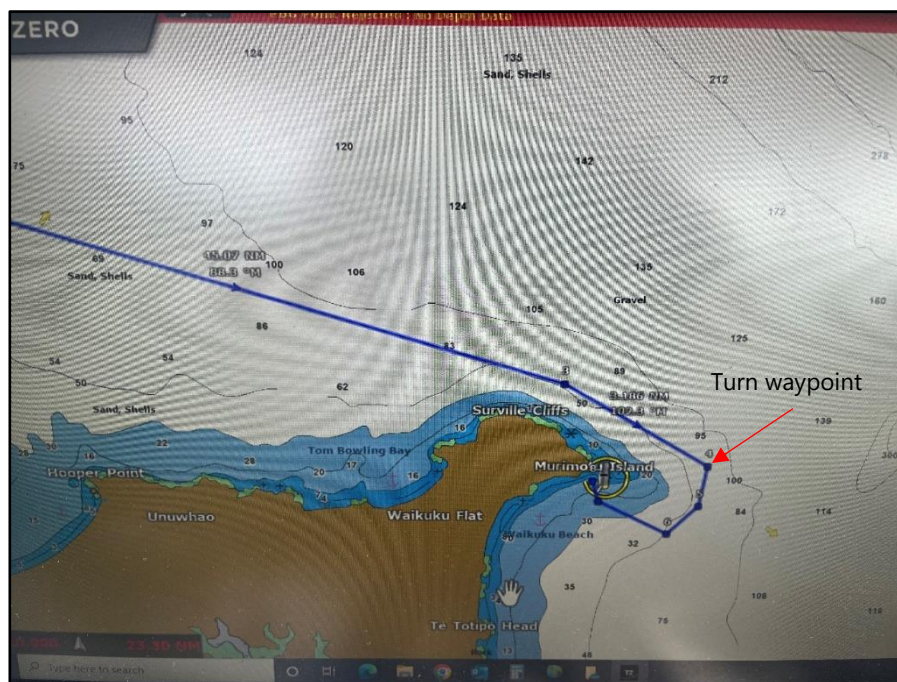
described one of these waypoints (the 'turn waypoint') as being about 1.4 nautical miles off Murimotu Island (about 0.8 nautical miles outside the 10 metre depth contour), where the skipper intended to begin taking the *Enchanter* south. (See Figure 11 for a screenshot representing the skipper's planned track, taken from another company-owned vessel.) The skipper said they were adjusting the autopilot to broadly follow this track. If the track was followed, they would have kept the vessel in about 50 metres water depth as the *Enchanter* closed with the coastline and reached the turn waypoint.<sup>24</sup> The skipper was aware that it was risky to pass too close to the coastline when sea conditions were adverse, particularly when the waves were from the northeast quarter.

**Figure 11: Screenshot from a chart plotter, representing the skipper's intended route around Murimotu Island (taken from another company-owned vessel)**

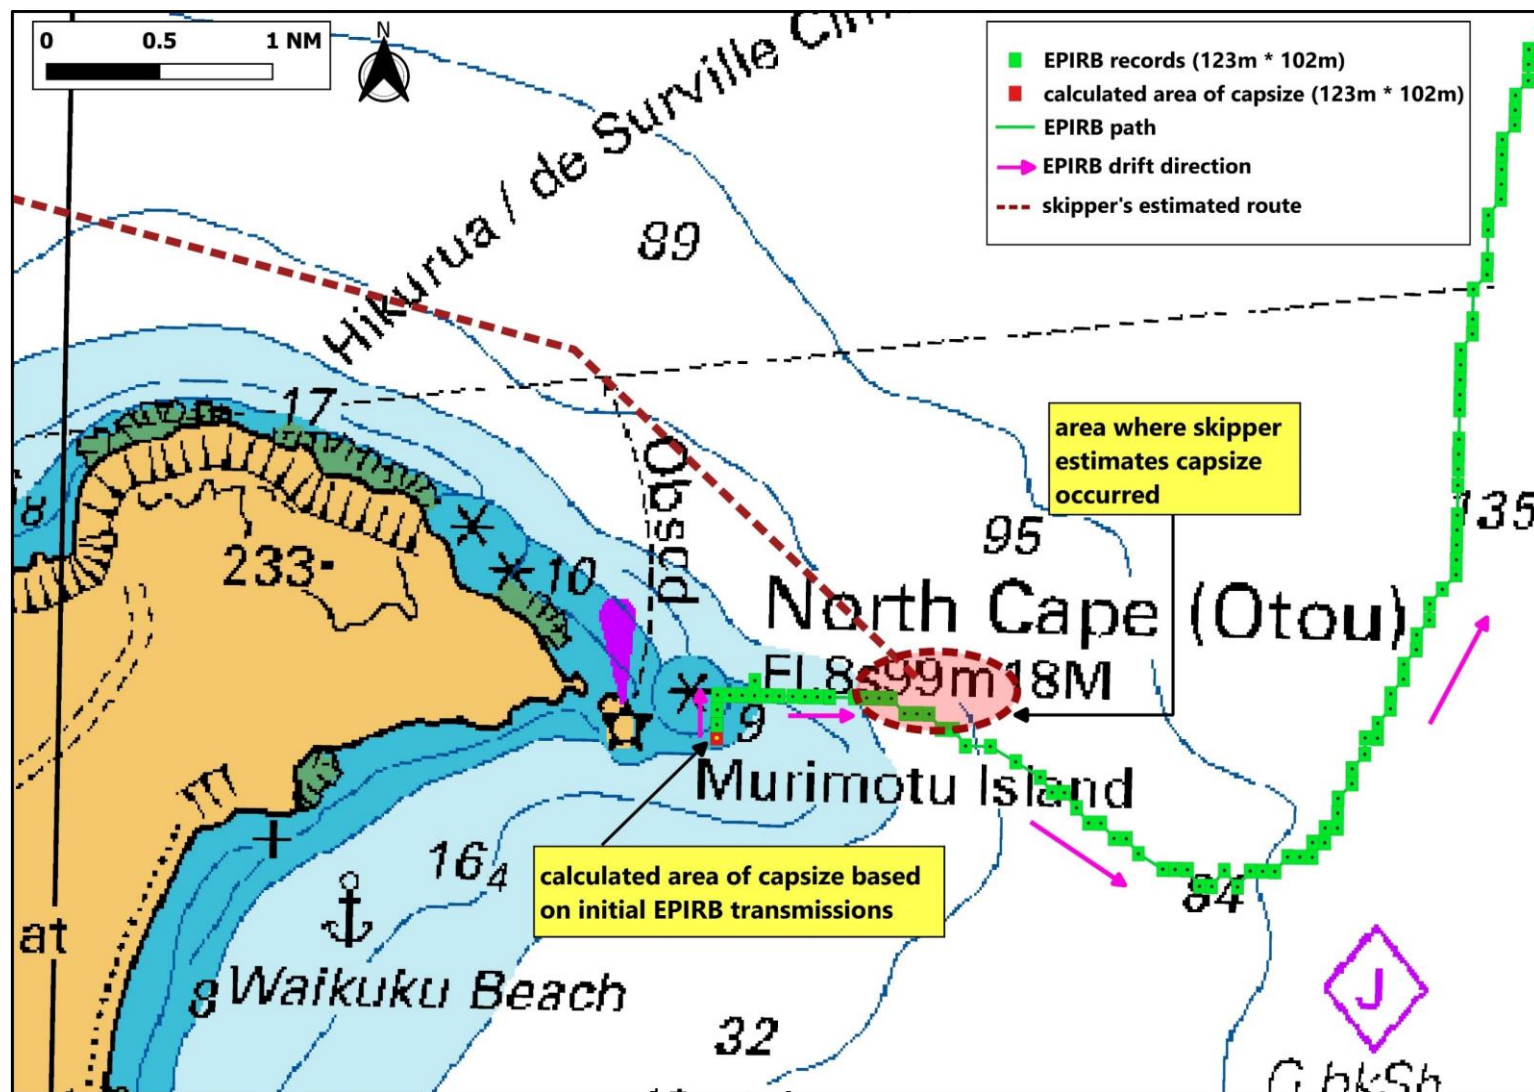
Figure 12: Part of Chart NZ51 showing the track of the EPIRB encoded GNSS positions (green rectangles, representing location area of certainty) and *Enchanter's* track as estimated by the skipper (red)

- 3.25 Using the encoded positions transmitted by the EPIRB, the initial drift of the flybridge was northward at about 0.14 knots. Taking into consideration the encoded positions area of certainty, as shown by the green rectangles in Figure 12, the EPIRB's rate of drift was between about 0.06 to 0.17 knots.

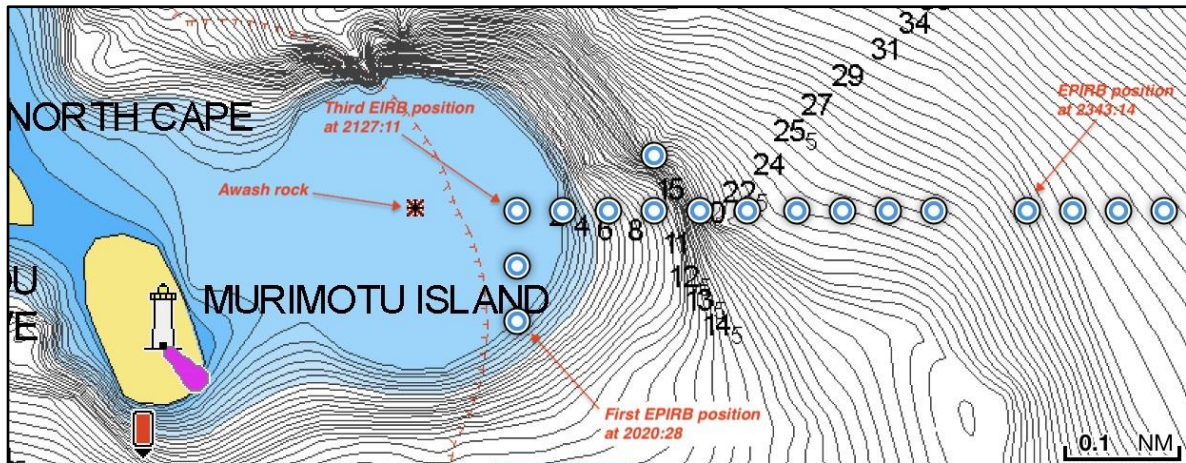
**Figure 13: Portion of Navionics chart for North Cape showing encoded GPS positions transmitted by the EPIRB marked by key times.**

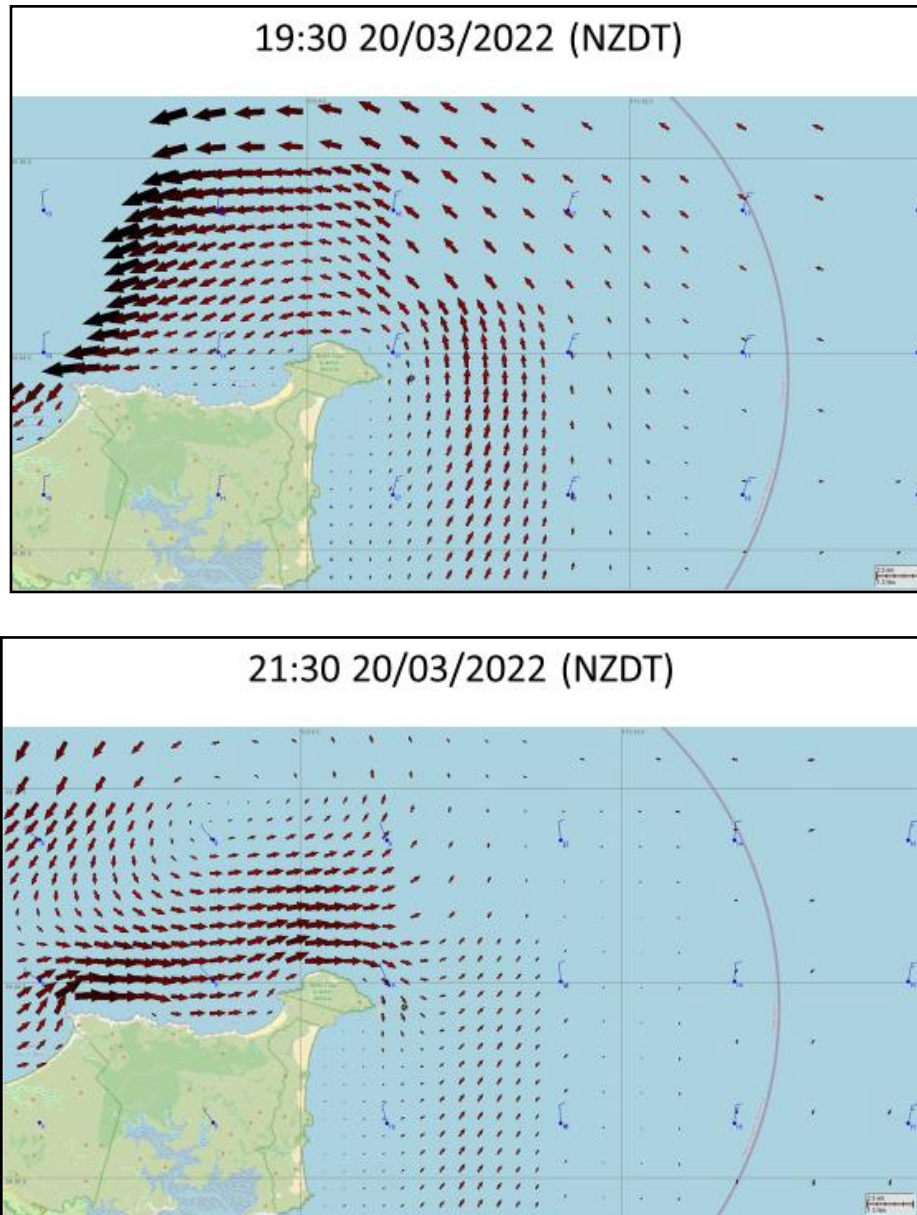
**Figure 14: Combined tide and current drift modelling for 20 minutes before the accident (top) and 100 minutes after (bottom), conducted by the RCC during the SAR operation**

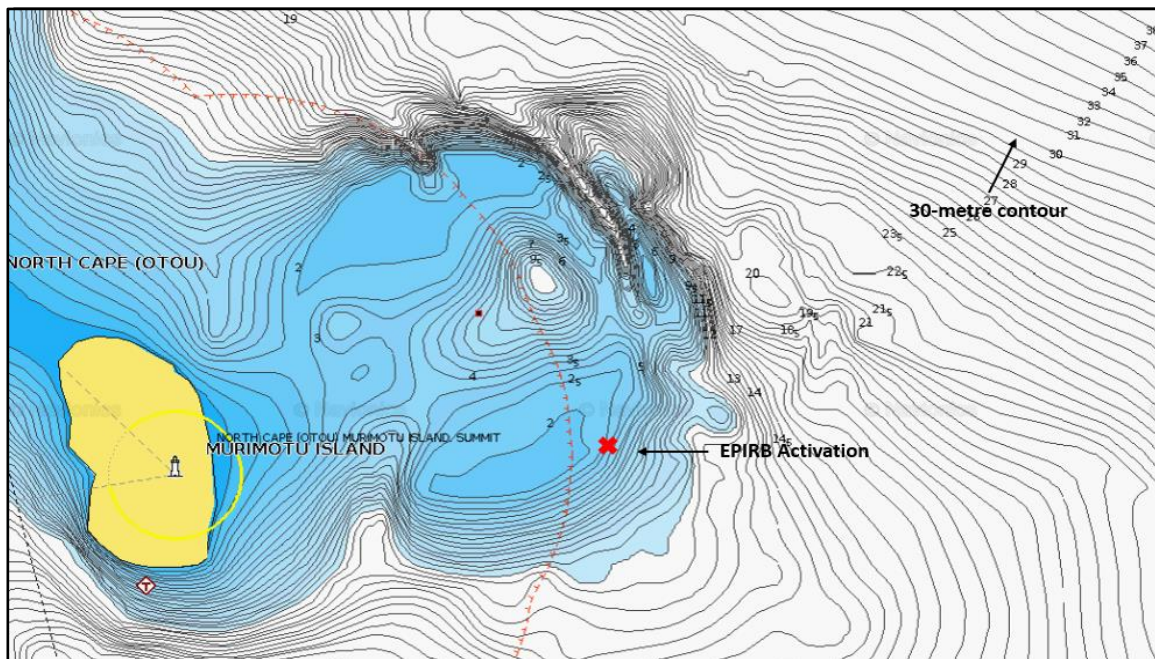
Figure 15: Marked up portion of Navionics chart for North Cape

- 3.43 The underwater topography off Murimotu Island matches the wave performance observed by the passenger. From seaward, the seabed off Murimotu Island slopes steeply from 50 to 10 metres water depth over 0.7 nautical miles (1300 metres). The seabed slopes very steeply from 30 to 2 metres water depth (see Figure 15). To the observer on the *Enchanter's* aft deck a larger wave would have begun visibly peaking in the distance, with a sharp rise when the wave met with the 10-metre contour.

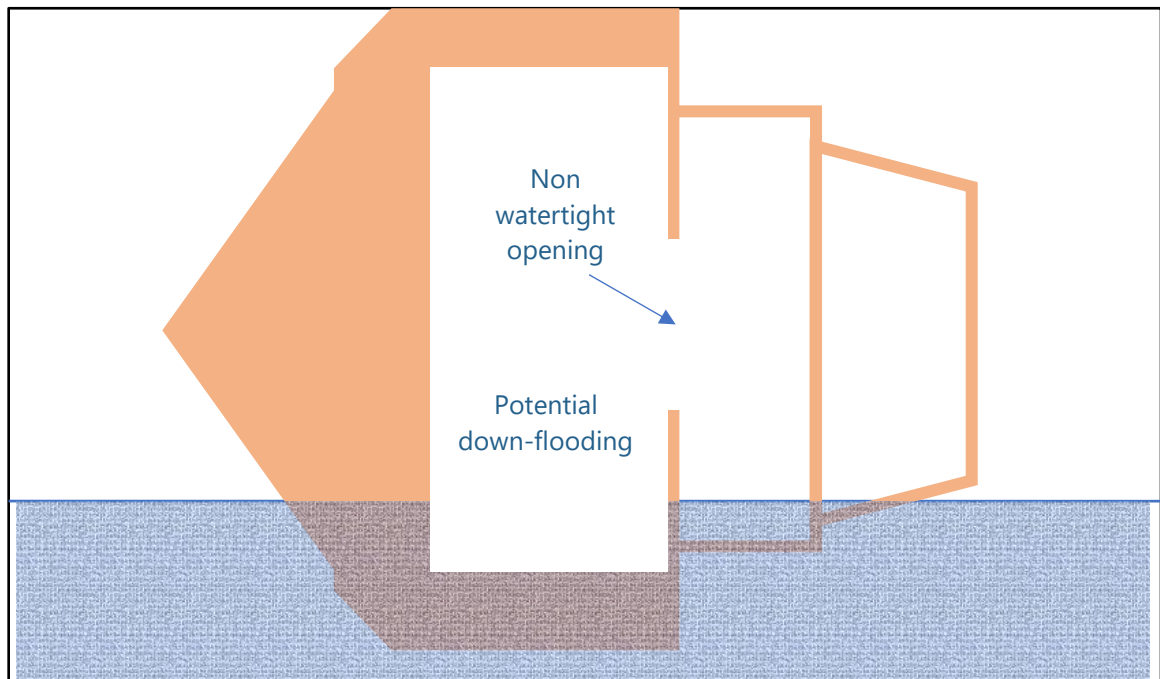
- 3.51 The naval architect conducting the stability analysis explained that the basis for considering the hull as watertight was that these openings would remain above the waterline when the vessel was heeled to its maximum angle before losing positive stability. The three main openings through which down-flooding could occur were all located around the centreline of the vessel and were calculated to be well above the waterline if the vessel were floating on its side (see Figure 17).

**Figure 17: Representation of a vessel floating on its side with openings near the centreline (not to scale)**

superstructure would have provided buoyancy and thus contributed to the dynamic stability of the vessel (see Figure 17). It is not possible to say definitively whether it would still have eventually capsized. That would depend on whether the vessel righted itself with successive waves and what openings there were in the superstructure to allow seawater to invade the saloon space – for example, open windows and the main rear door.

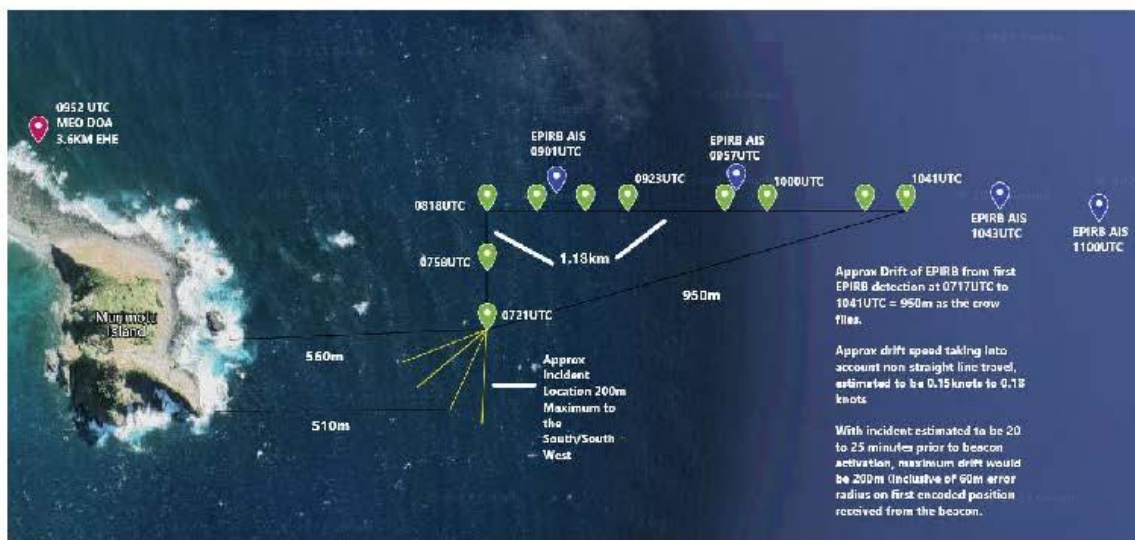
**Image 1**

- The above image shows a plot of encoded positions and AIS transmission from the EPIRB for the first 3.5 hours. The first plot at 0721 UTC provides a position approx. 560 metres off shore (with a 60 metre error radius to be applied around the position).
- Noting a very straight line drift of the encoded position, this is due to the limitations of COSPAS-SARSAT data processing, and limiting the encoded position to 2 decimal places on the SIT 185 sent to RCCNZ, which rounds the positions up or down.

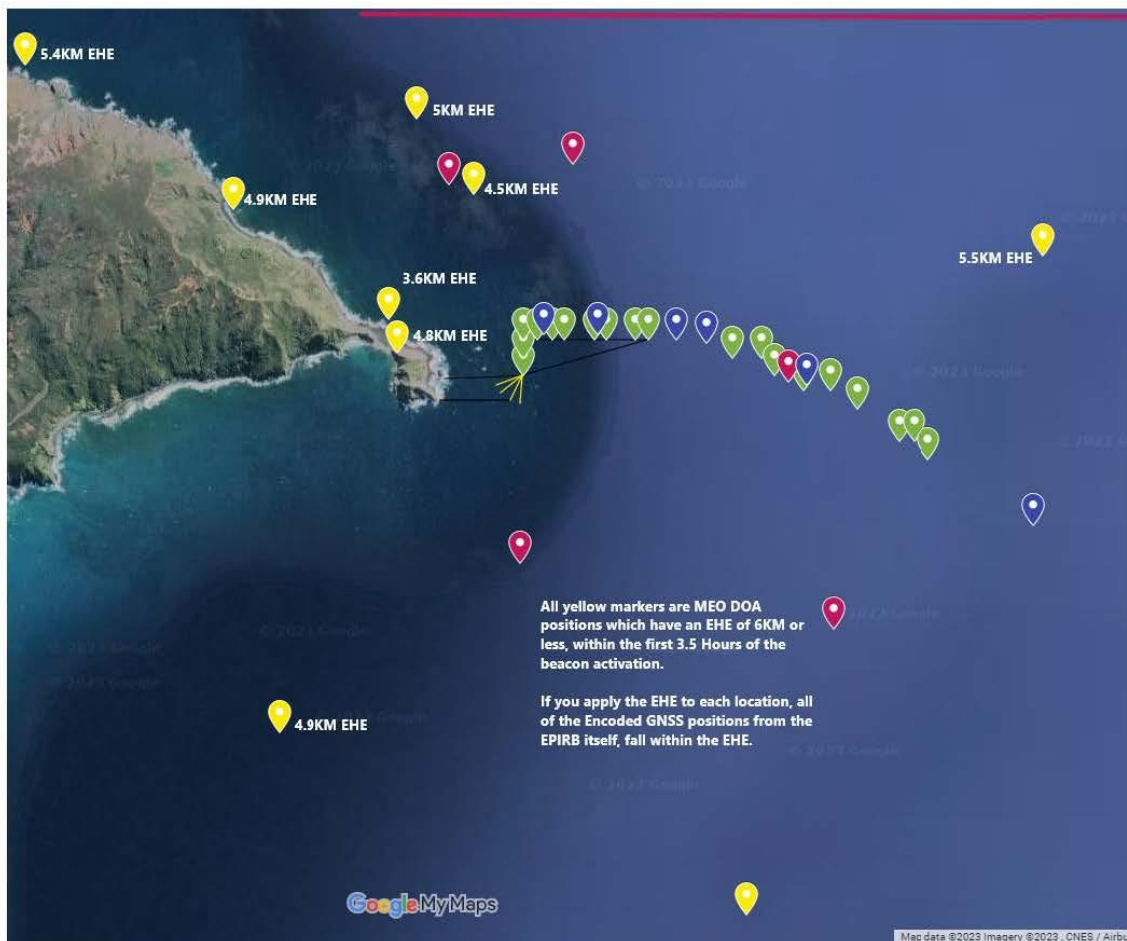
**Image 2**

- To provide context, the yellow markers indicate MEOSAR DOA positions (independent of the EPIRBs GNSS position) which have an EHE of less than 6 kilometres. These position were all received within the first 3.5 hours of the beacon activation, and when you apply their relevant EHE, the GNSS position with the same timestamp is encompassed with the radius of the EHE.
- The pink location markers on this image indicate positions which provided an EHE of more than 6km, which still encompasses their corresponding encoded positions provided by the beacon.

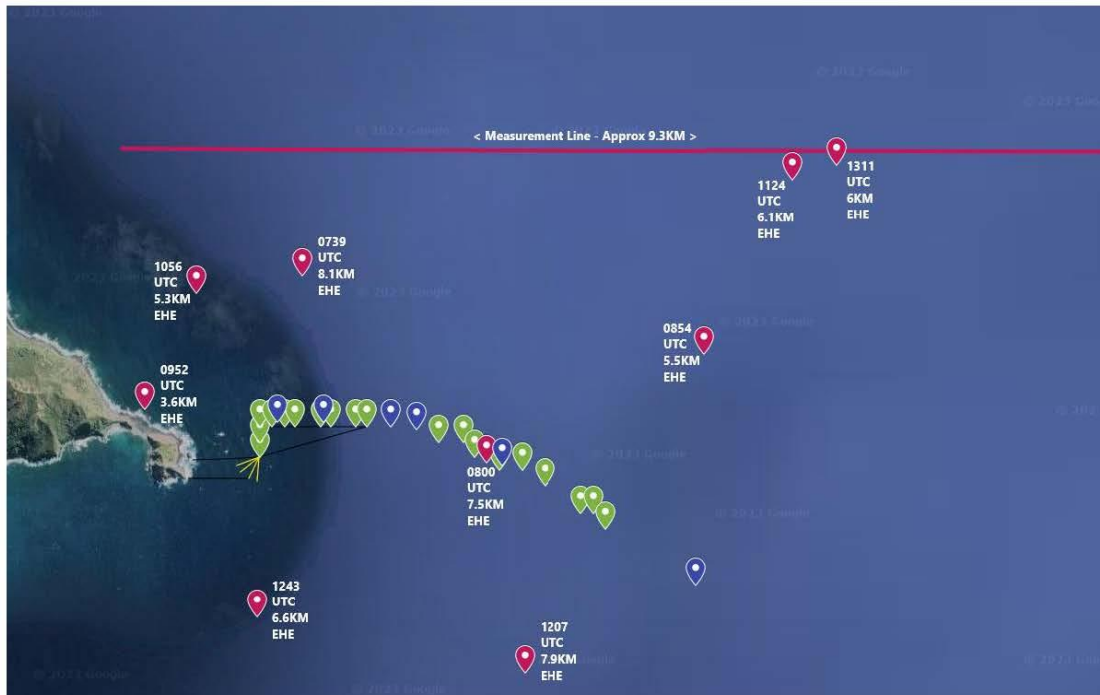
**Image 3**

- Image 3 provides further MEOSAR independent hits including positions with an EHE greater than 6 kilometres.
- The pink line at the top of the image measures approx. 9.3km, to give context to the EHE provided, which shows that the EPIRBs GNSS position is inside the radius of all MEO DOA positions.

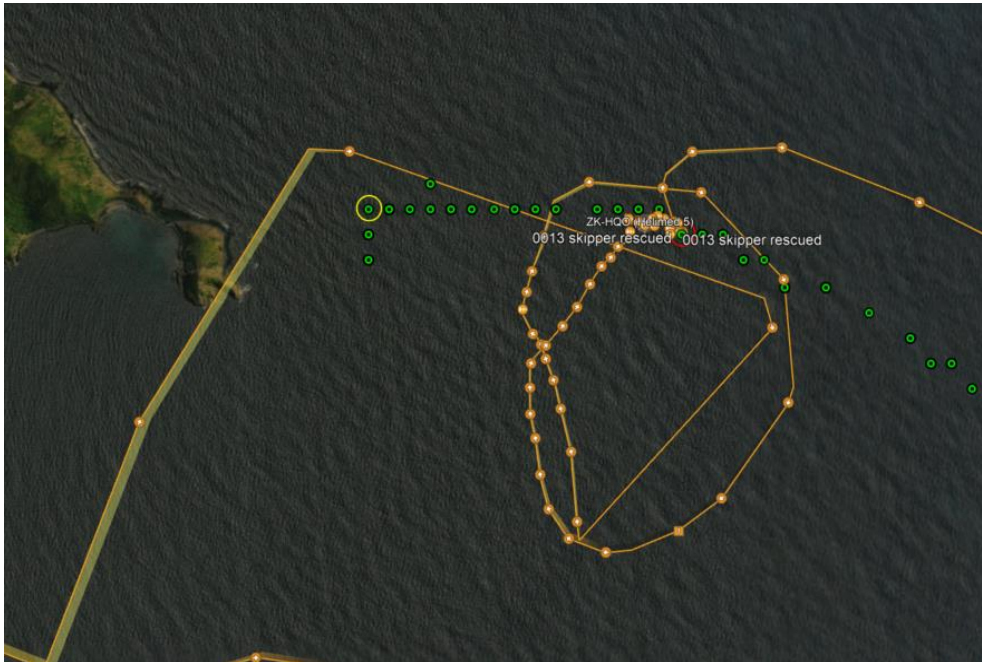
Flight data from the rescue helicopter confirms that the first rescue helicopter on scene retrieved the three survivors from the flybridge within 61 metres of the EPIRB's encoded position (see Figures 33 and 34).

**Figure 33: Flight data showing helicopter hovering over EPIRB encoded position (green dots)**

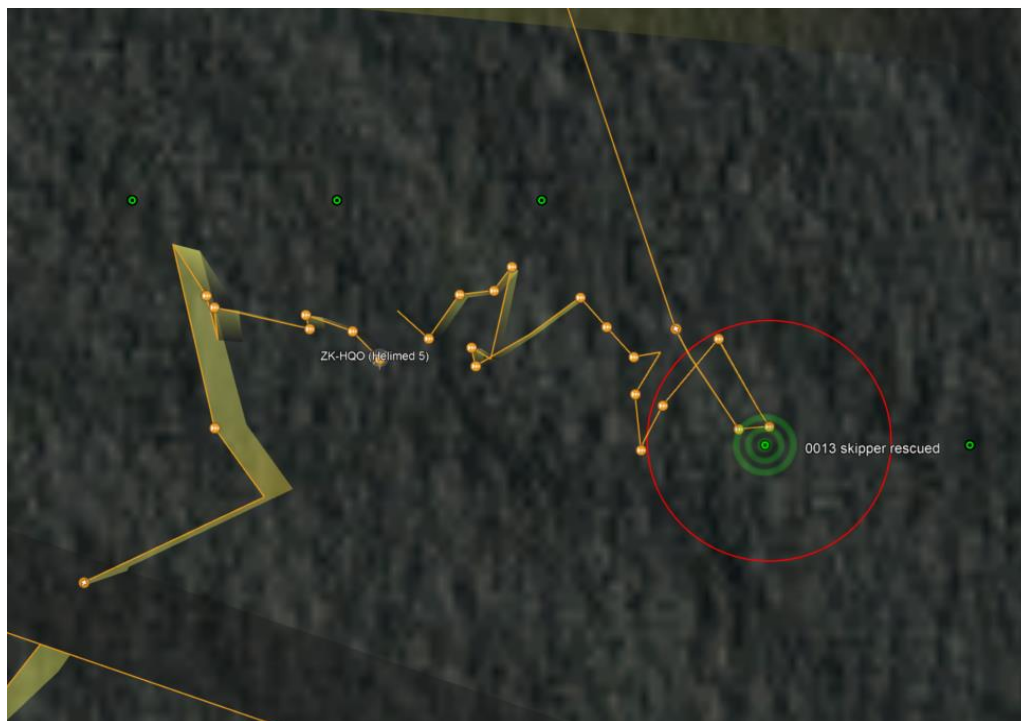
**Figure 34: Close up of helicopter flight path hovering over EPIRB encoded position (green dot).  
Red circle indicates the 61-metre accuracy around the EPIRB encoded position at 0013**
