Report 09-007: Piper PA32-260, ZK-CNS, impact with ground following a loss of control after take-off, near Claris, Great Barrier Island, 29 September 2009

Piper PA32-260

ZK-CNS

impact with the ground following a loss of control after take-off

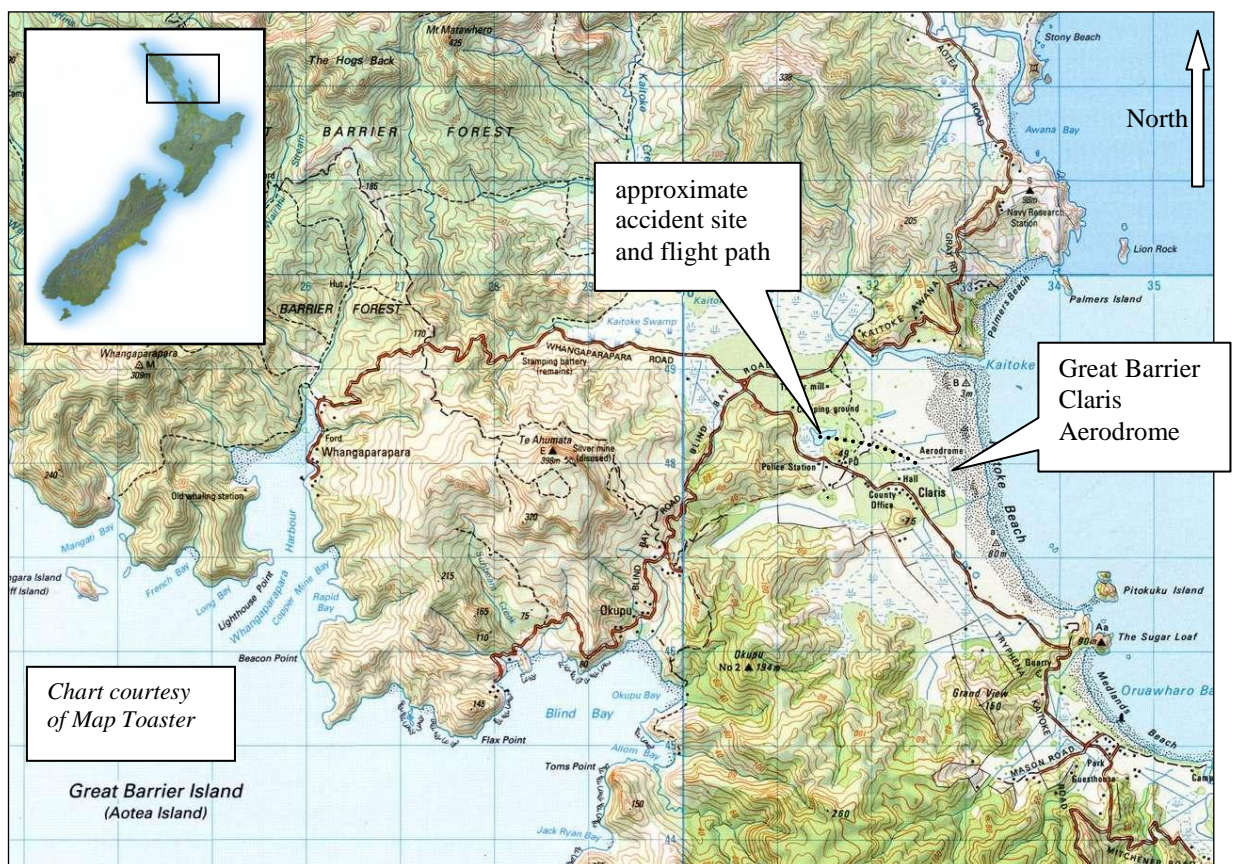
Figure 1
Great Barrier Island and Great Barrier Aerodrome
(MetaMedia Ltd 1997-2009)

- 1.1.13 The pilots then saw trees ahead at about their level, so the pilot started a shallow left turn towards a clear area over a swamp to avoid the trees, but the aeroplane began to sink and clipped a bush. The pilot continued to manoeuvre the aeroplane over the swampy area, but the left wingtip eventually hit some bushes and the aeroplane cartwheeled into the swamp. The aeroplane came to rest on its right side after the right wing broke, facing back towards the end of the runway about 700 m away (see Figures 1 and 2). No fire occurred.

- 1.6.2 Hilly terrain (see Figure 1) rising to 345 m lay some 3 kilometres (km) to the north, and 4 km to the south rising to 406 m. Another range of hills some 4 km to the west ran in a northwest direction, reaching the highest point of 627 m at Mount Hobson, some 7 km away along the extended centreline of runway 28. A note on the aerodrome chart advised that during strong southwest winds wind shear could be encountered on short final for runways 24 and 28. Company and other personnel advised that the southwest winds were the worst winds and they could create turbulence and downdraughts. The northeast winds were not known to generate the same problems. The company’s route guide said that wind shear and turbulence were common in strong wind conditions and advised that runway 10 was the preferred runway for take-off for obstacle clearance, with the tailwind not to exceed the performance limit of the aeroplane.

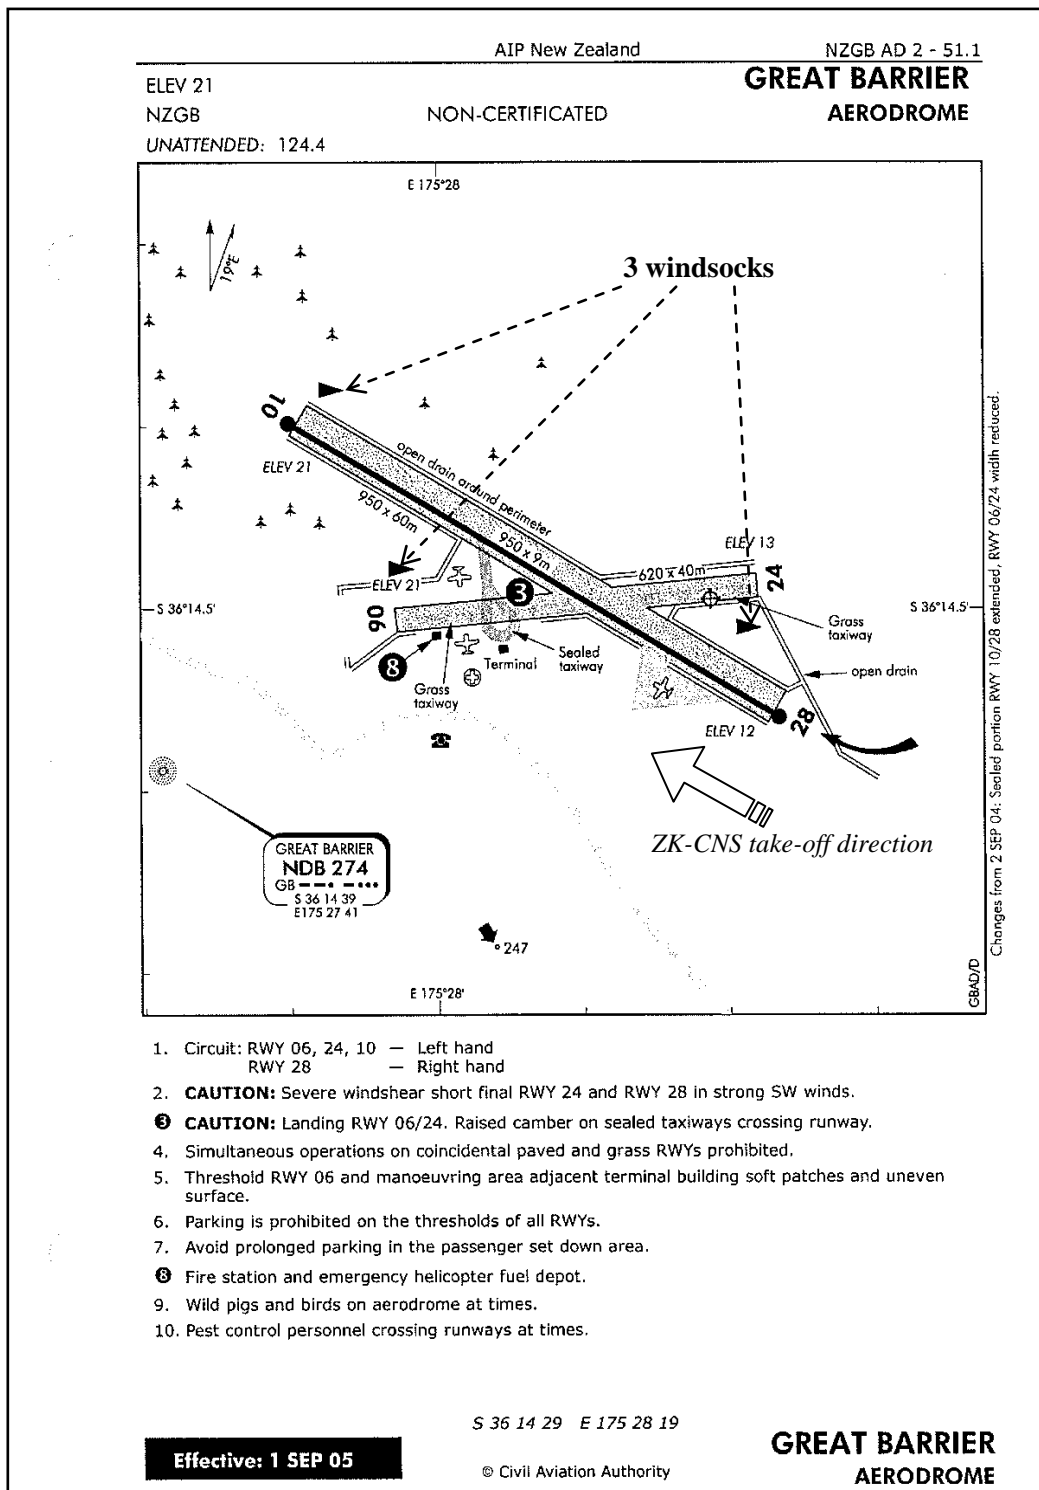
Figure 3
Great Barrier Aerodrome chart

- 1.6.1 Great Barrier Aerodrome (see Figure 3) had an elevation of 21 feet and consisted of a main sealed bitumen runway 10 and 28 of 950 m in length for take-off and landing, and a grass cross-runway 06 and 24 of 620 m. Runway 10 and 28 each had a group rating³ of 8 for landing and 7 for take-off and group 4 for runway 06 and 24. At the time the grass cross-runway was closed to operations. Auckland City Council was the owner and operator (CAA, 2005).

- 1.7.2 Visual flight conditions were observed to prevail at the time of the accident and the weather was said to be suitable for the flight. Three standard orange-coloured windsocks (see Figure 3) provided wind information at the aerodrome. The wind was observed to be blowing from the northeast but somewhat variable in direction at 10 to 15 knots.
