Report 09-201: collision: private jet-boat/private watercraft
Kawarau River, Queenstown, 5 January 2009

Final Report

Marine inquiry 09-201
Collision: private jet-boat/private personal watercraft
Kawarau River, Queenstown, 5 January 2009

Approved for publication: March 2011

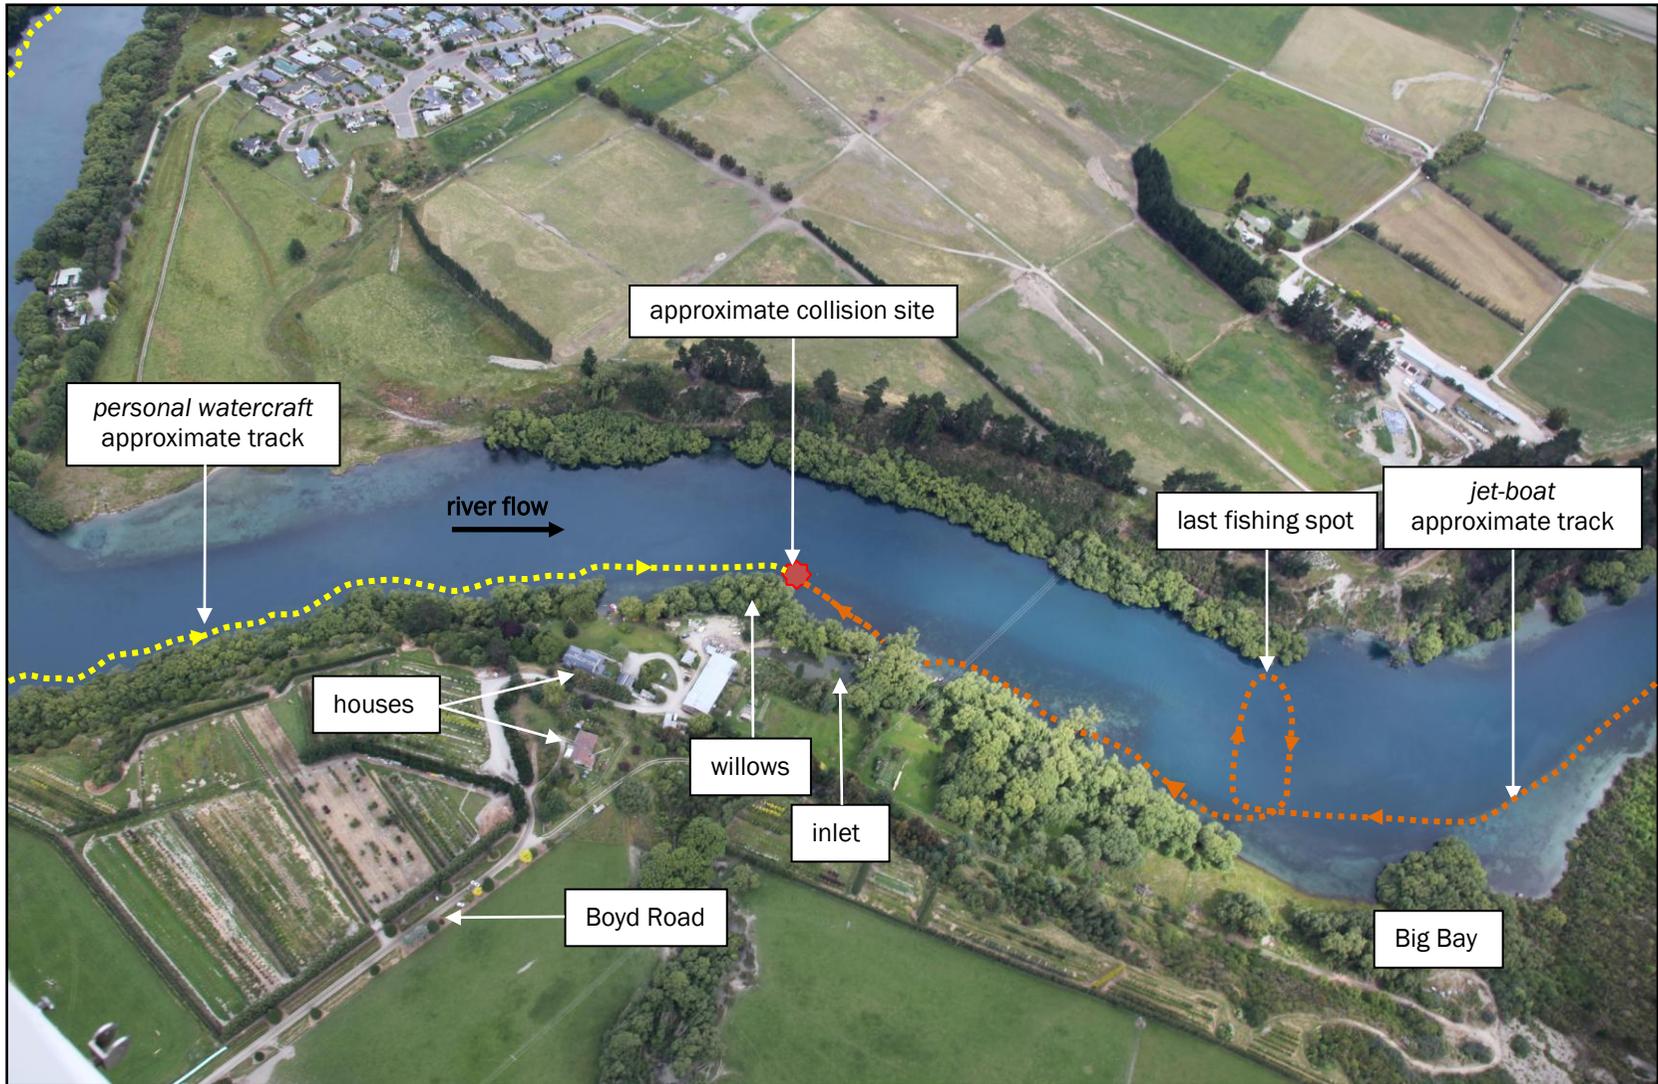
Figure 2
Aerial photography showing topography of accident site

- 3.1.15. The *personal watercraft* driver said that he took extra caution as he approached a corner close to where he knew there was a house at the end of Boyd Road, because on previous trips he had seen people swimming in the river there. He slowed down a little to about 30 mph and adjusted his line so that his craft was about 6 to 7 m from the willow trees (Figure 2).

- 4.2.16. Figures 2 and 3 show what the nephew described as the path taken by the *jet-boat* immediately before the collision, weaving in and out of 2 willow arches close to the side of the riverbank for about 250 m. The description the nephew gave was that the *jet-boat* had been on that side since heading upriver from below the confluence of the Kawarau and Shotover Rivers.

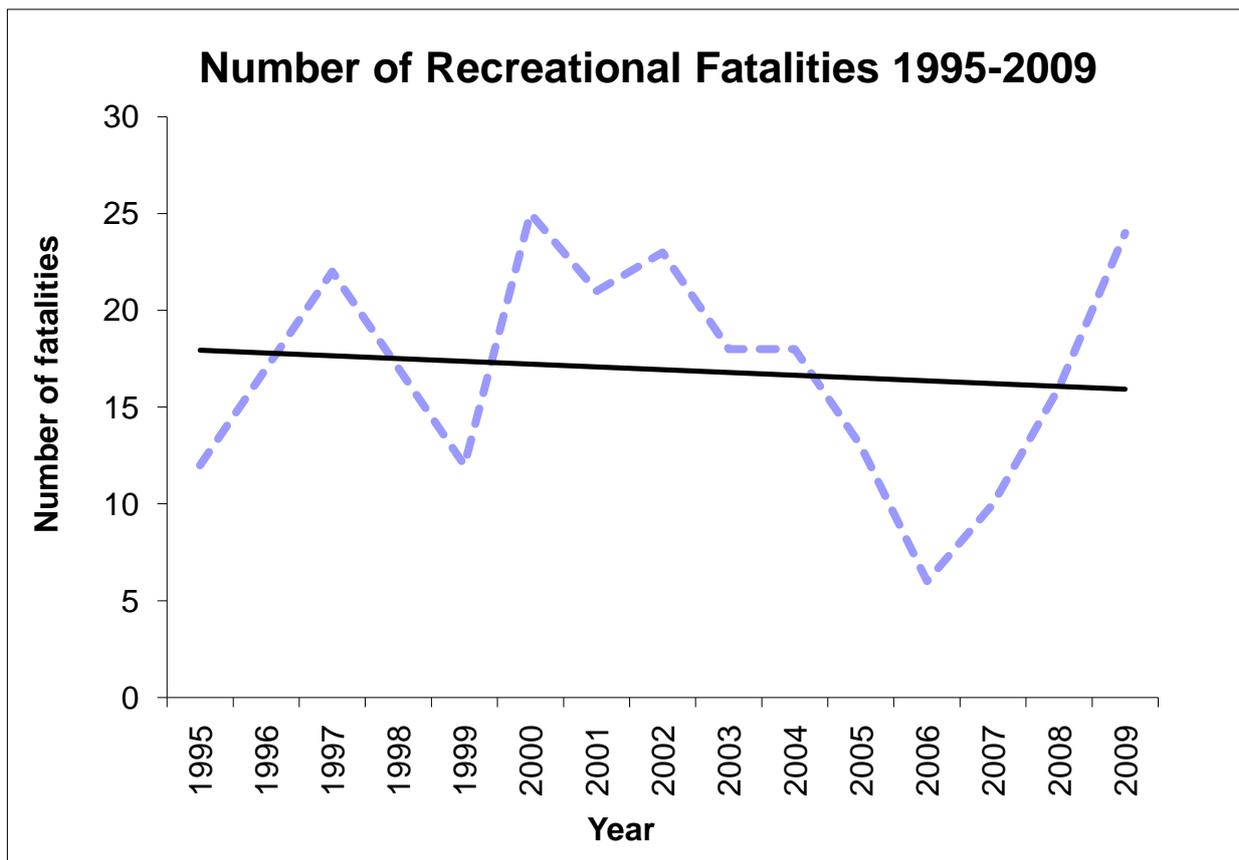
Figure 8
Graph of recreational fatalities in New Zealand 1995 to 2009

- 41 accidents resulted in 46 deaths in the 35 months between January 2007 and November 2009
- 34 fatalities would almost certainly have been avoided if lifejackets had been worn
- 16 fatalities would probably have been avoided if suitable communication equipment had been carried and useable following an immersion incident
- 8 fatalities had alcohol as a contributing factor.

3.8.5. A graphical representation of fatality statistics supplied to the Commission by Maritime NZ is shown in Figure 8.
