Final Preliminary Report

Prepared by the Transport Accident Investigation Commission

The Royal Commission of Inquiry into the Sinking of the
MV Princess Ashika

15 February 2010

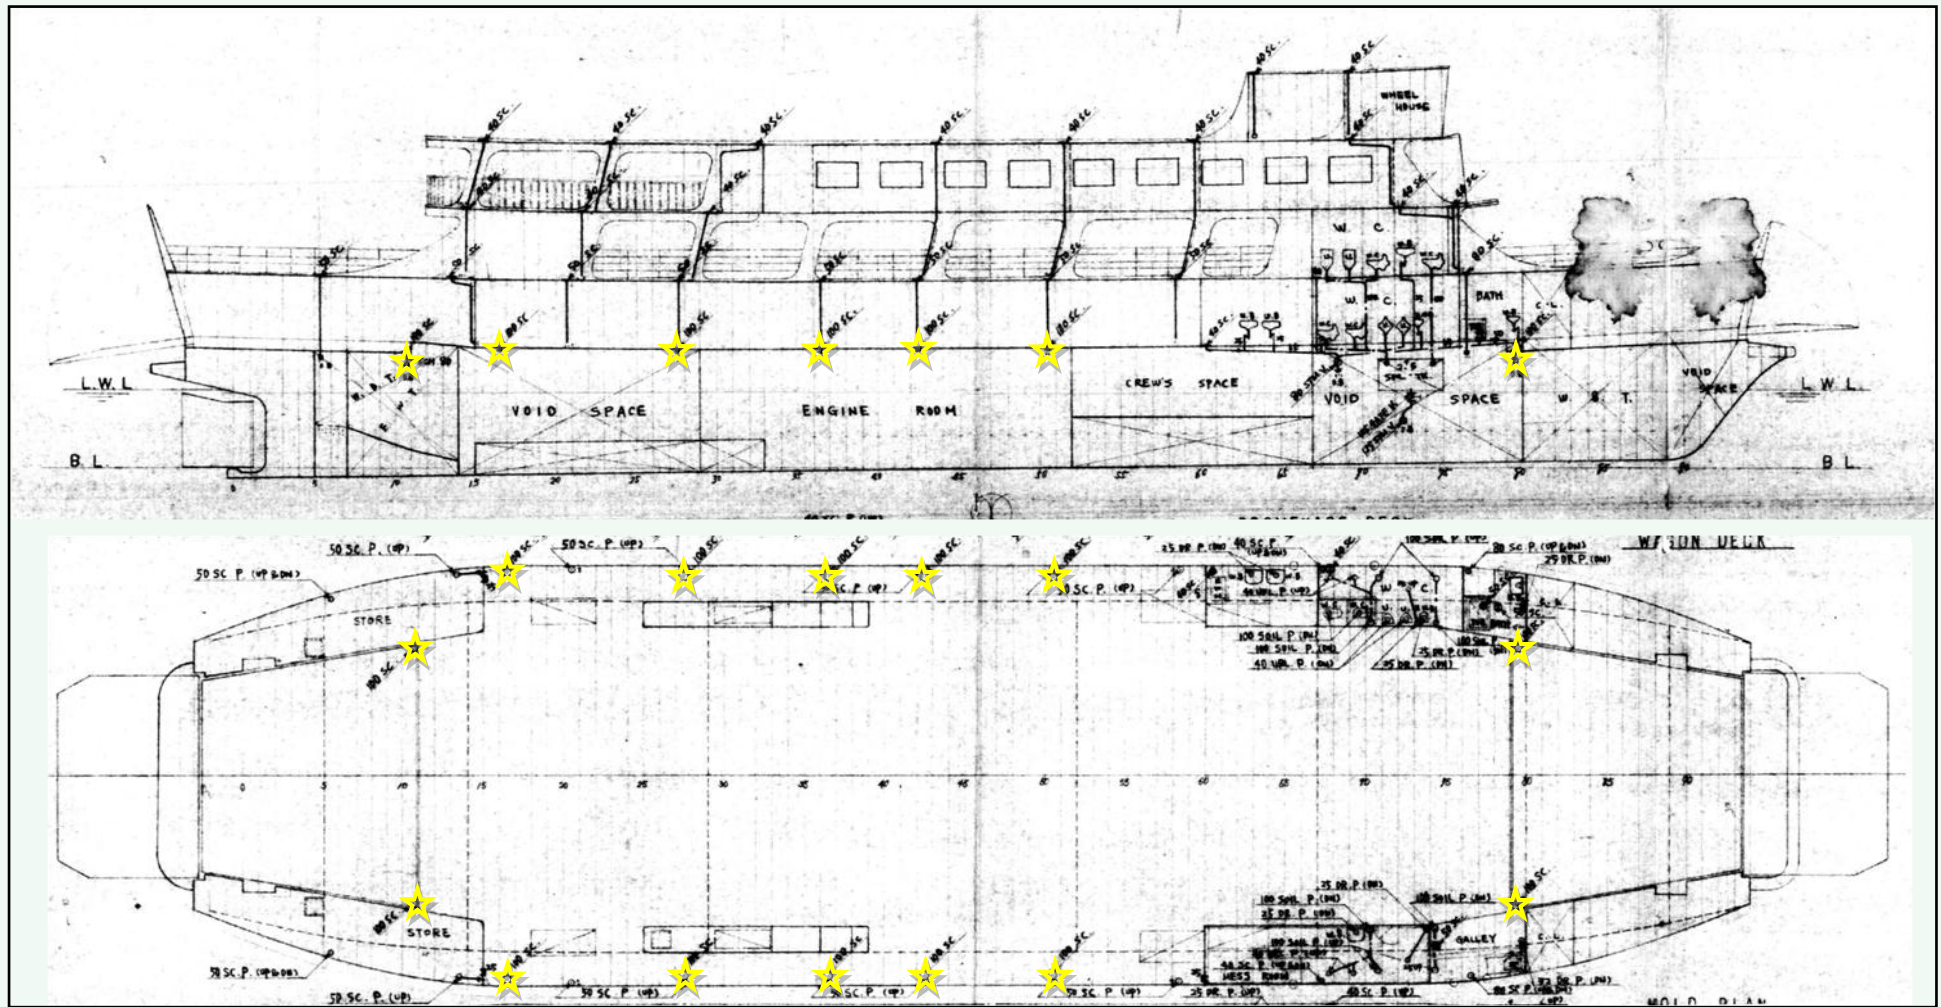
Figure 8 Layout of scuppers on the cargo deck

non-return devices, each with a nominal diameter of 100 mm. There was no fixed method of pumping water from the cargo deck (Figure 8)

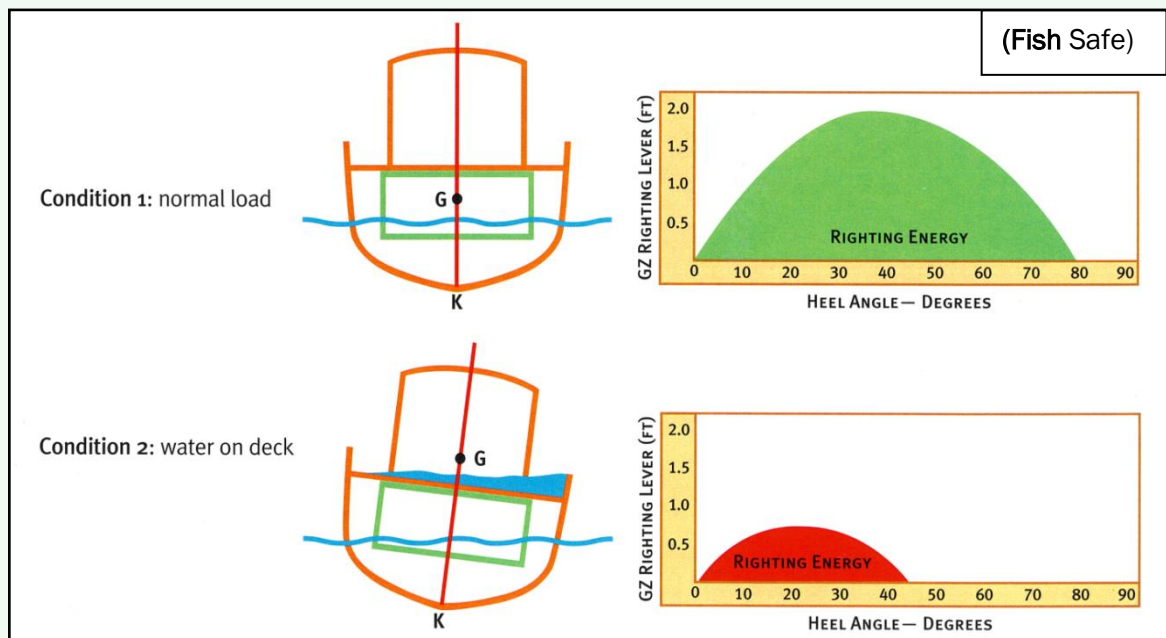
Figure 23 Water on deck

- free surface effect (see Figure 23) – When a vessel with a partially filled tank or with free water on its deck is heeled, the liquid will seek to remain parallel with the waterline and will flow to the low side. The centre of gravity of the liquid, being the centre of its volume, will move with the liquid towards the lower side of the vessel and this will cause the vessel's centre of gravity to shift, thereby reducing the vessel's stability. The greater the surface area covered by liquid, the greater the effect. The area covered with water is more significant than the depth of water, and this is especially true for water on deck

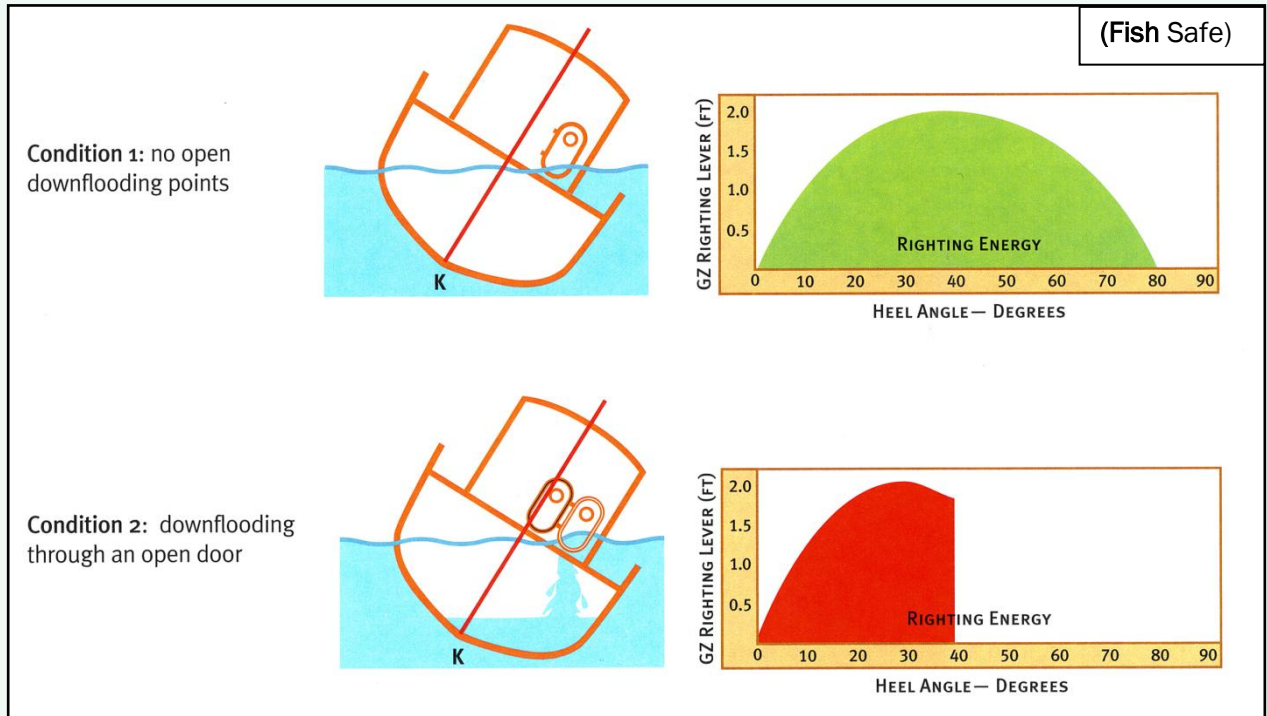
Figure 24 Downflooding

- downflooding (see Figure 24) – Downflooding is the entry of water into the hull that results in progressive flooding with which pumps cannot keep up. Watertight and weathertight integrity is necessary to prevent downflooding. Downflooding introduces free surface, which raises the centre of gravity, increases the draught and reduces freeboard. Consequently, it reduces the reserve buoyancy and stability, and if no corrective action is taken quickly enough to stop it, it may cause an extreme list and represent a progressive loss of stability that may finally result in capsize

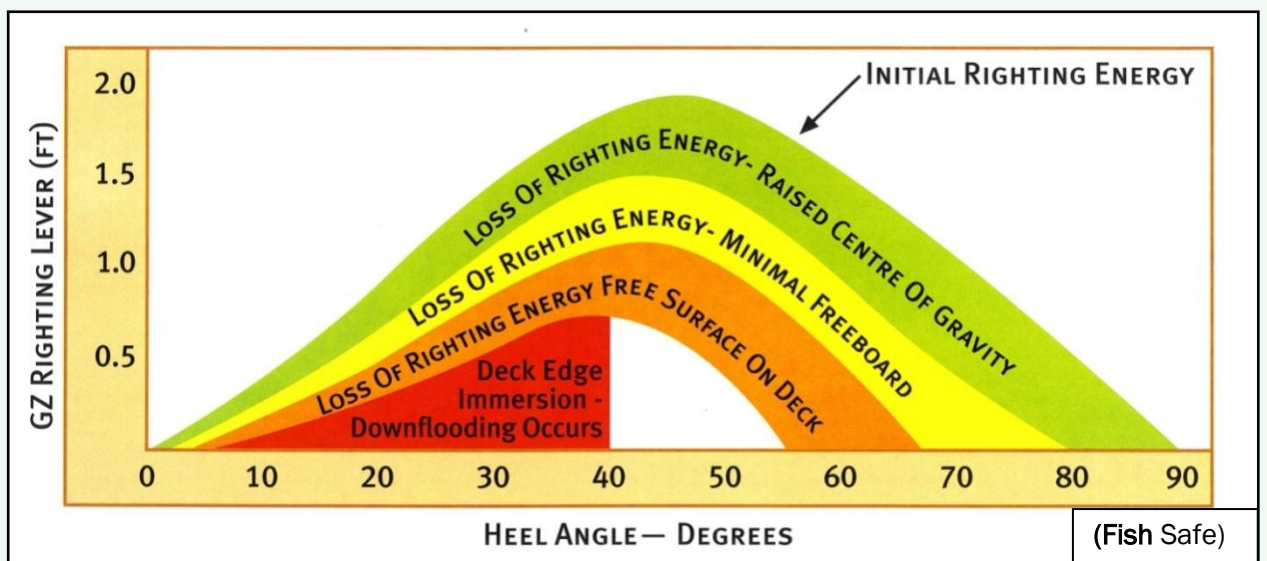
Figure 25 Compromised stability

- the accident voyage of the **Princess Ashika** is a good illustration of the phenomena. The buoyancy and stability were compromised by the progressive and cumulative effect of the factors mentioned above, until the vessel capsized (see Figure 25).

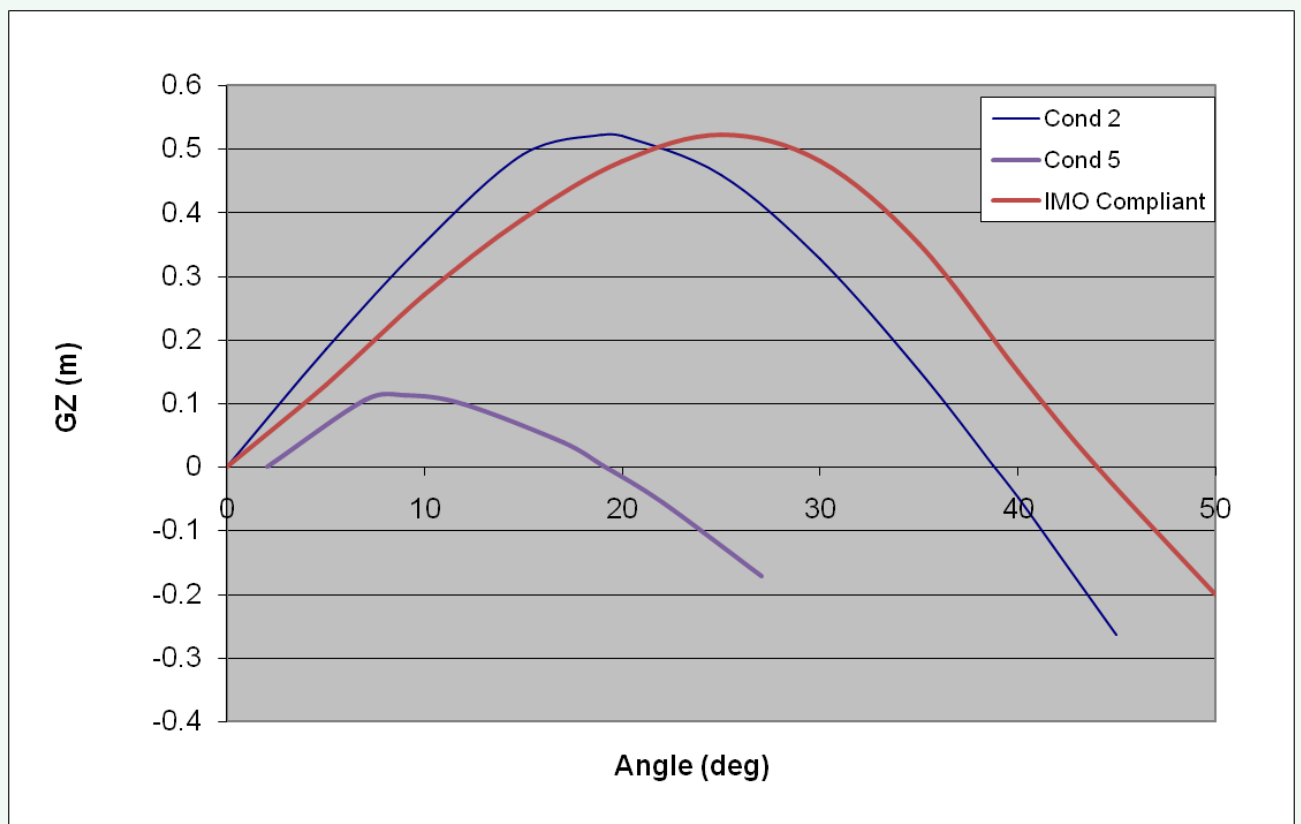
Figure 27 Princess Ashika stability compared with IMO compliance

- 1.6.18. The overloading was the result of loading ballast in addition to cargo and passengers, as well as a failure to ensure that void spaces were reasonably dry; this was illustrated by comparing condition No 2 (hypothetical condition with bilges dry and no ballast) with condition No 5 (actual departure condition with water ballast and significant accumulation of bilge water) (see Figure 27).

- 1.6.19. A comparison of the stability curves for conditions No 2 and 5 demonstrated the impact on stability of the overloading (combined with free surfaces of water). The hypothetical condition No 2 was close to compliance with IMO stability criteria, whereas the curve for condition No 5 is drastically reduced, representing approximately one-third of the IMO criterion for area under the curve (see Figure 27).
