Inquiry 09-210: Bulk carrier, Taharoa Express, cargo shift,  
Port Taharoa, 16 December 2009

Marine inquiry 09-210  
Bulk carrier, Taharoa Express, cargo shift  
Port Taharoa, 16 December 2009

Approved for publication: November 2013

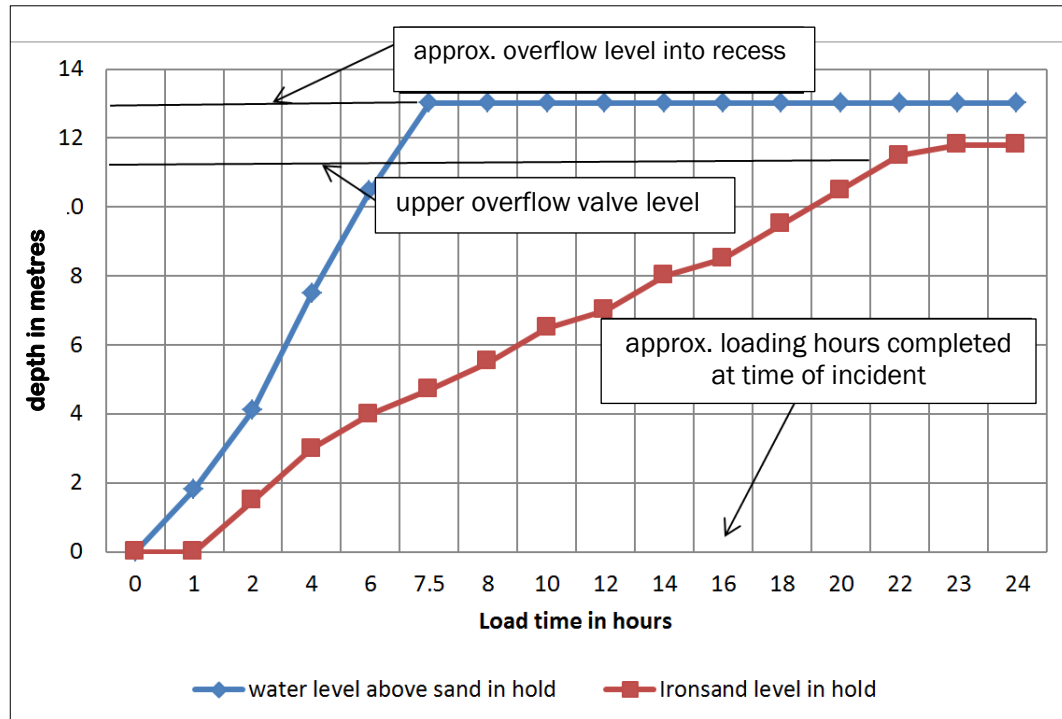
Relative levels of ironsand and water when loading, number 3 hold

- The graph below is drawn from data provided by Class NK (Nippon Kaiji Kyokai) from when the ship was converted to load slurry cargo in 1999. It is an approximation of the relative level of ironsand and water over time when loading number 3 hold. The graph demonstrates the amount of free-water above the ironsand at any given time. When considering that several cargo holds could have free-water above the cargo at any time during the loading process, the effect on the ship's metacentric height can be significant.

- A cargo hold with free-water is similar to a partially filled tank. When the ship is subject to a heeling force, the free-water above the ironsand in the hold will try to remain parallel with the ship's waterline. The centre of gravity of the free-water will move with the liquid, and its effect is to raise the ship's centre of gravity, causing a corresponding decrease in the ship's metacentric height and therefore its stability. This rise in centre of gravity and subsequent reduction in the stability of the ship is called the free surface effect.

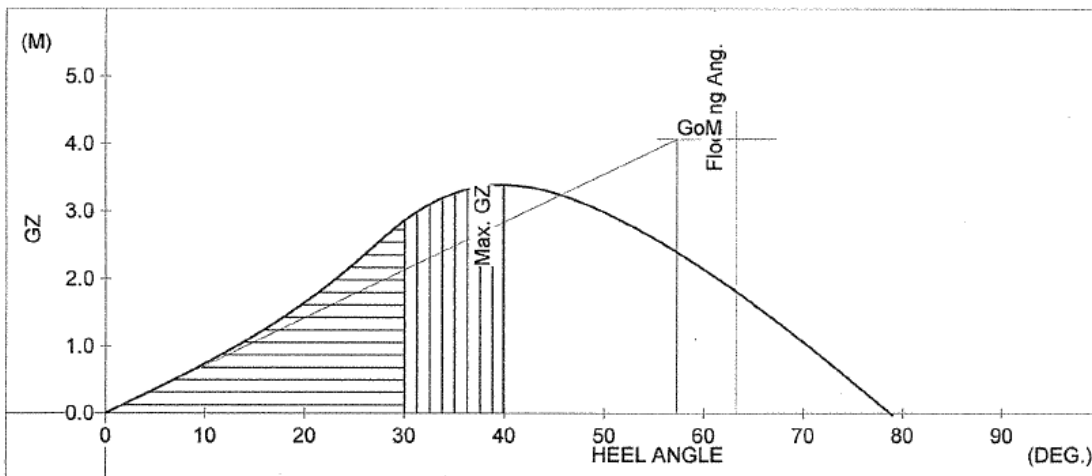
CONDITION : V-82 SEQ-4-16DECCOND VESSEL CARGO SHIFTED

IMO A.749(18), Chapter 3.1 Stability

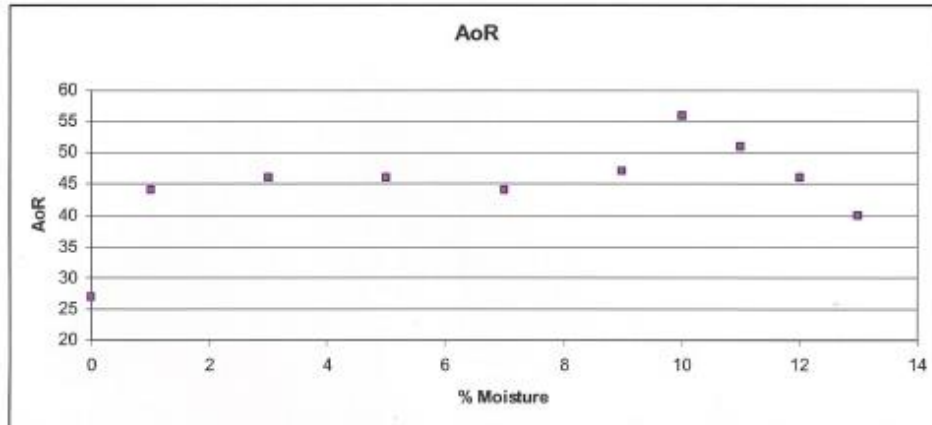
Graph 5.1: Angle of repose vs. Moisture.

When bulk granular materials are poured onto a horizontal surface, a conical pile will form. The angle between the surface of the pile and the horizontal surface is known as the angle of repose. Testing as per NZSM laboratories.

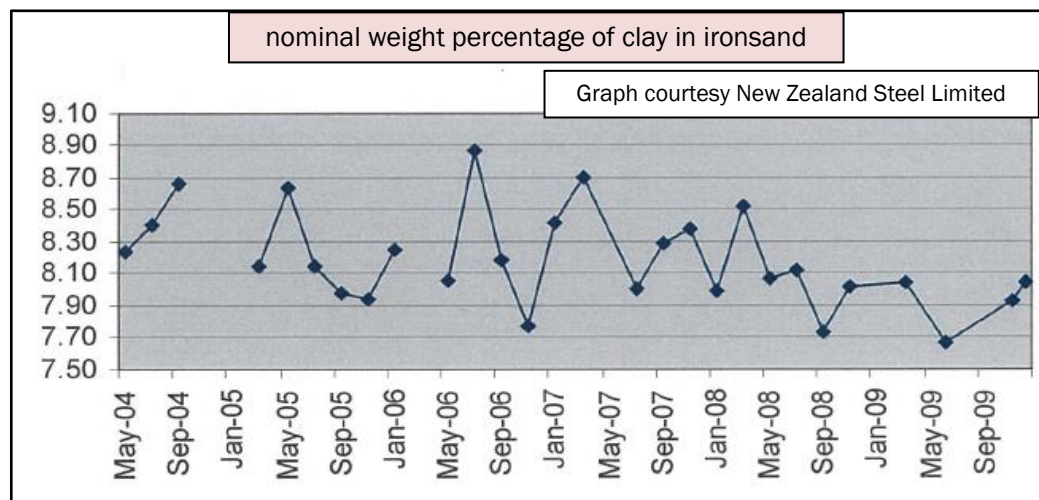
### Historical review of clay elements

4. The ironsand was tested to determine if clay or slimes (present in the ironsand) were higher than in previous shipments.
5. The results of the review indicated that the physical and chemical parameters of the ironsand were similar at the top and bottom of the hold, and also to the historical and “Cargo Declaration” quoted figures. Also noted was an overall reduction in clay elements in the previous 6 years due to improved processing and cleaning of the ironsand

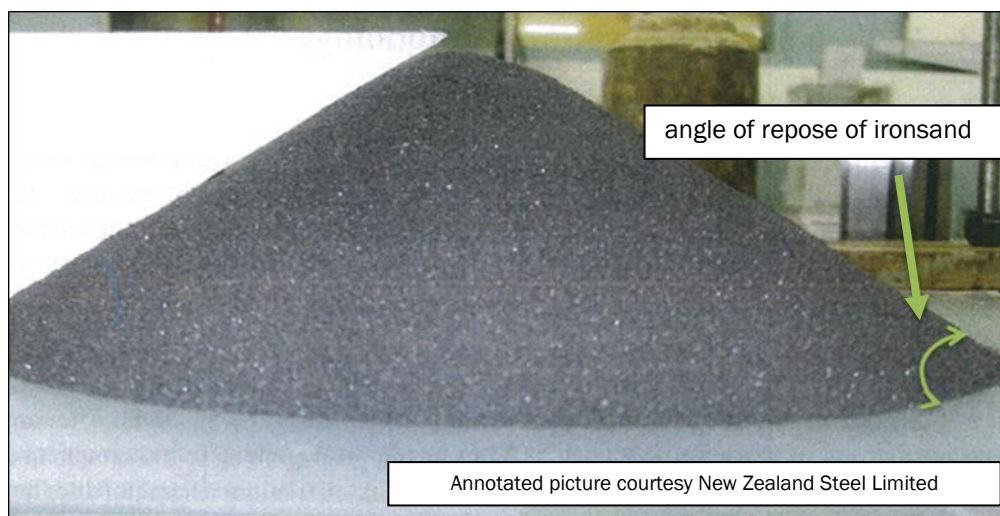
Angle of repose of ironsand

- 4.2.12. Testing for the underwater angle of repose was first done only after this incident. Those tests showed that the underwater angle of repose of ironsand was only  $24.7^\circ$ . This meant that for a slump to occur the pile of ironsand deposited underwater in one or more holds had to develop a slope angle (to the horizontal plane) greater than  $24.7^\circ$ . Under normal loading conditions, such a piling up of the cargo should not have occurred. However, the ullage measurements taken before and after the incident suggested that cargo had been allowed to mount up on one side of one cargo hold, while simultaneously being offset by cargo being allowed to mount up on the other side in another cargo hold. In such a situation the ship would have remained upright and the crew would have been none the wiser unless they were accurately monitoring the distribution and profile of the ironsand in all holds. The evidence suggested that they were not doing this (see the following section 4.4 and Appendices 9 and 10).

10. The NZSL report (2011) stated that the angle of repose of the ironsand, measured as the angle above horizontal, was the steepest slope at which the material would stand. The angle of repose of loosely deposited ironsand was determined by 2 methods: deposition as dry ironsand and deposition of ironsand underwater.
