Aviation inquiry 10-007:  
Boeing 737-800, ZK-PBF and Boeing 737-800, VH-VXU, airspace incident,  
near Queenstown Aerodrome, 20 June 2010

# Final Report

10-007  
Boeing 737-800, ZK-PBF and  
Boeing 737-800, VH-VXU  
airspace incident  
near Queenstown Aerodrome  
20 June 2010

Approved for publication: 13 March 2012

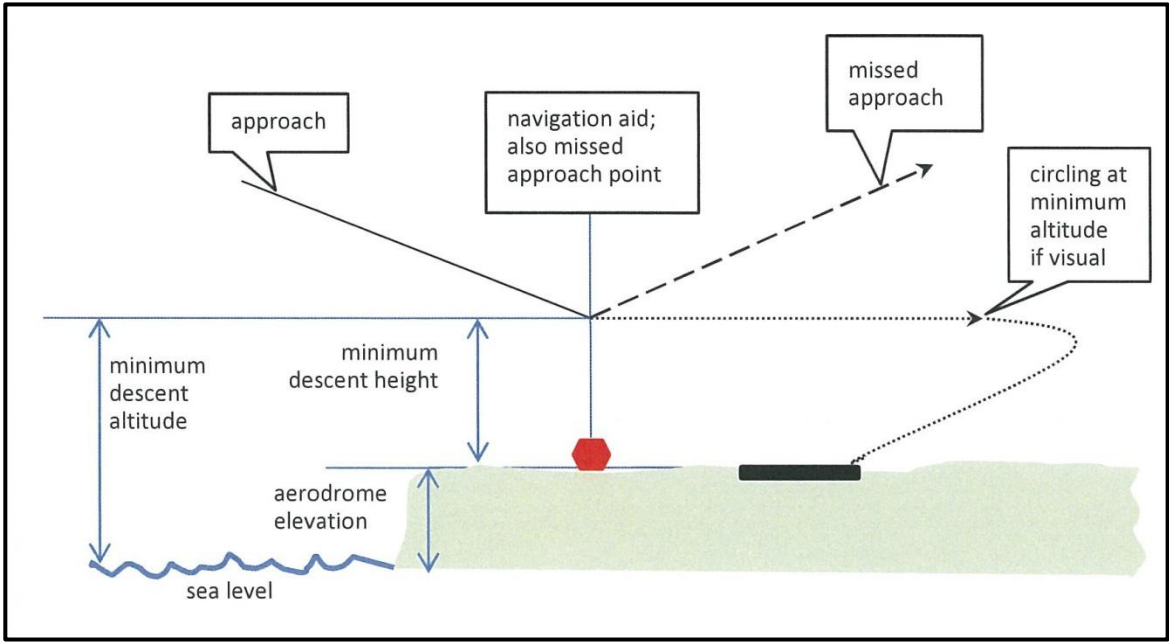
Figure 1  
Key terms in an instrument approach

- 3.1.5. An aircraft’s vertical position is normally referenced to altitude. The approach minimum descent altitude is the lowest altitude to which a pilot may descend before acquiring the required visual reference to make a safe landing. If the required visual reference is not achieved by the missed approach point, or cannot be maintained after that point, the missed approach procedure must be flown (see Figure 1).

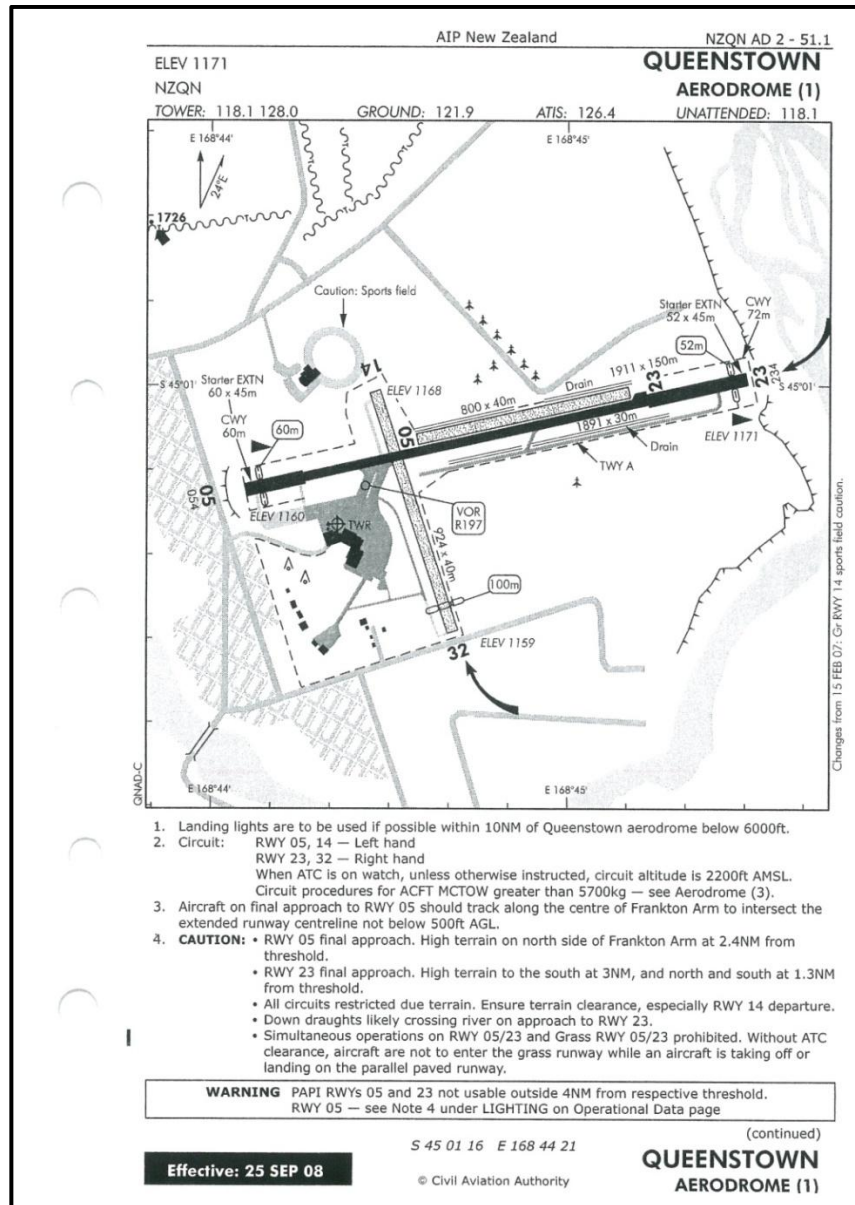
Figure 4  
 Queenstown Aerodrome layout

3.2.11. 'Deer Park Hill' was a hill immediately south of the aerodrome. After Pacific Blue had flown overhead the aerodrome and turned to go behind Deer Park Hill, the pilots saw that they would likely lose visual contact with the runway because of low cloud. At 1345 they advised ATC that they had commenced a missed approach and were tracking to position AFTON, the missed approach holding point 15 miles from the VOR/DME.

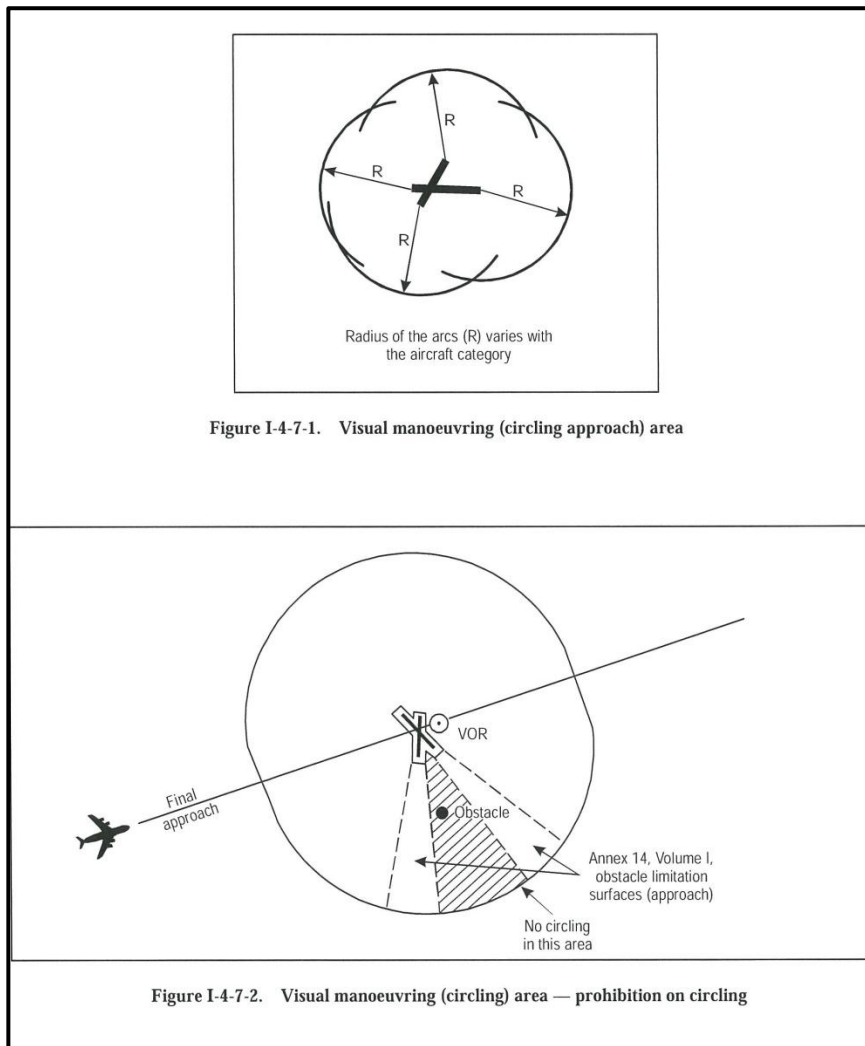
**Figure 8**  
**Circling area construction, and example**  
 (Figure taken from PANS-OPS (ICAO, 2006a, p.I-4-7-6))

3.7.19. The circling minimum descent altitude ensured obstacle clearance only when operating within the circling area from which the minimum descent altitude was determined. When operating below the minimum descent altitude, the circling area was irrelevant, because obstacle clearance then depended on the pilot having visual reference. Therefore, PANS-OPS and the national rules stated, in part (ICAO, 2006a, 7.3.3):
