Interim Factual Report 10-008: Cessna C152 ZK-JGB and Cessna C152 ZK-TOD,  
mid-air collision, near Feilding, Manawatu, 26 July 2010

# Interim Factual Report

Aviation Inquiry 10-008: Cessna C152 ZK-JGB  
and Cessna C152 ZK-TOD, mid-air collision, near  
Feilding, Manawatu, 26 July 2010

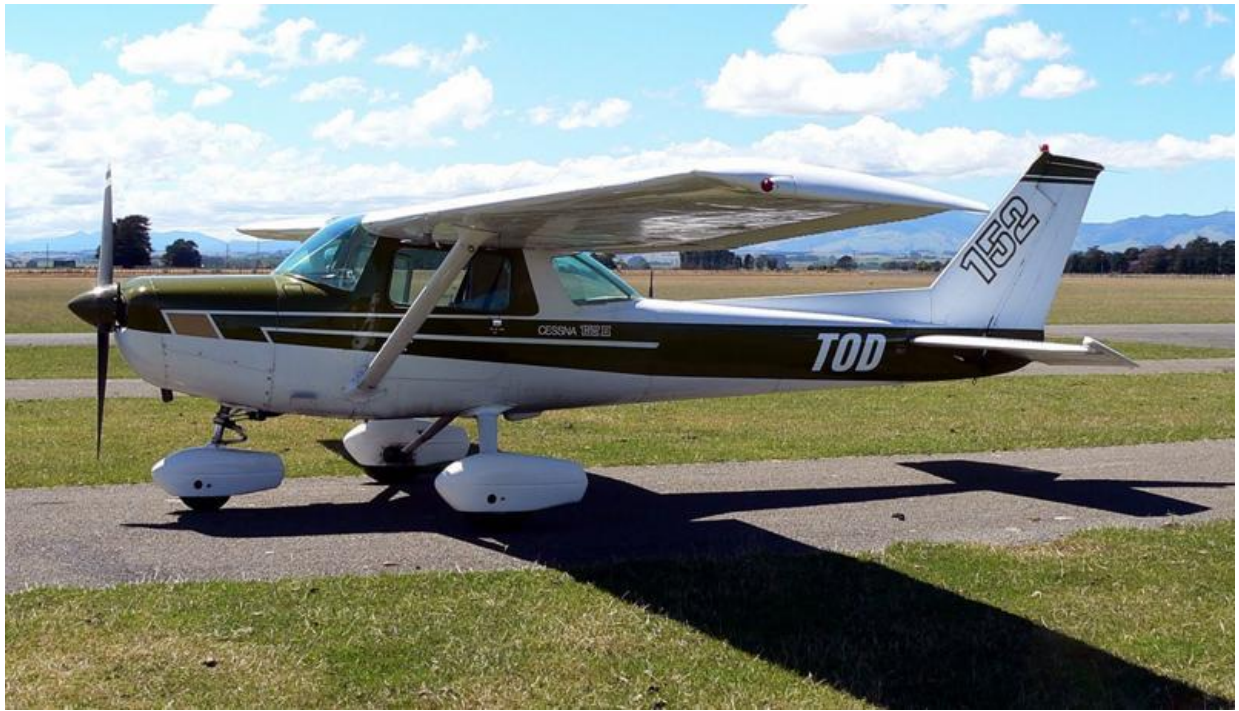
Cessna C152 ZK-TOD  
(Courtesy of Flight Training Manawatu)

- 1.2.1. ZK-TOD was destroyed in the ground impact. Impact marks on the leading edge of the right wing were consistent with having been struck by a tyre, with black rubber deposit on the surface of the indentation. Outer sections of the right wing, including the aileron, were found about 280m north of the main wreckage.

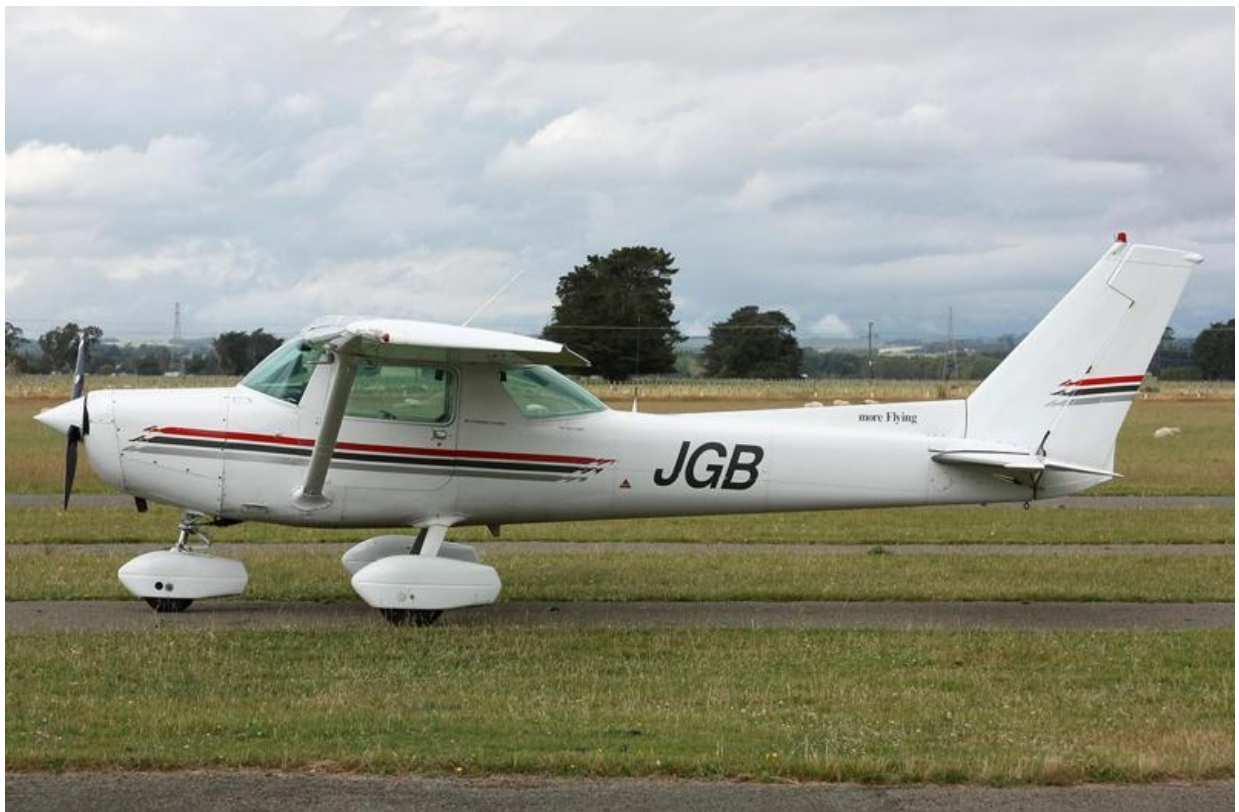
Cessna C152 ZK-JGB  
(Courtesy of Flight Training Manawatu)

- 1.2.2. The fixed non-retractable nose wheel of ZK JGB had been forced rearward. The fuel line to the carburettor was broken, as well as the carburettor. This is considered the most likely reason for the engine stopping in flight.
