Addendum to Final Report AO-2010-009: Walter Fletcher FU24, ZK-EUF
loss of control on take-off and impact with terrain,
Fox Glacier aerodrome, South Westland, 4 September 2010

Addendum to Final Report

Aviation inquiry 10-009
Walter Fletcher FU24, ZK-EUF
loss of control on take-off and impact with terrain
Fox Glacier aerodrome
South Westland
4 September 2010

Approved for publication: September 2015

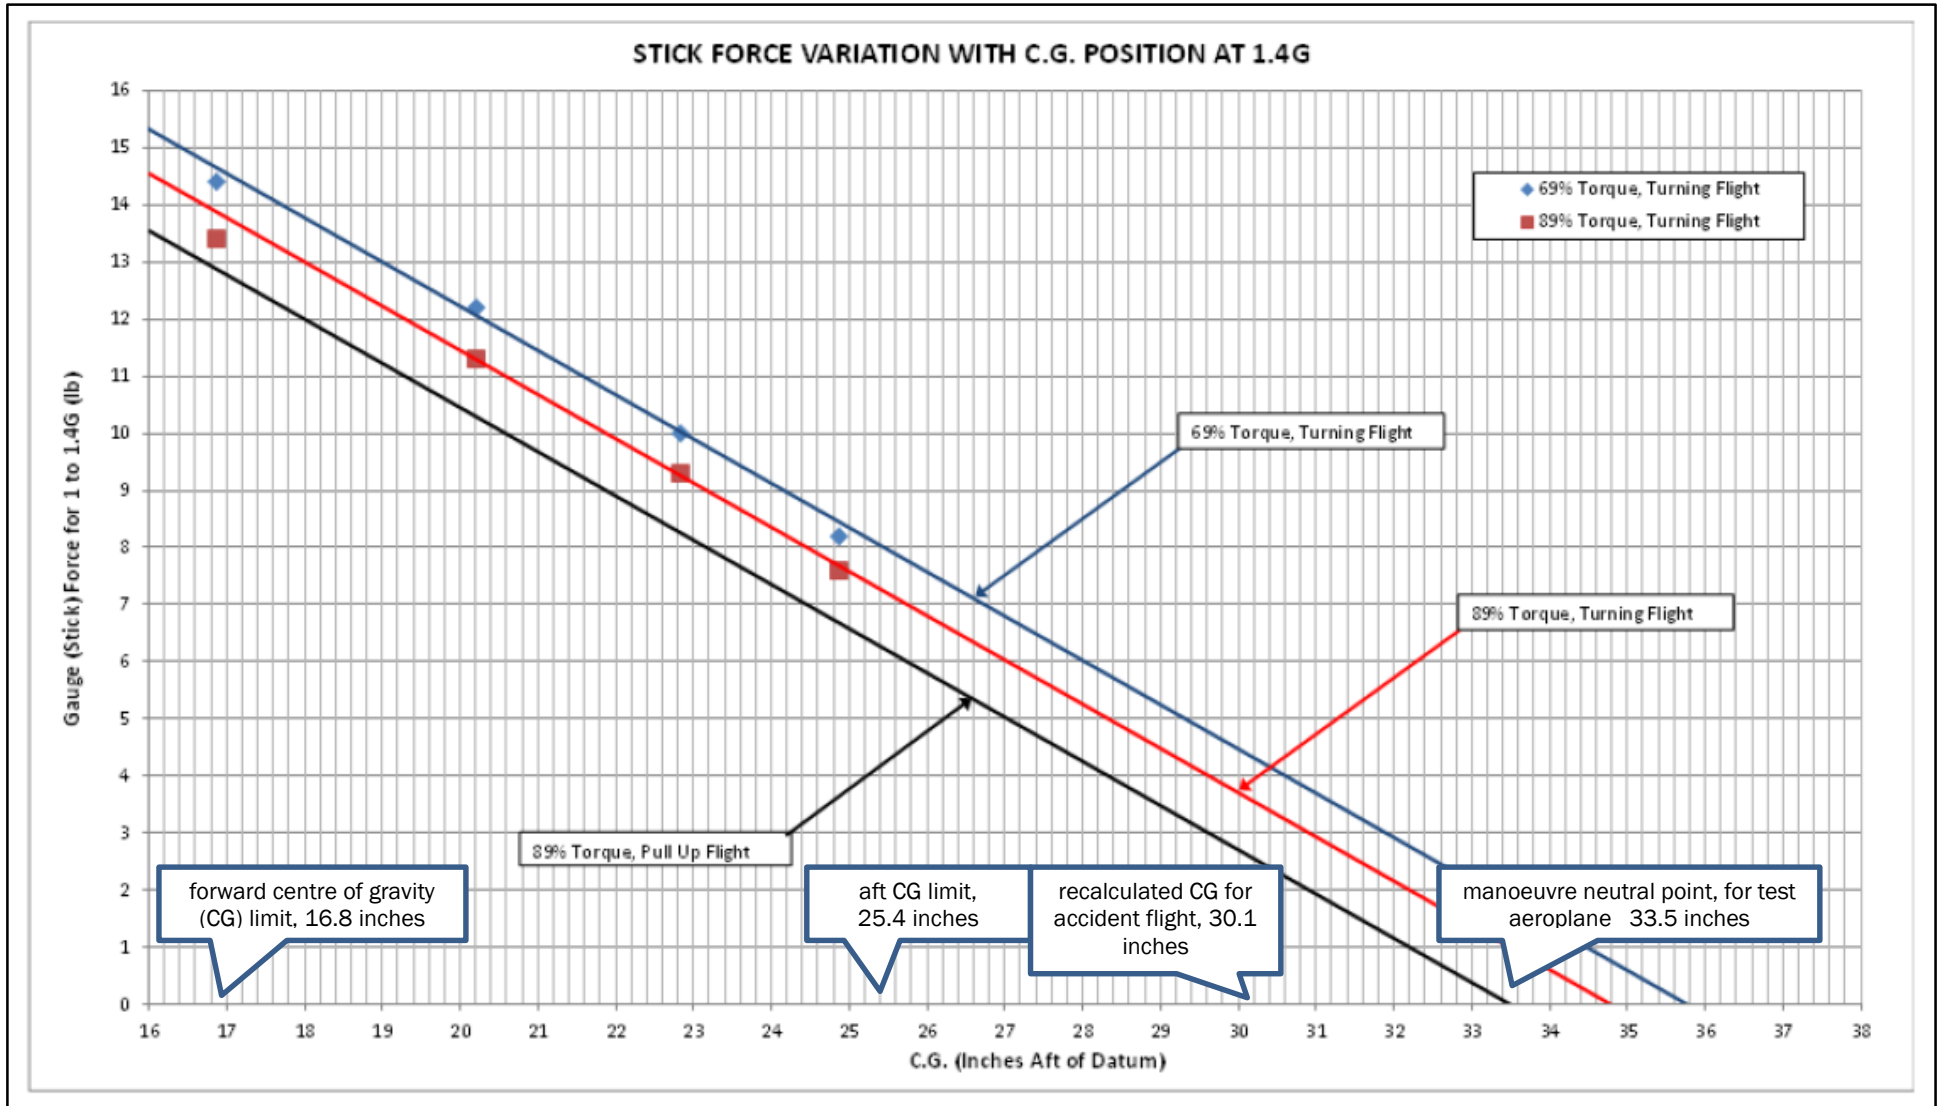
Figure 3
Flight test results used for finding the manoeuvre neutral point

- 7.8. The test results conformed to conventional aerodynamic theory (see Figure 3, which reproduces Figure 2 of Appendix 5). Measurements of the control stick force were taken at two power settings, one of which was the nominal take-off power for the Walter Fletcher. The plotted results produced straight-line graphs showing that the stick force per G (measured on the vertical axis) decreased as the centre of gravity moved rearward. At the points where the extensions of the plotted graphs cut the horizontal axis, the stick force per G was zero. The corresponding centre of gravity positions (on the horizontal axis) were the manoeuvre neutral points for the respective engine power settings.

- 7.12. The manoeuvre neutral point moves forward at higher engine power settings, which will reduce the stick force per G. The engine manufacturer advised that the engine fuel control unit could not produce an uncommanded increase in power above normal take-off power. However, the engine control system on the Walter Fletcher did not prevent pilots exceeding the nominal power limit, because they had to have the ability to adjust the maximum power according to the environmental conditions on the day. Therefore the possibility could not be excluded that at the point of take-off the pilot inadvertently or deliberately exceeded the nominal take-off power, which would have reduced the stick force and might have been a cause of the steep climb.

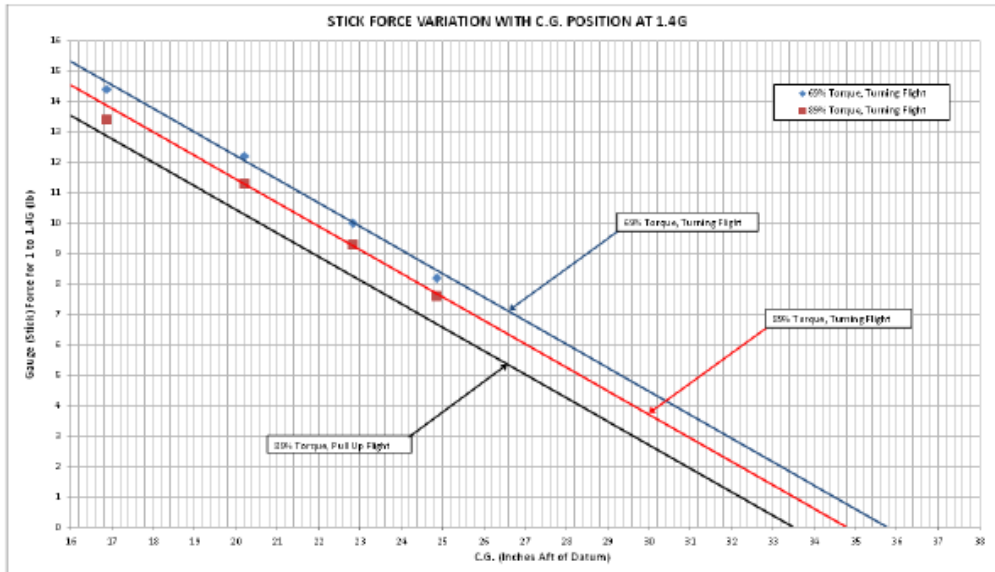
Figure 2

- A fitted linear regression through SGF versus CG position flight test points for 69% engine torque (MCP).
- A fitted linear regression through SGF versus CG position flight test points for 89% engine torque (TO).

Also shown is the “turning flight” to “pull up” SFG increment of -1 lb applied to the 89% turning flight fitted line. This line intersects the graph horizontal axis at a CG position of 33.5” aft of datum.

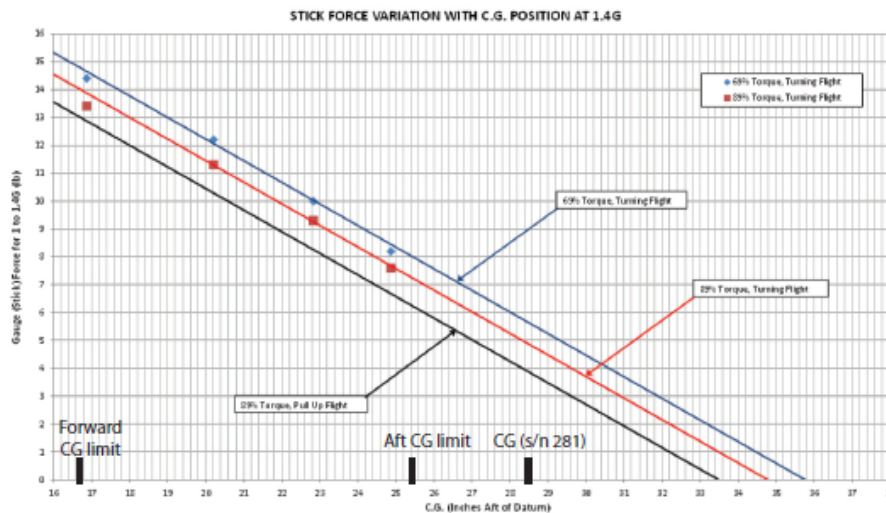
Figure 2: Determination of aircraft manoeuvre margin.(Reproduced from Ref. [1])

Figure 2 in Reference [1] (replicated and annotated in Figure 2) shows sufficient margin. Although the precision of the data points has been given, the tests are quite transient in nature, so a significant amount of uncertainty exists when taking the measurements.

As acknowledged by the investigators, the data presented in the report effectively demonstrates a spot check has been carried out. Accurate calculation of the MNP requires the investigators to carry out a series of incremental g tests and conducting the corresponding analysis. This is illustrated in Figure 3 that shows the gradient of required elevator angle (η) to normal acceleration (g) at aft and forward centres of gravity are required to obtain MNP (h_m). A similar approach is recommended to obtain stick-free MNP, which will require the measurement of stick force instead of elevator angle.
