Report 10-102: collision between 2 metro passenger trains
after one struck a landslide and derailed between Plimmerton and Pukerua Bay,
North Island Main Trunk, 30 September 2010

Final Report

Rail inquiry 10-102
collision between 2 metro passenger trains after
one struck a landslide and derailed between
Plimmerton and Pukerua Bay,
North Island Main Trunk
30 September 2010

Approved for publication: May 2012

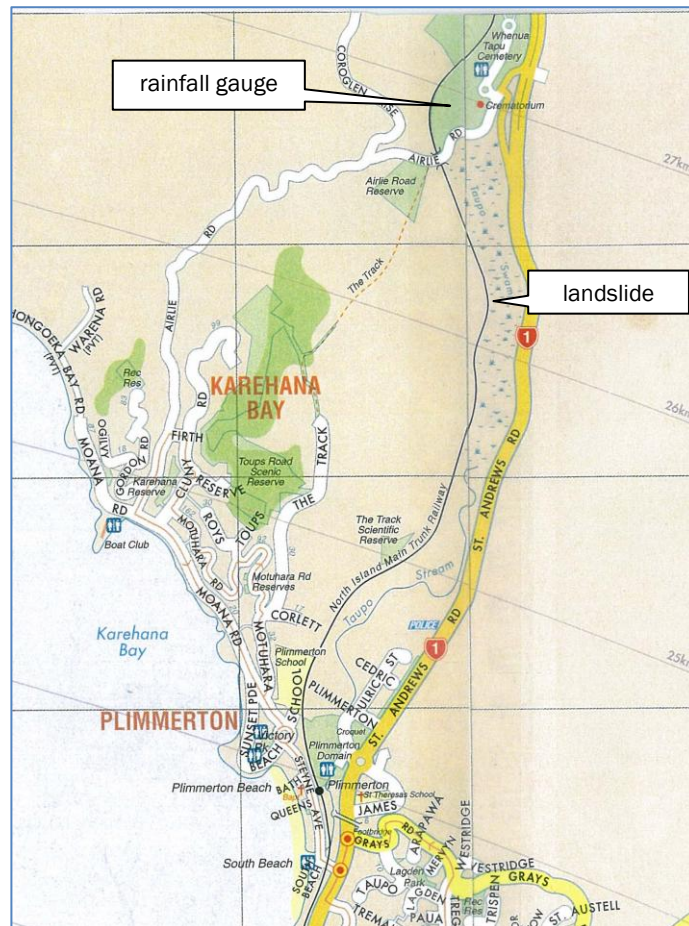
Figure 3
Location of rainfall monitoring gauge close to the landslide
 Source: Avis Wellington street directory

- 3.4.1. The regional council had a rainfall monitoring site near Taupo Stream at Whenua Tapu Cemetery, about a kilometre north of the landslide (see Figure 3).
