Report 10-203: *Marsol Pride*, uncontrolled release of fire-extinguishing gas into engine room, Tui oil and gas field, 27 May 2010

Final Report

Marine inquiry 10-203
Marsol Pride, uncontrolled release of
fire-extinguishing gas into engine room,
Tui oil and gas field, 27 May 2010

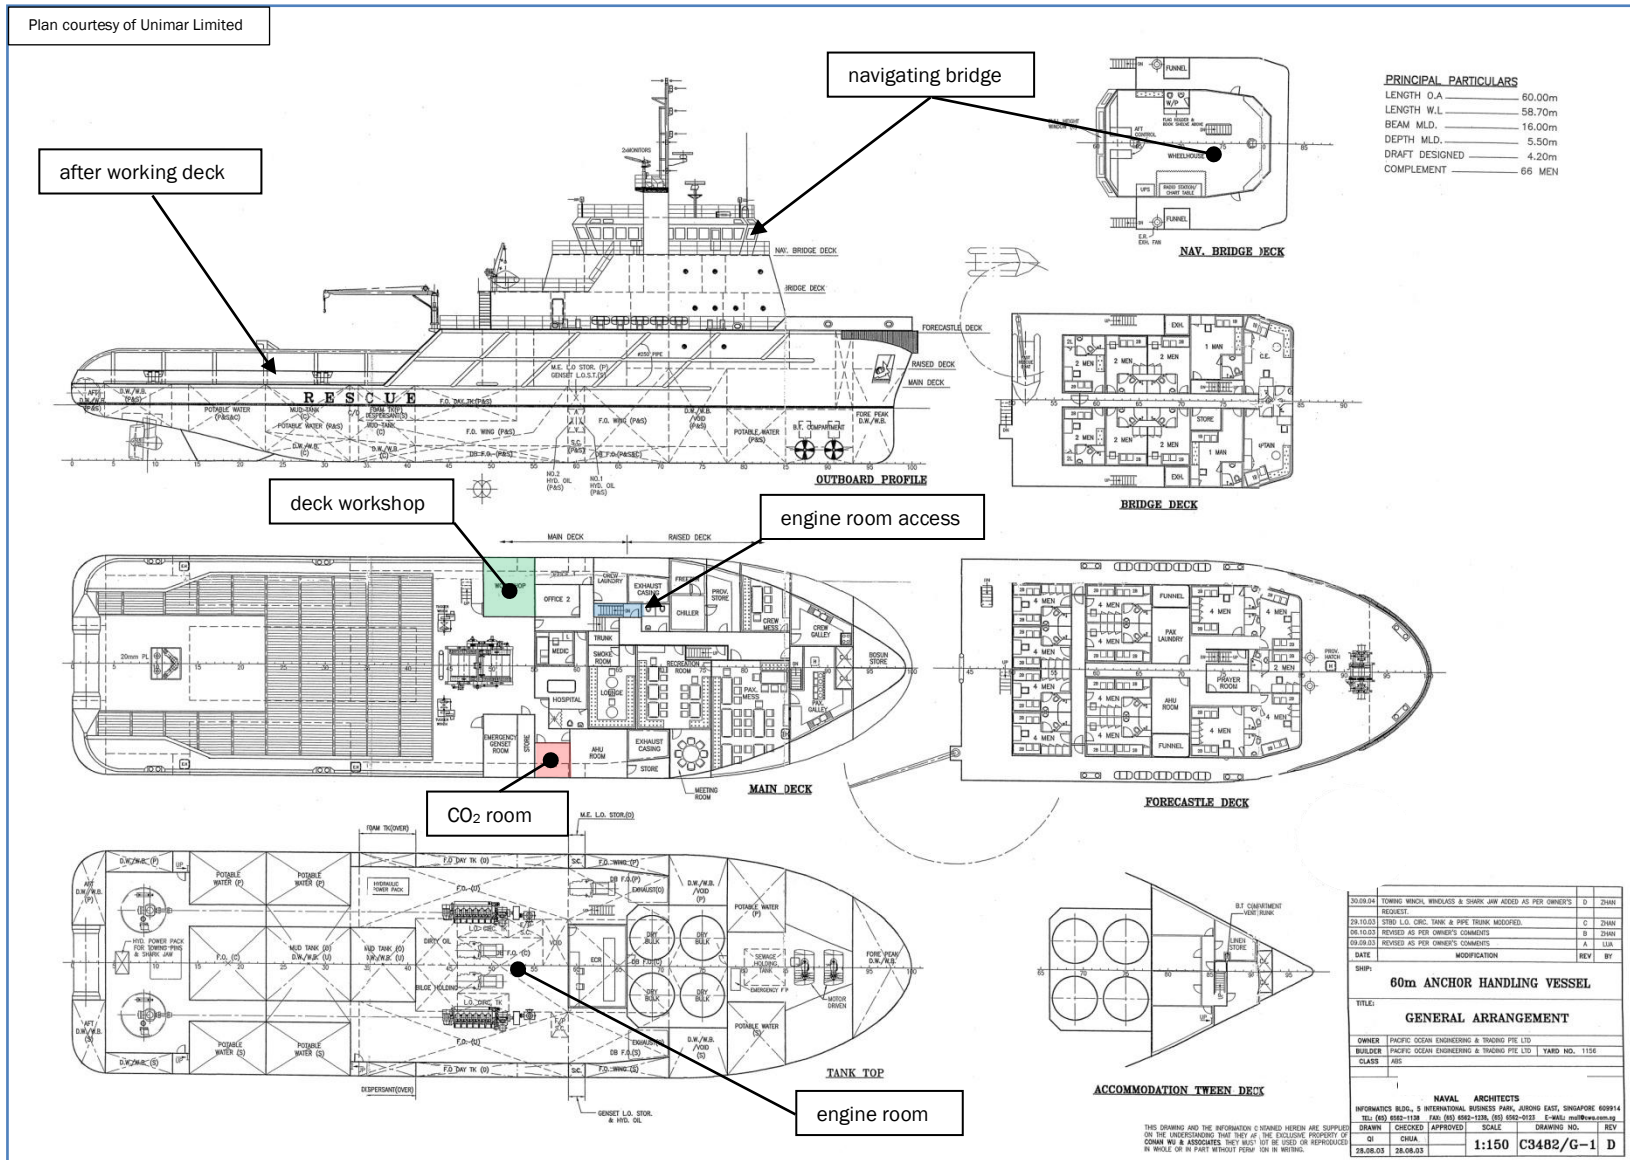
Figure 1
General arrangement plan of the Marsol Pride

- 3.1.6. The third engineer was on duty in the engine room, where he was required to be when the vessel was operating in DP mode (see Figure 1). At about 2320, he entered the engine control room and as he did the CO₂ alarm sounded and the warning light started to flash. This meant that CO₂ gas from the fixed fire-smothering system was about to be released into the engine room. He picked up a portable radio transceiver and vacated the engine room.

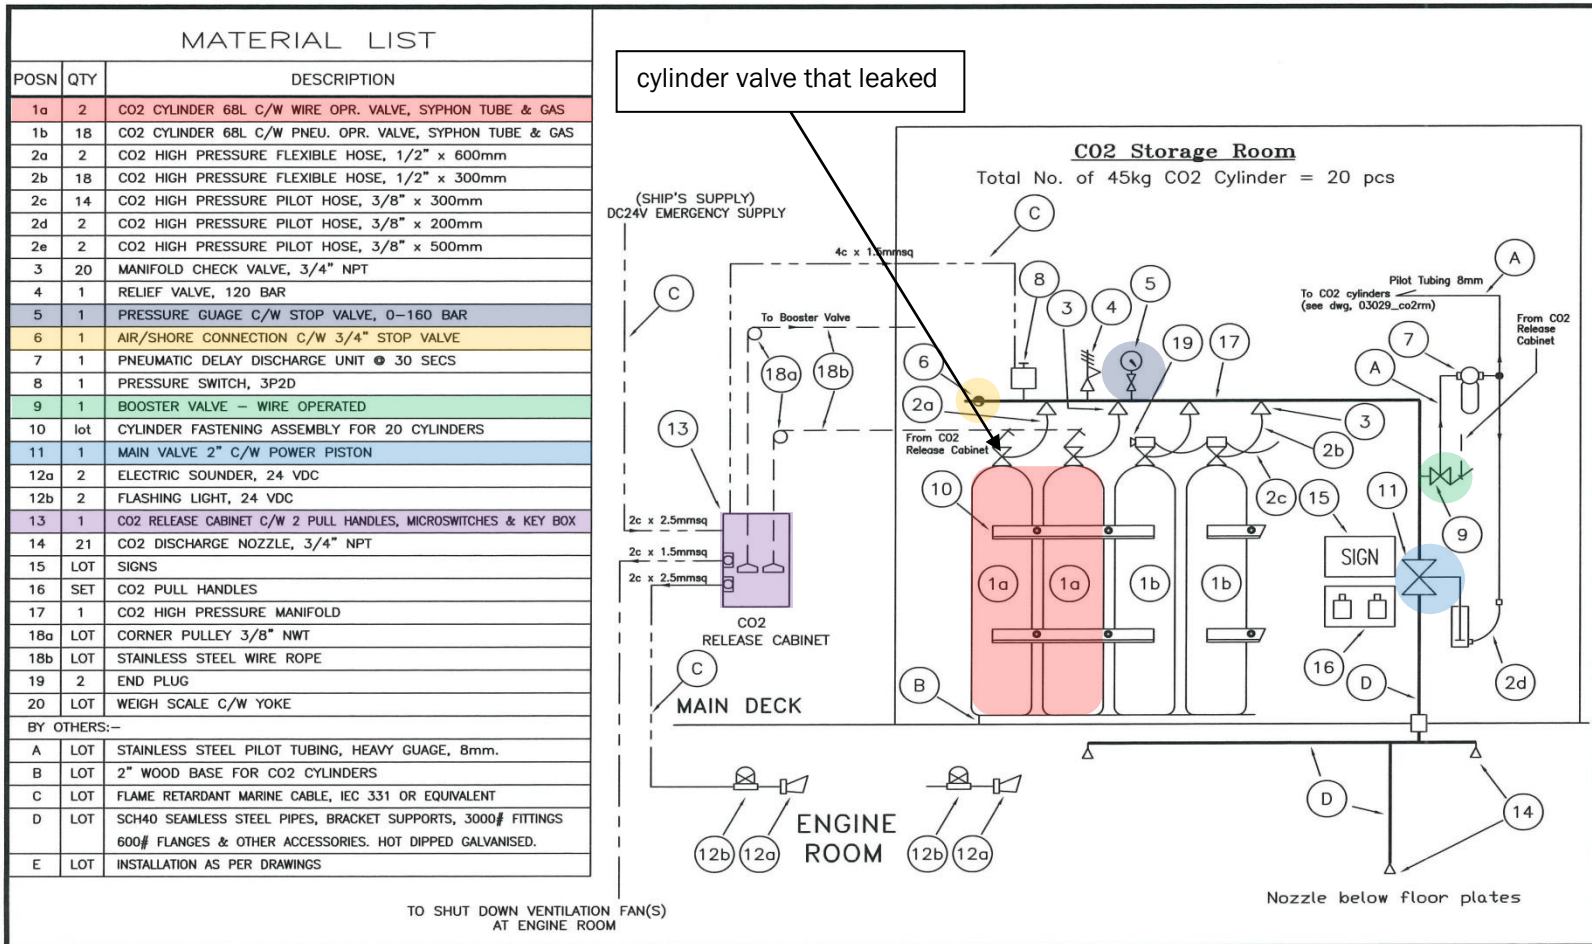
- 3.2.3. The operator goes to the remote CO₂ release cabinet, unlocks it and opens the door (item No. 13 shaded purple). Opening the door releases a micro-switch that activates the CO₂ alarm in the engine room and switches off the engine room air supply fans. The alarm serves to warn all persons to evacuate the engine room and the fans are stopped to prevent the CO₂ gas being displaced by fresh air. Inside the cabinet are 2 handles, of which one is mechanically connected to the valves on the 2 pilot cylinders inside the CO₂ room. Pulling this handle opens the pilot cylinder valves and CO₂ gas fills and pressurises the CO₂ manifold (item No. 17). If the engine room CO₂ alarm had not already been activated, a pressure switch installed on the manifold would activate it then (item No. 8).

- 3.2.4. No CO₂ gas has been released into the engine room at this point, and neither should it until the second handle is pulled. This second handle opens the boost valve (item No. 9 shaded in green). Opening this boost valve achieves 2 things; the first is it uses the CO₂ pressure in the manifold to activate a "gang release" mechanism that opens the valves of the other 18 CO₂ cylinders and CO₂ from those cylinders is open to the pressure manifold. The "gang release" mechanism is not shown in Figure 4.

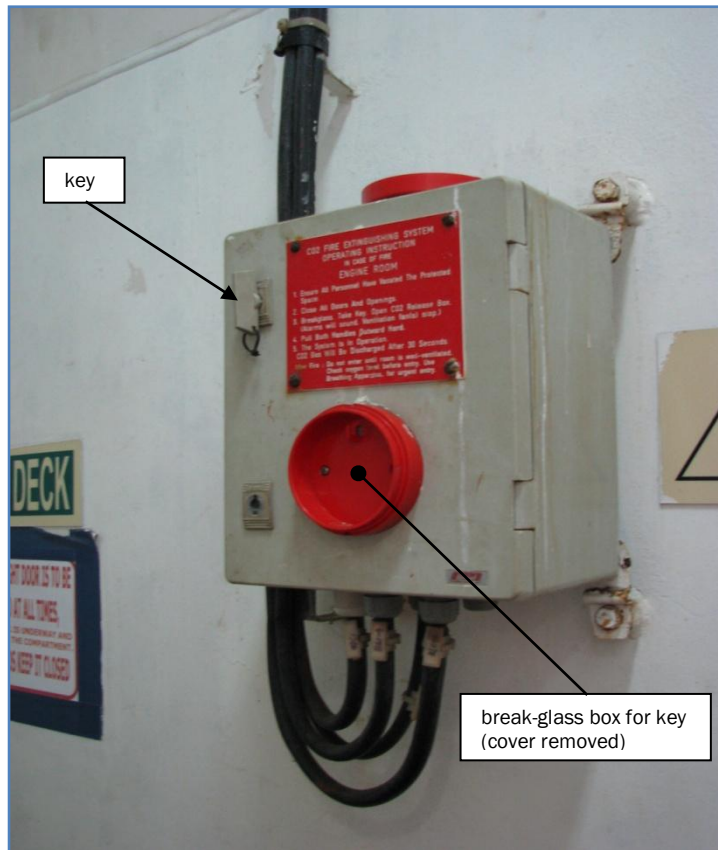
Figure 3
CO₂ system remote release box

- 3.1.7. Once the third engineer had vacated the engine room he contacted the night-master using the radio to advise him that the CO₂ alarm had been activated and he was going to investigate the cause. He then made his way to the CO₂ remote control cabinet (see Figure 3) that was located outside the CO₂ room.

- 3.1.8. When the third engineer got to the cabinet, he found it locked as it should have been. Opening the door to the control cabinet normally released a microswitch that sounded the CO₂ alarm in the engine room. The microswitch had in the past developed a fault that erroneously sounded the CO₂ alarm, even though the door was closed, so he unlocked the cabinet to see if he could find any fault with the alarm microswitch. At this time the chief engineer arrived and together they could not find any fault with the switch. The chief engineer retrieved the key for the CO₂ room and opened the door so they could inspect the CO₂ installation.

- 3.1.9. On entering the CO₂ room they noticed that the pressure gauge for the CO₂ manifold was registering a pressure of about 30 bar [3 megaPascals]. They also found that the discharge hose on the number one (No.1) pilot cylinder was covered with condensation and frosted (see Figure 3). The chief engineer then opened the air/shore connection ball valve in an attempt to vent the gas in the manifold to atmosphere and reduce the pressure on the line. The pressure initially reduced, but the escaping CO₂ iced up and blocked the ball valve, and the pressure in the manifold began to rise again.
