Inquiry 10-204: Bulk carrier *Hanjin Bombay*, grounding,
Mount Maunganui, 21 June 2010

Final Report

Marine inquiry 10-204
Bulk carrier *Hanjin Bombay*, grounding,
Mount Maunganui, 21 June 2010

Transport Accident Investigation Commission

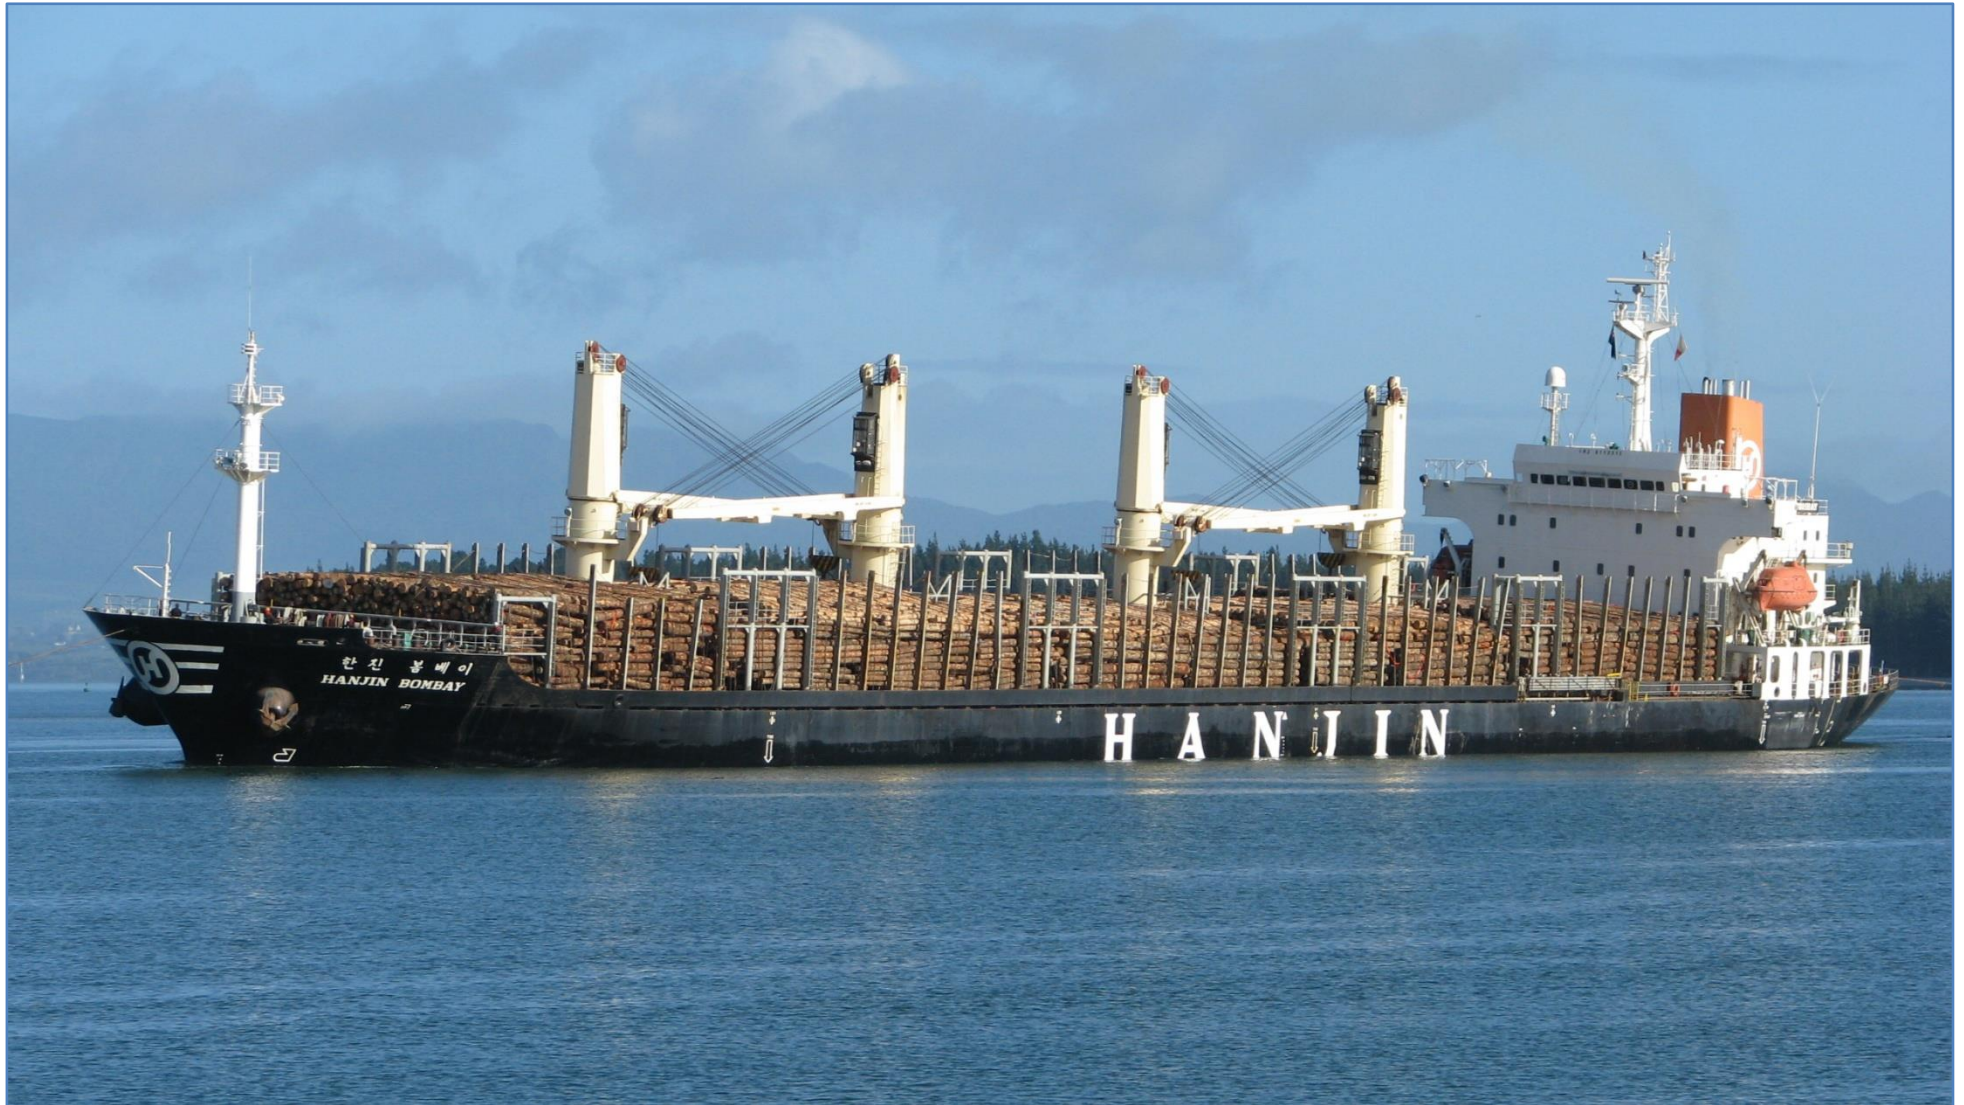
The *Hanjin Bombay* re-entering Tauranga Harbour after the accident

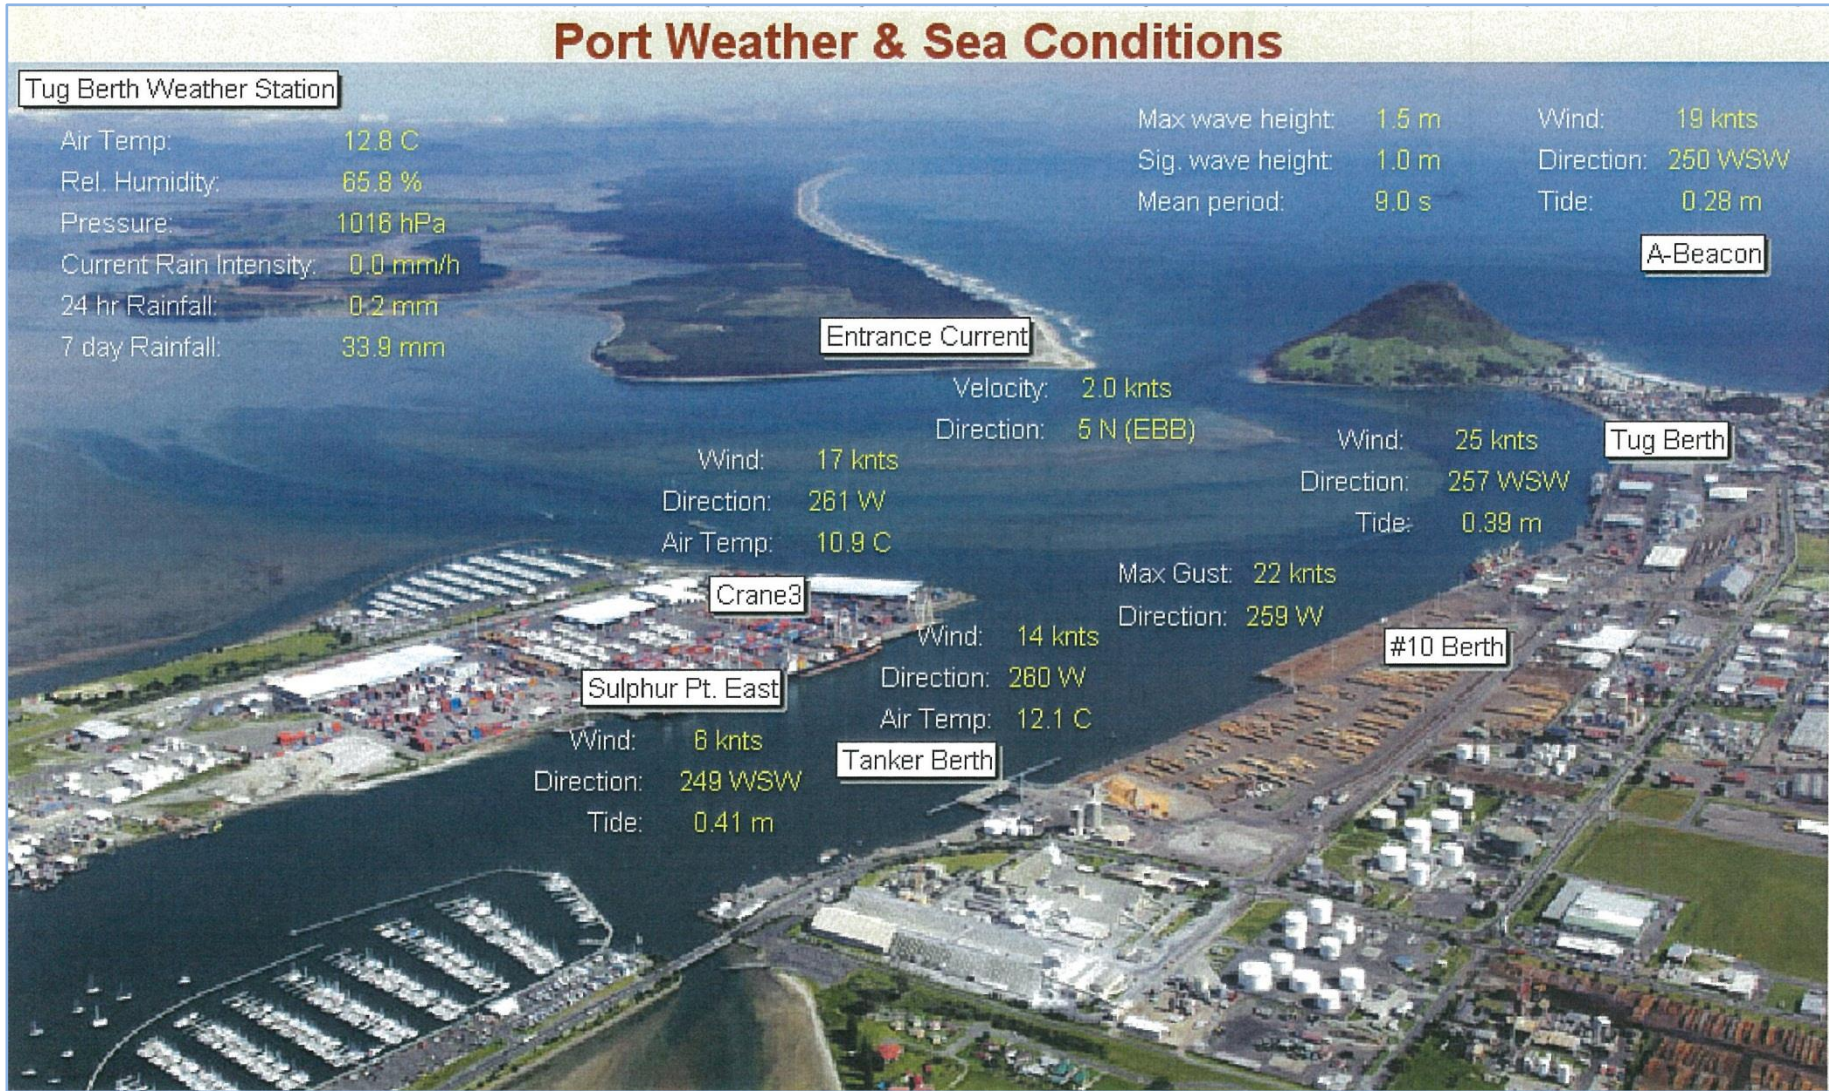
Figure 4
Climatic conditions for the port of Tauranga at the time of the grounding

- 3.7.1 Port of Tauranga Limited had numerous meteorological sensors around the port, which were used to produce a picture of the conditions within the port and out to “A” beacon. The prevailing conditions at the time of the accident are shown in Figure 4, which for “A” beacon are wind from a west-south-westerly direction with a speed of about 19 knots, a significant wave height of 1 m and a tidal height of 0.28 m. The tidal stream in the entrance channel was running at about 2 knots in a northerly direction (ebbing).
